#### Airworthiness Directives; Boeing Model 747-400 Series Airplanes Equipped With General Electric Model CF6-80C2 Series Engines

**ACTION:** Notice of proposed rulemaking (NPRM).

**Boeing:** Docket 2002–NM–128–AD.  
Supersedes AD 2000–09–03,  
Amendment 39–11711.

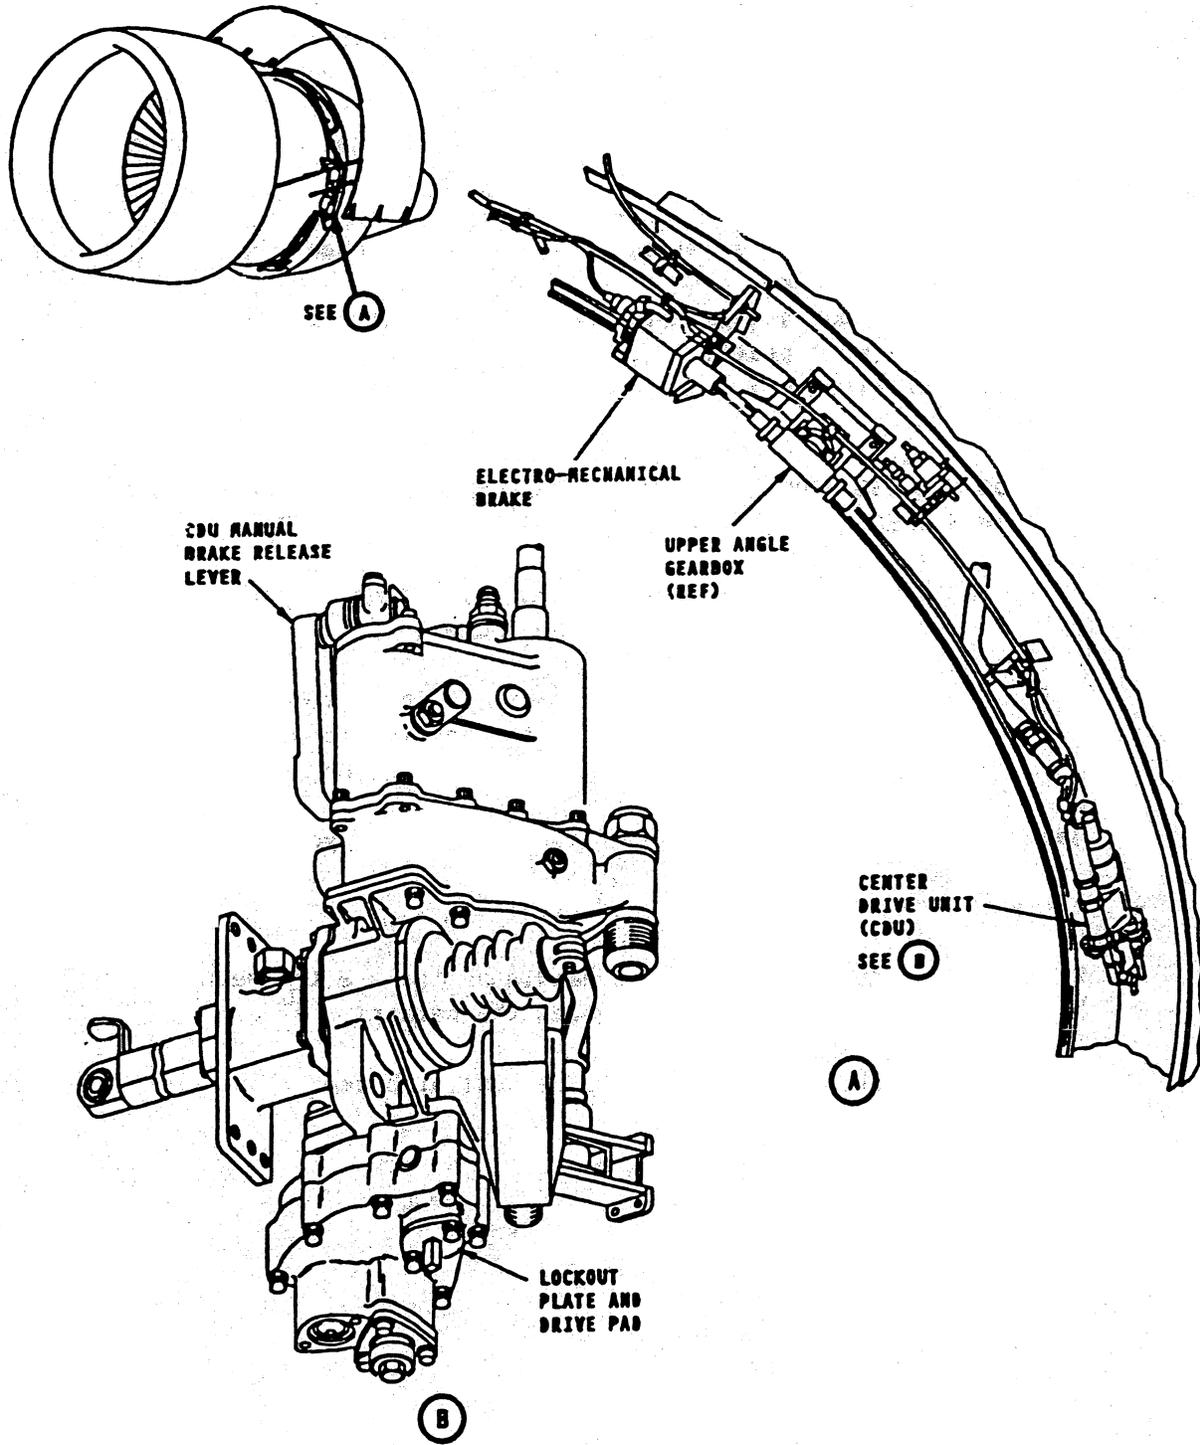
Electro-Mechanical Brake and CDU Cone Brake Torque Check  
Figure 1

**Caution:** Do not use more than 100 pound-inches of torque when you do this check. Excessive torque will damage the CDU.

(8) If the torque is less than 15 pound-inches, you must replace the CDU.
