[Docket No. 2002-SW-25-AD]

Airworthiness Directives; Schweizer Aircraft Corporation Model 269A, 269A-1, 269B, 269C, and TH-55A Helicopters**AGENCY:** Federal Aviation Administration, DOT.**ACTION:** Notice of proposed rulemaking (NPRM).

Schweizer Aircraft Corporation: Docket No. 2002-SW-25-AD. Supersedes AD 2001-25-52, Amendment 39-12726, Docket No. 2001-SW-58-AD.

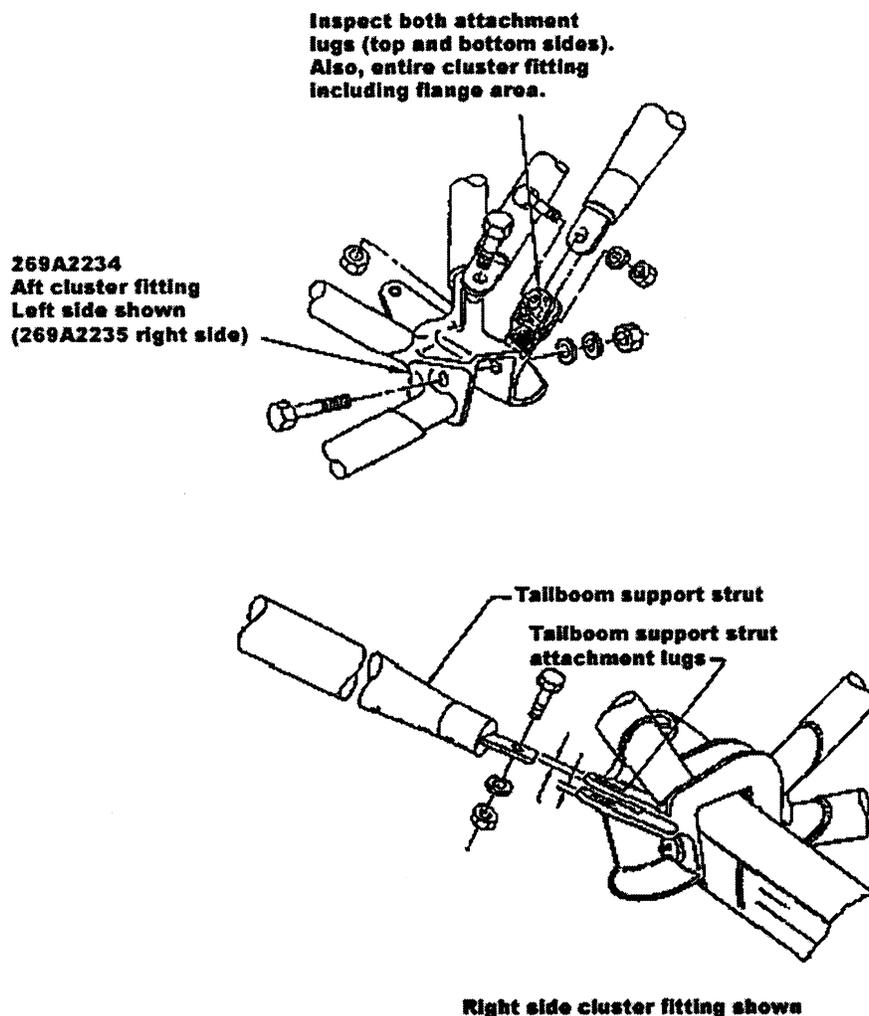
Figure 1

(2) Dye-penetrant inspect the lugs on each cluster fitting. See the following Figure 1:

(3) If a crack is found, before further flight, replace the cracked cluster fitting with an airworthy cluster fitting.
