DEPARTMENT OF TRANSPORTATION

[Docket No. 2002-SW-31-AD]

Airworthiness Directives; Model HH-1K, TH-1F, TH-1L, UH-1A, UH-1B, UH-1E, UH-1F, UH-1H, UH-1L, and UH-1P; and Southwest Florida Aviation Model SW204, SW204HP, SW205, and SW205A-1 Helicopters, Manufactured by Bell Helicopter Textron, Inc. (BHTI) for the Armed Forces of the United States

ACTION: Notice of proposed rulemaking (NPRM).

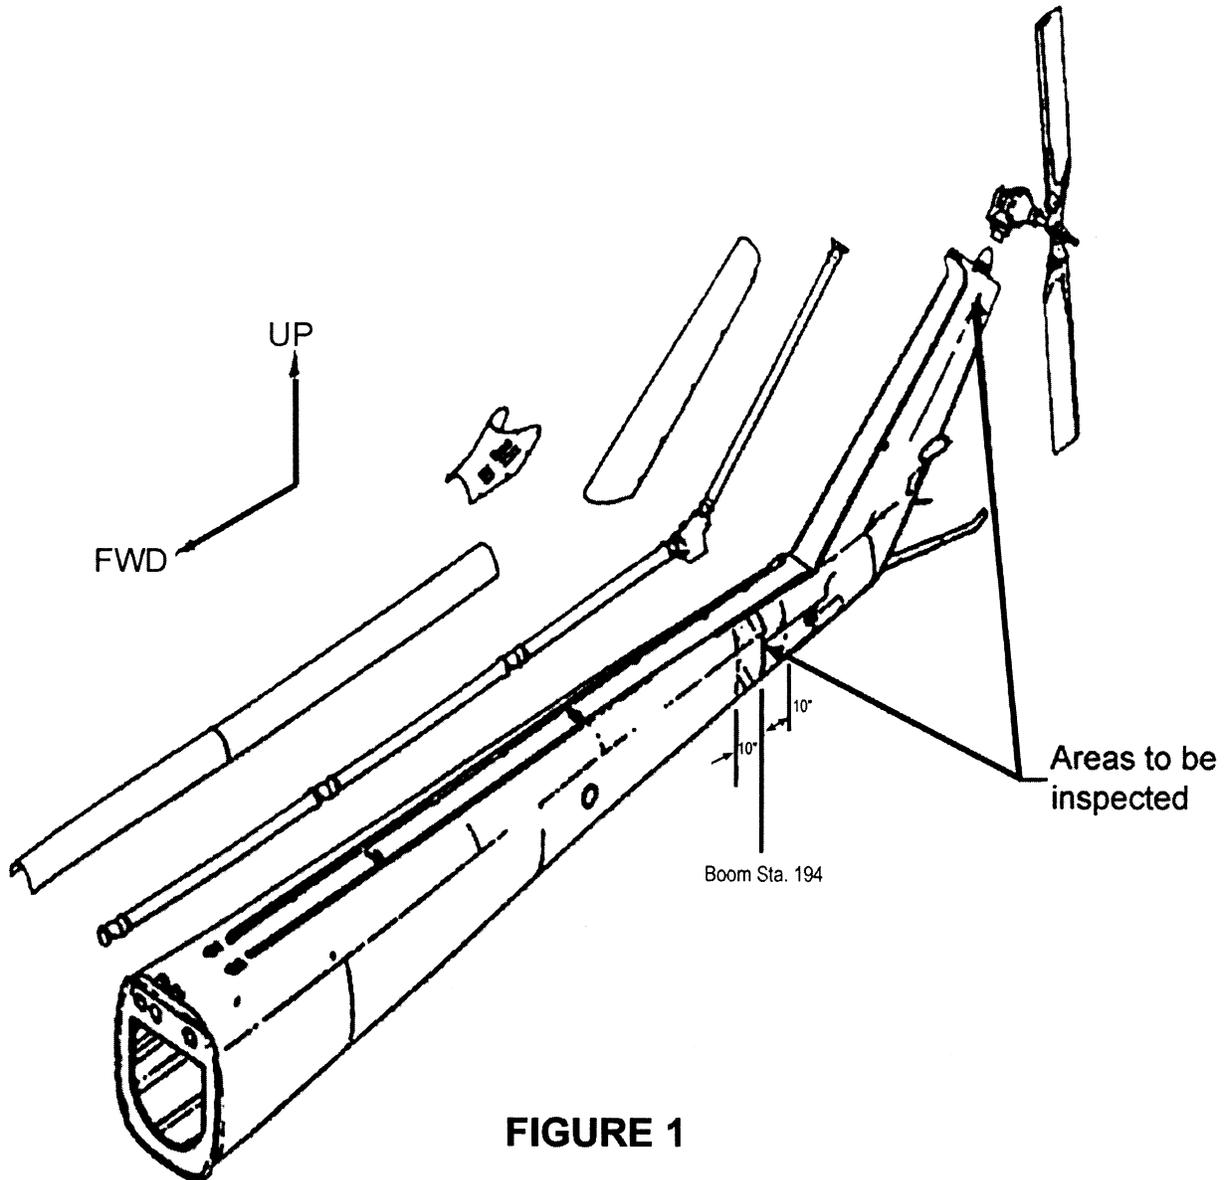
FIGURE 1

To detect a crack in the skin of a tailboom assembly, tail rotor gearbox support fitting, or vertical fin spar, which could cause failure of the tailboom and loss of control of the helicopter, accomplish the following:

(1) Visually inspect the tailboom assembly skin joint at Boom Station (BS) 194 for fretting, corrosion, loose or working rivets, or a crack. Inspect 10 inches forward and 10 inches aft of BS 194 (BS 194 skin joint area) as shown in the following Figure 1:

Note 2: The tailboom skin joint at BS 194 is located at the bulkhead just forward of the attachment area for the 42-degree tail rotor gearbox assembly (42-degree gearbox) and the intersection between the vertical fin forward canted bulkhead and the lower tailboom skin.

(2) Visually inspect the vertical fin forward spar caps (2) for a crack at the intersection with the tail rotor gearbox support fitting. Refer to Figure 1 of this AD.

(b) Before further flight, and thereafter at intervals not to exceed 500 hours TIS, radiographically inspect the BS 194 skin joint area in accordance with the requirements of ASTM E 1742-00, MIL-STD-453C, or another FAA-accepted equivalent, for any tailboom assembly with:

(c) If a crack is found in any part, replace it with an airworthy part before further flight. Repair any corrosion or other damage that exceeds the limitations in the maintenance or overhaul manuals before further flight.
