DEPARTMENT OF TRANSPORTATION

[Docket No. 2002-SW-31-AD]

Airworthiness Directives; Model HH-1K, TH-1F, TH-1L, UH-1A, UH-1B, UH-1E, UH-1F, UH-1H, UH-1L, and UH-1P; and Southwest Florida Aviation Model SW204, SW204HP, SW205, and SW205A-1 Helicopters, Manufactured by Bell Helicopter Textron, Inc. (BHTI) for the Armed Forces of the United States

ACTION: Notice of proposed rulemaking (NPRM).

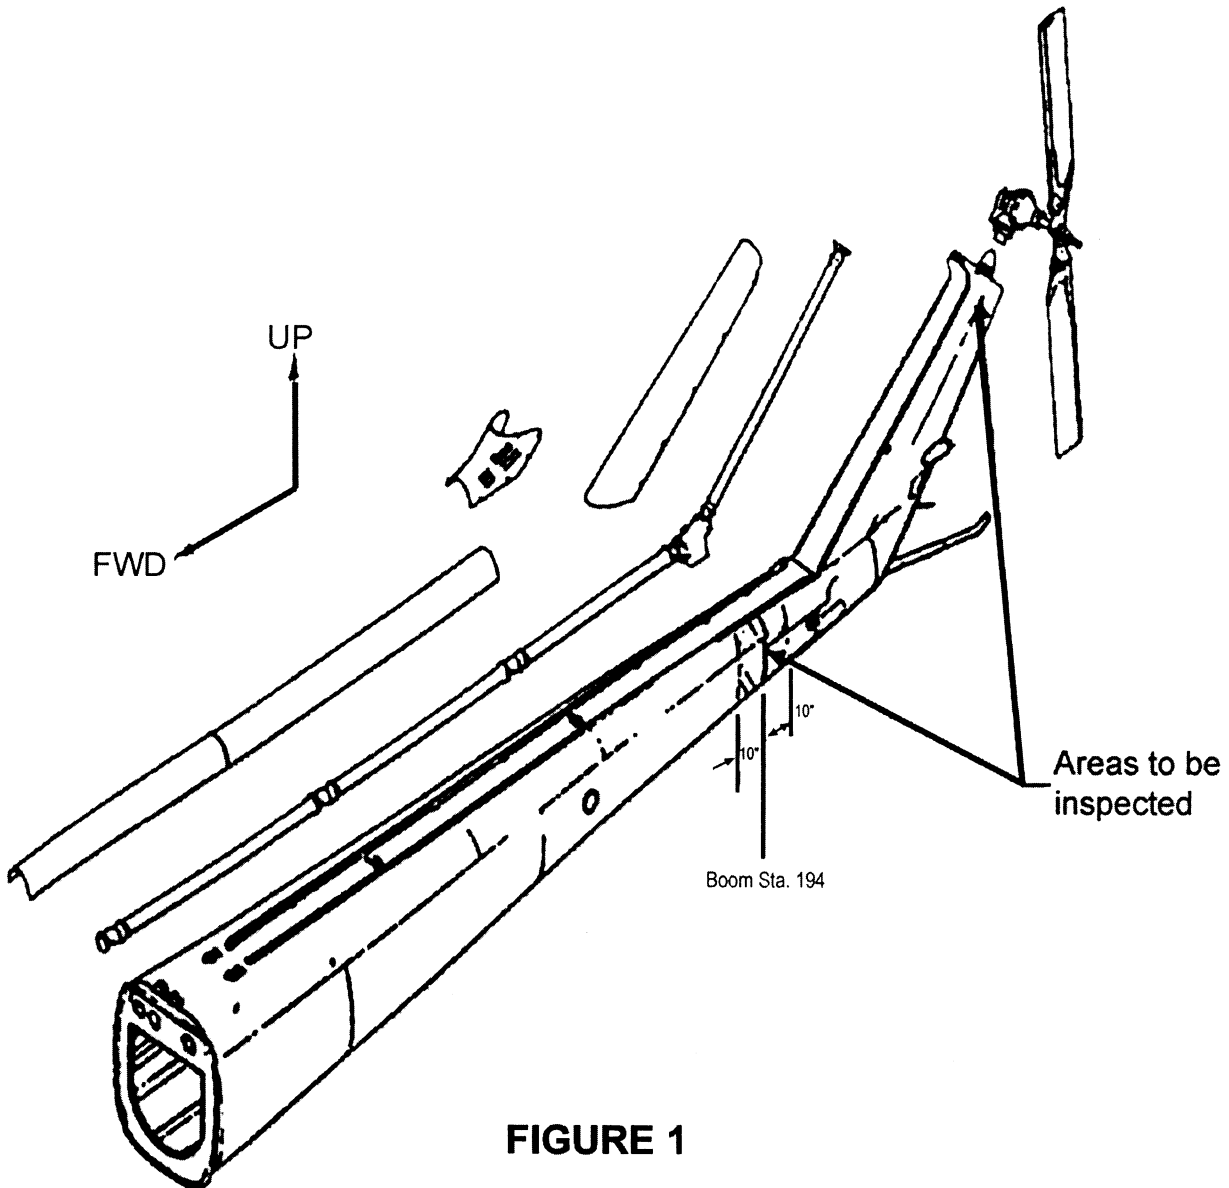
FIGURE 1

(1) Visually inspect the tailboom assembly skin joint at Boom Station (BS) 194 for fretting, corrosion, loose or working rivets, or a crack. Inspect 10 inches forward and 10 inches aft of BS 194 (BS 194 skin joint area) as shown in the following Figure 1:

Note 2: The tailboom skin joint at BS 194 is located at the bulkhead just forward of the attachment area for the 42-degree tail rotor gearbox assembly (42-degree gearbox) and the intersection between the vertical fin forward canted bulkhead and the lower tailboom skin.

(2) Visually inspect the vertical fin forward spar caps (2) for a crack at the intersection with the tail rotor gearbox support fitting. Refer to Figure 1 of this AD.

(1) Any fretting, corrosion, loose or working rivets, or a crack in the BS 194 skin joint area; or

(b) Before further flight, and thereafter at intervals not to exceed 500 hours TIS, radiographically inspect the BS 194 skin joint area in accordance with the requirements of ASTM E 1742-00, MIL-STD-453C, or another FAA-accepted equivalent, for any tailboom assembly with:

(c) If a crack is found in any part, replace it with an airworthy part before further flight. Repair any corrosion or other damage that exceeds the limitations in the maintenance or overhaul manuals before further flight.
