[Docket No. 2003-SW-06-AD; Amendment 39-13064; AD 2003-04-15]

Airworthiness Directives; Sikorsky Aircraft Corporation Model S-76A, B, and C Helicopters

2003-04-15 Sikorsky Aircraft Corporation: Amendment 39-13064. Docket No. 2003-SW-06-AD.

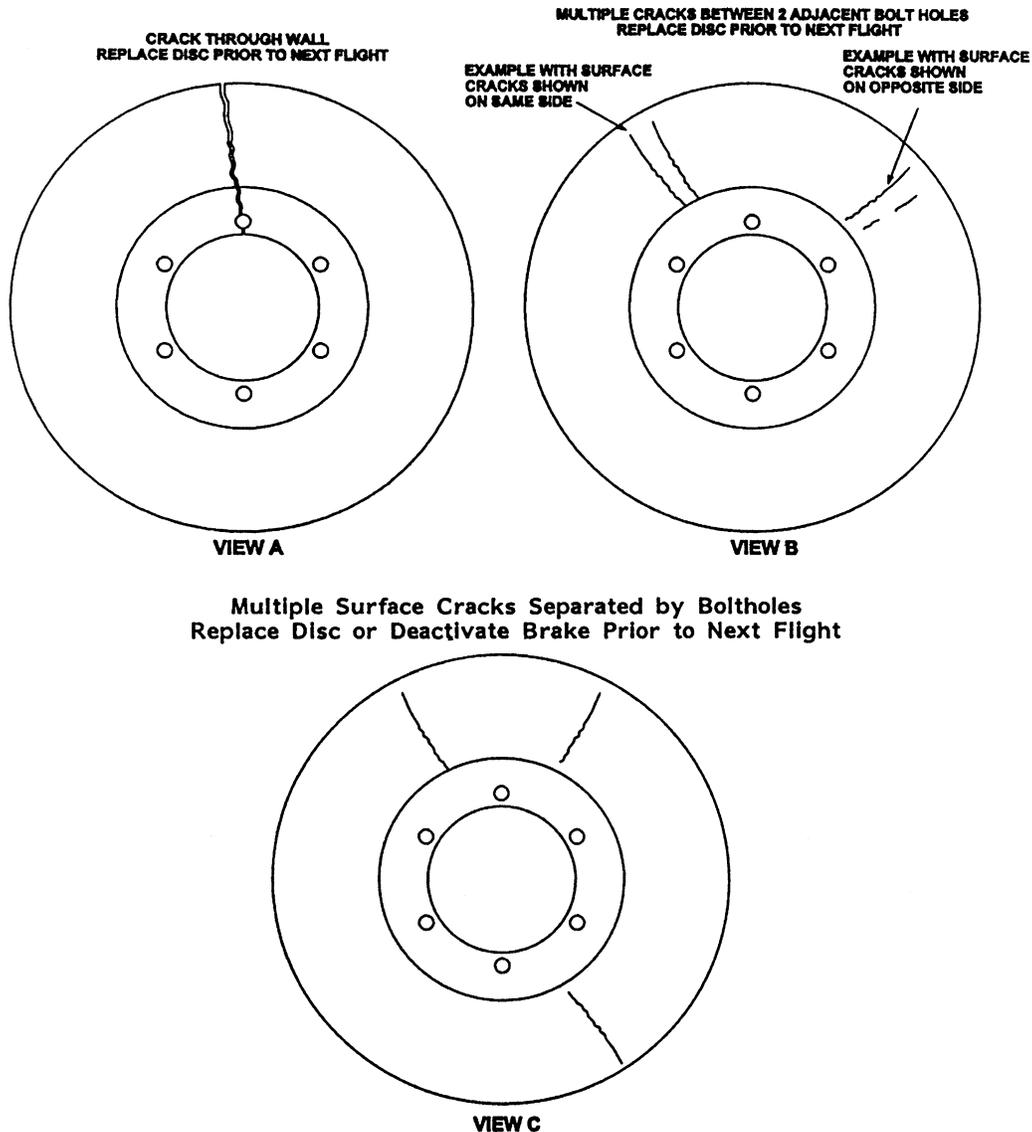
**RBD INSPECTION LIMITS
FIGURE 1.**

(b) Before the first flight of the next day following any day in which the RBD was used, visually inspect each RBD, P/N 76363-09103-104, for a crack, and perform the following actions. See Figure 1.

Note 3: Short "glazing" cracks are not a cause for rejection.

(1) If you find a crack through the entire RBD thickness as shown in Figure 1, View A, replace the RBD with an airworthy RBD, other than P/N 76363-09103-104, before further flight.

(2) If you find two or more surface cracks between adjacent boltholes as shown in Figure 1, View B, replace the RBD with an airworthy RBD, other than P/N 76363-09103-104, before further flight.

(3) If you find a surface crack or surface cracks separated by the boltholes as shown in Figure 1, View C, replace the RBD with an airworthy RBD, other than P/N 76363-09103-104, or deactivate the RBD before further flight.
