[Docket No. 2002-SW-55-AD; Amendment 39-13060; AD 2002-25-51]

#### Airworthiness Directives; Agusta S.p.A. Model A109E Helicopters

**2002-25-51 Agusta S.p.A (Agusta):** Docket No. 2002-SW-55-AD. Supersedes AD 2002-17-51, Amendment 39-12936, Docket No. 2002-SW-42-AD.

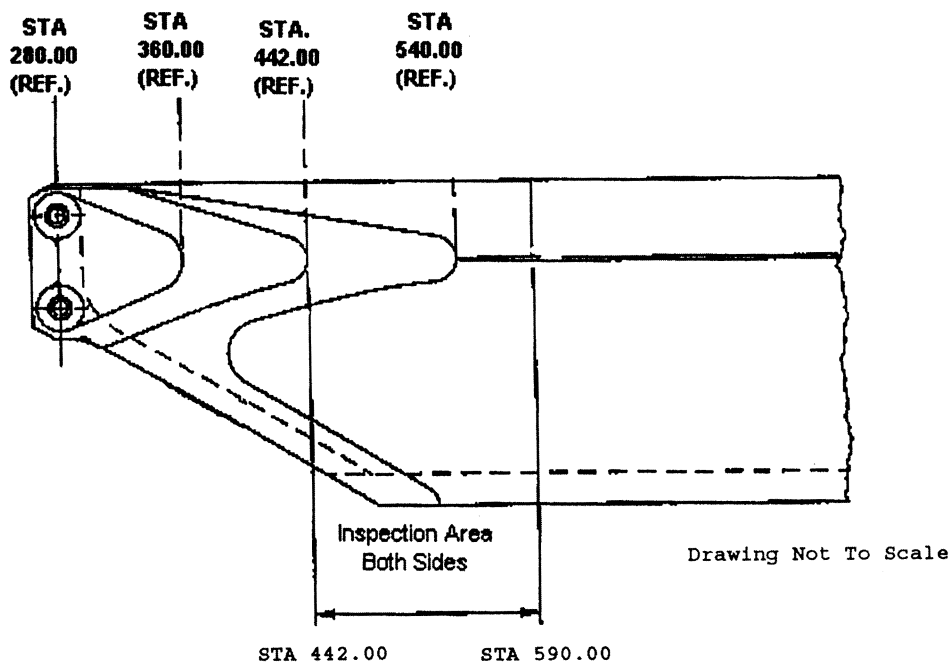
FIGURE 1

(b) Before each start of the helicopter engines, visually check both sides of each tail rotor blade for a crack in the area depicted in Figure 1 of this AD. An owner/operator (pilot) holding at least a private pilot certificate may perform this visual check and must enter compliance with this paragraph into the aircraft maintenance records in accordance with 14 CFR 43.11 and 91.417(a)(2)(v). See Figure 1:

Part Number 109-8132-01-111 Tail Rotor Blade

rotor blade for a crack in the area depicted in Figure 1 of this AD. An owner/operator (pilot) holding at least a private pilot certificate may perform this visual check and must enter compliance with this paragraph into the aircraft maintenance records in accordance with 14 CFR 43.11 and 91.417(a)(2)(v). See Figure 1.

(d) Before further flight, replace any unairworthy T/R blade with an airworthy blade.

(j) Before further flight, replace any unairworthy T/R blade with an airworthy blade.
