Federal Register

Thursday, March 13, 2003

[Docket No. 2001-SW-53-AD; Amendment 39-13079; AD 2003-05-03]

#### Airworthiness Directives; Bell Helicopter Textron Canada Model 407 Helicopters

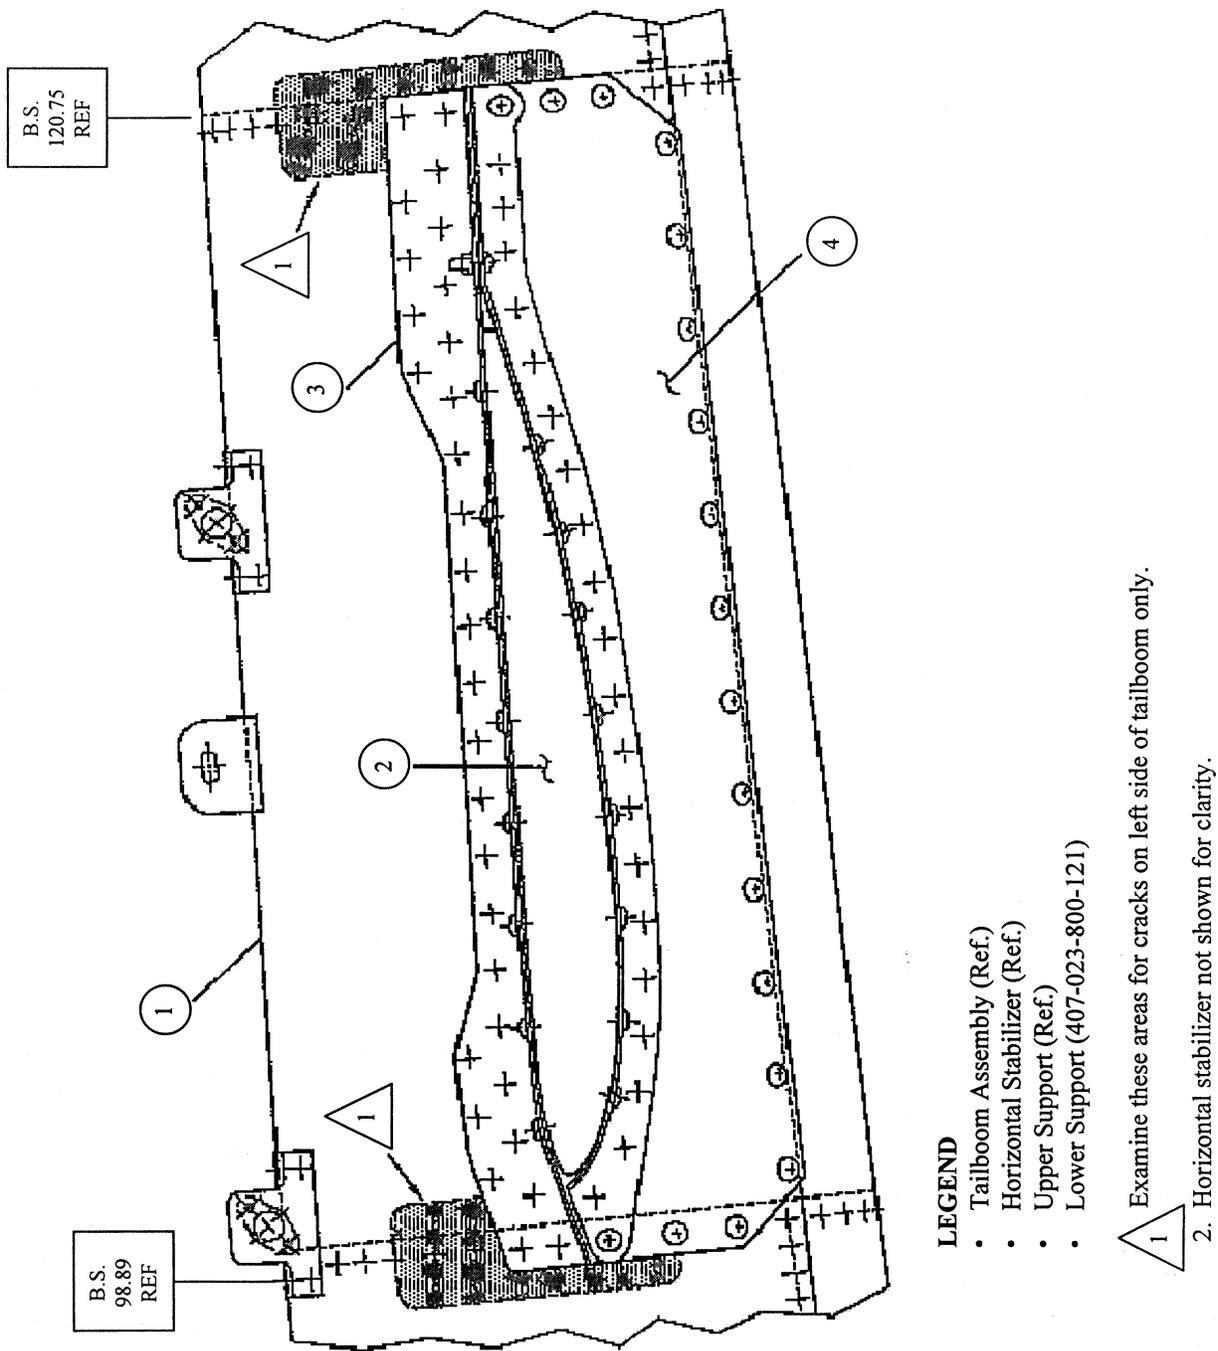
Figure 1. Preflight Check of the Tailboom

Applicable tailboom	Compliance time	Actions	In accordance with
(a) Tailboom, P/N 407-030-801-101 and -105, that have not been modified in accordance with Bell ASB 407-01-048, Revision B, dated April 25, 2002.	Before the first flight of each day	Visually check the tailboom for cracks. An owner/operator (pilot) holding at least a private pilot certificate may perform the visual check required by this paragraph, but must enter compliance with this paragraph into the helicopter records in accordance with 14 CFR 43.11 and 91.417(a)(2)(v).	Figure 1 of this AD.

1. Examine these areas for cracks on left side of tailboom only.  
 2. Horizontal stabilizer not shown for clarity.

(f) All applicable part-numbered tailbooms.	Before further flight .....	If a crack is found, replace the tailboom.	The applicable maintenance manual.
