[Docket No. 2002-SW-54-AD; Amendment 39-13087; AD 2003-05-11]

Airworthiness Directives; Bell Helicopter Textron Canada Model 407 Helicopters

2003-05-11 Bell Helicopter Textron

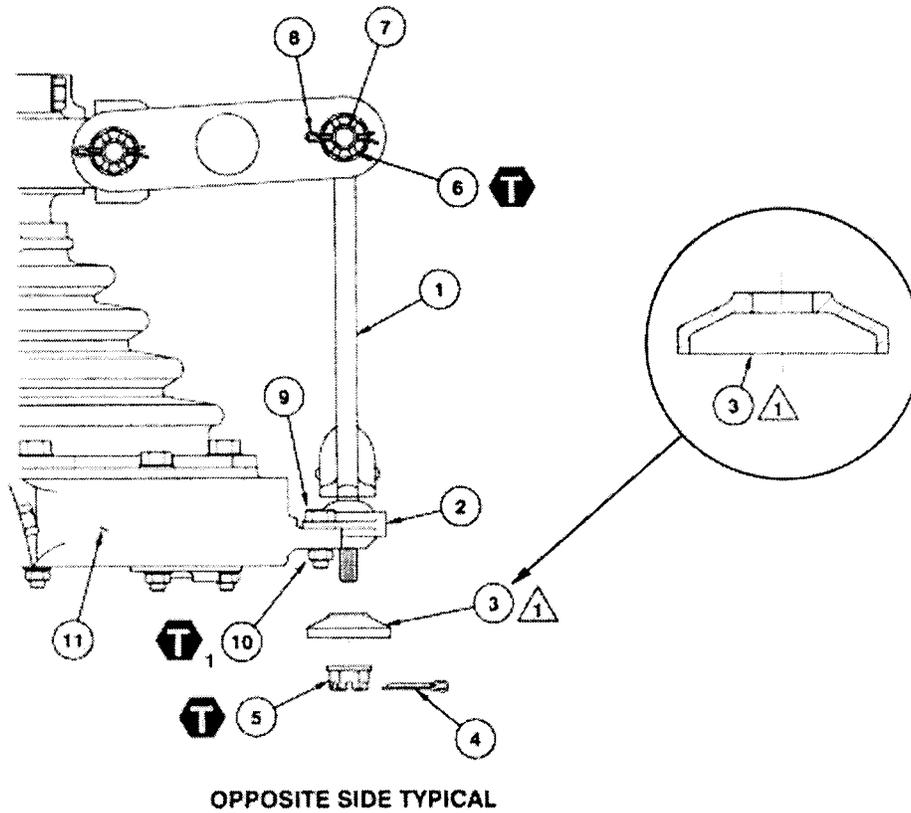
Figure 1. Correct cup washer direction, installation of

To detect an incorrectly installed swashplate drive link cup washer (cup washer), which could limit the travel of the swashplate outer ring and lead to failure of the stud portion of the swashplate drive link, and subsequent loss of control of the helicopter, accomplish the following:

(a) Visually check both cup washers, part number (P/N) 406-010-412-101, for correct installation in accordance with Figure 1 of this AD. If both cup washers are installed correctly, no further action is required. This visual check may be performed by an owner/operator (pilot) holding at least a private pilot certificate, and must be entered into the aircraft records showing compliance with this paragraph in accordance with sections 43.11 and 91.417(a)(2)(v) of the Federal Aviation Regulations (14 CFR sections 43.11 and 91.417(a)(2)(v)). See the following Figure 1:

- Washer shown is correctly installed.
- 2. Washers under bolt head (9) and nut (10) are not shown for clarity.

(b) If a cup washer is installed incorrectly, remove and replace the swashplate outer ring, each cup washer, bearing and liner, and drive link where the cup washer was installed incorrectly. Replace these parts in accordance with Part II of the Accomplishment Instructions in Bell Helicopter Textron Alert Service Bulletin No. 407-02-55, dated October 29, 2002.

Note 2: In Part II, step 3.a. of the alert service bulletin, the swashplate is incorrectly referenced as item 10 of Figure 1. The reference should state item 11.
