[Docket No. 2000-SW-12-AD]

Airworthiness Directives; Eurocopter France Model AS350B, B1, B2, B3, BA, C, D, D1, and AS355E, F, F1, F2, and N Helicopters

ACTION: Supplemental notice of proposed rulemaking; reopening of comment period.

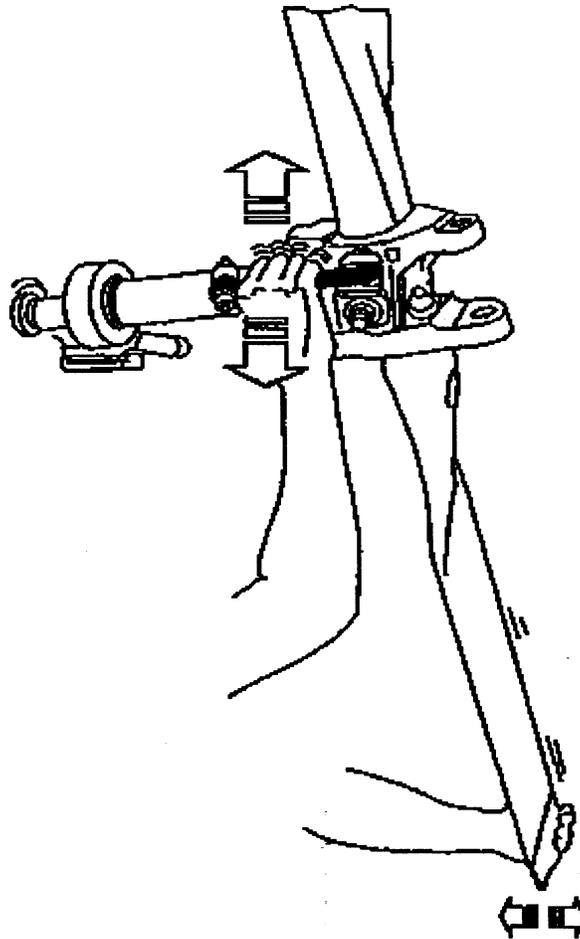
Figure 1: Manual Check for Play of the Tail Rotor Pitch Control Rod

(a) Before the first flight of each day, place the tail rotor pedals in the neutral position. If the helicopter is fitted with a tail rotor load compensator, discharge the accumulator as described in the rotorcraft flight manual. Check the bearing for play on the helicopter, by observation and feel, by slightly moving the tail rotor blade in the flapping axis while monitoring the bearing for movement. See the following Figure 1 of this AD:

(1) If the Teflon cloth is coming out of its normal position within the bearing, totally or partially, or if there is discoloration or scoring on the bearing, the bearing is unairworthy.

(2) An owner/operator (pilot) holding at least a private pilot certificate may perform this check and must enter compliance into the aircraft maintenance records in accordance with 14 CFR 43.11 and 91.417(a)(2)(v).

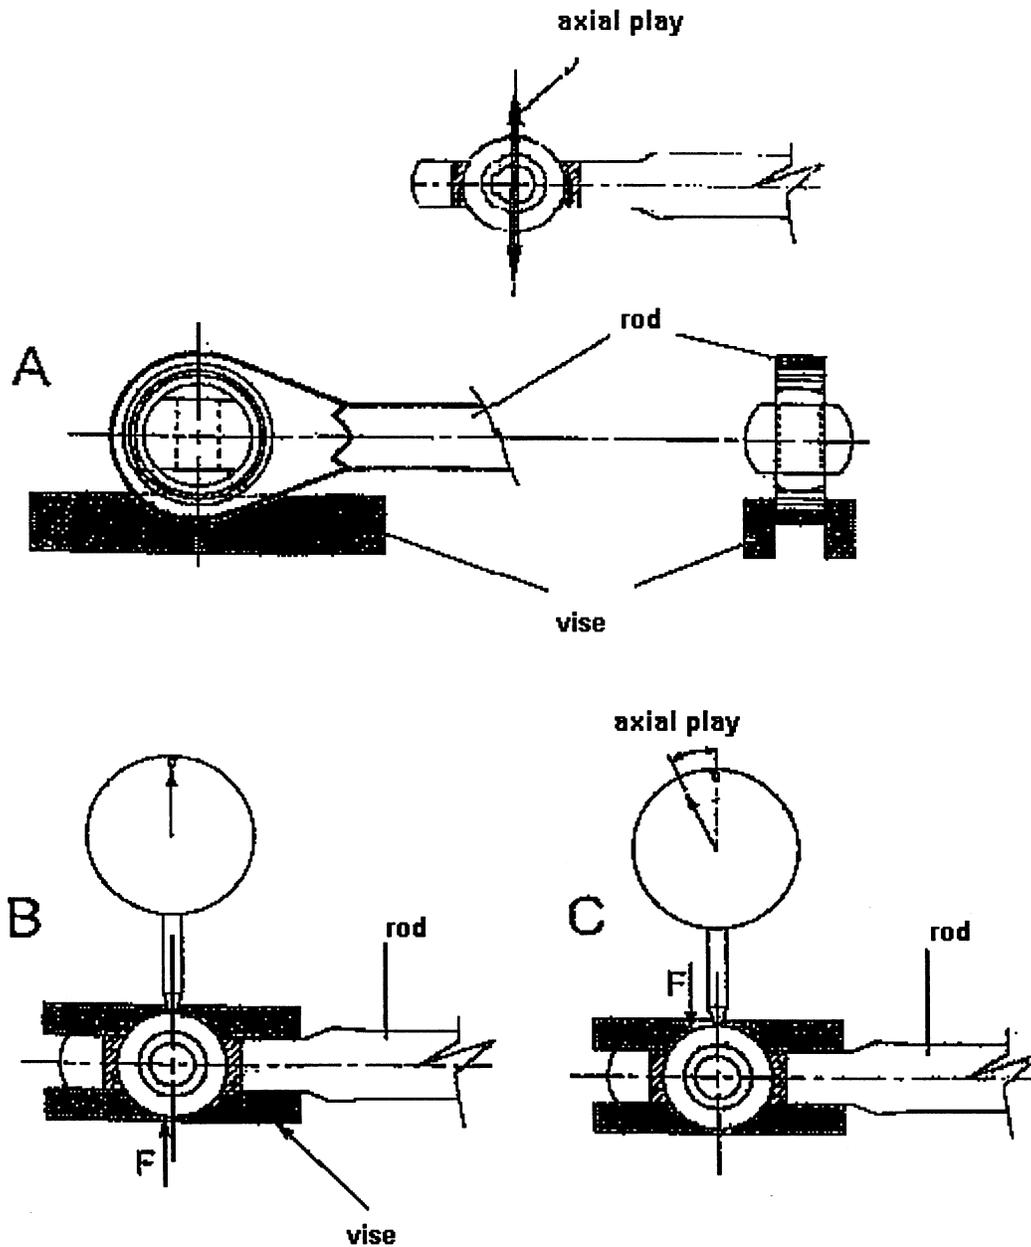
Figure 2: Measurement of the Axial Play (A) of the Bearing

(b) If a pilot or mechanic detects play, a mechanic must remove the control rod from the helicopter, and using a dial indicator, measure the bearing wear according to the following and as shown in Figures 2 and 3 of this AD:

(2) Mount the control rod in a vise as shown in Figure 2 of this AD.

(3) Using a dial indicator, take axial play readings by moving the spherical bearing in the direction F (up and down) as shown in Figure 2 of this AD.

(8) If the radial play exceeds 0.008 inch or axial play exceeds 0.016 inch, replace the

control rod with an airworthy control rod before further flight.

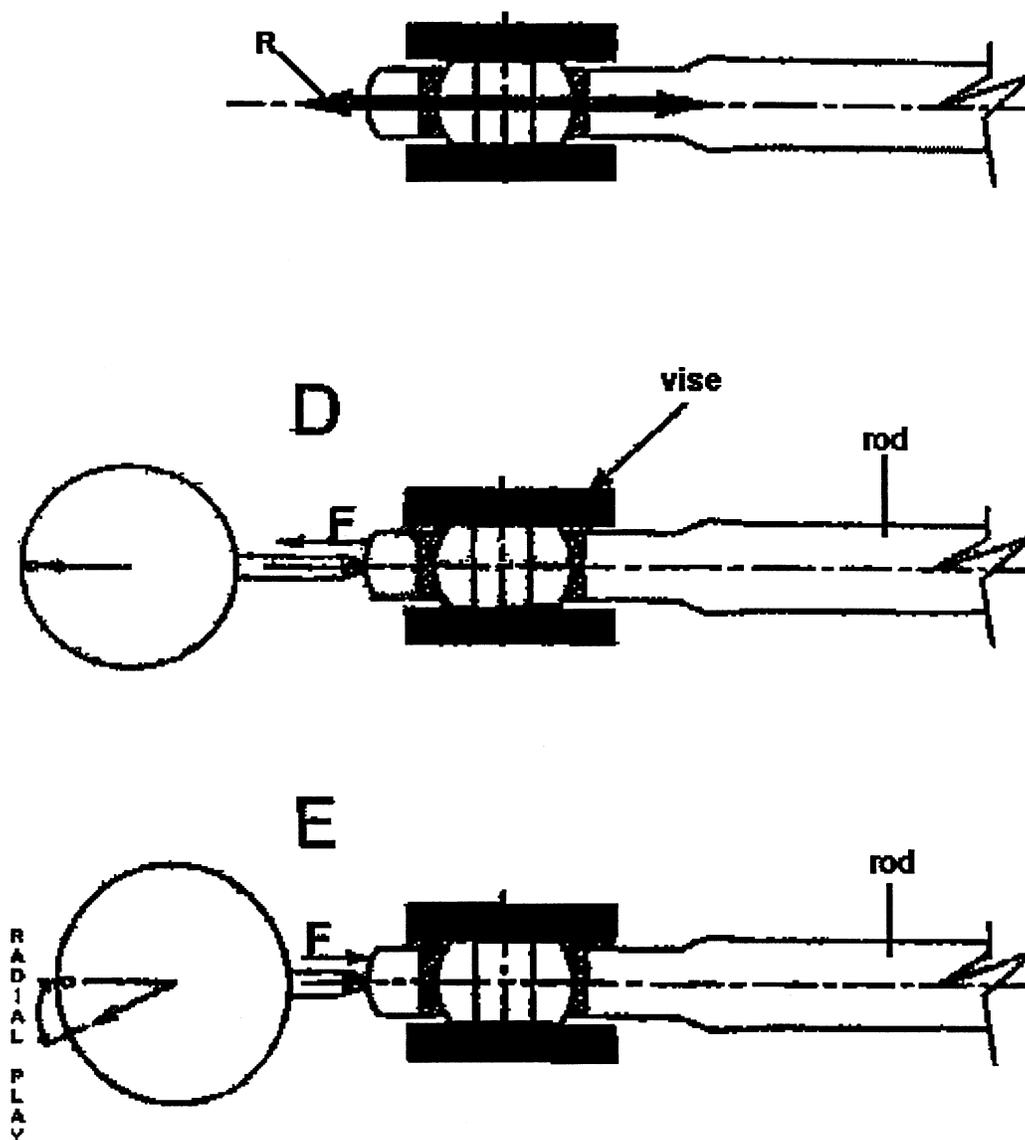
Figure 3: Measurement of the Radial Play (R) of the Bearing

(5) Mount the bearing in a vise as shown in Figure 3 of this AD.

(6) Using a dial indicator, take radial play measurements by moving the control rod in the direction F as shown in Figure 3 of this AD.
