[Docket No. 2000-SW-12-AD]

Airworthiness Directives; Eurocopter France Model AS350B, B1, B2, B3, BA, C, D, D1, and AS355E, F, F1, F2, and N Helicopters

ACTION: Supplemental notice of proposed rulemaking; reopening of comment period.

Eurocopter France: Docket No. 2000–SW–12–AD.

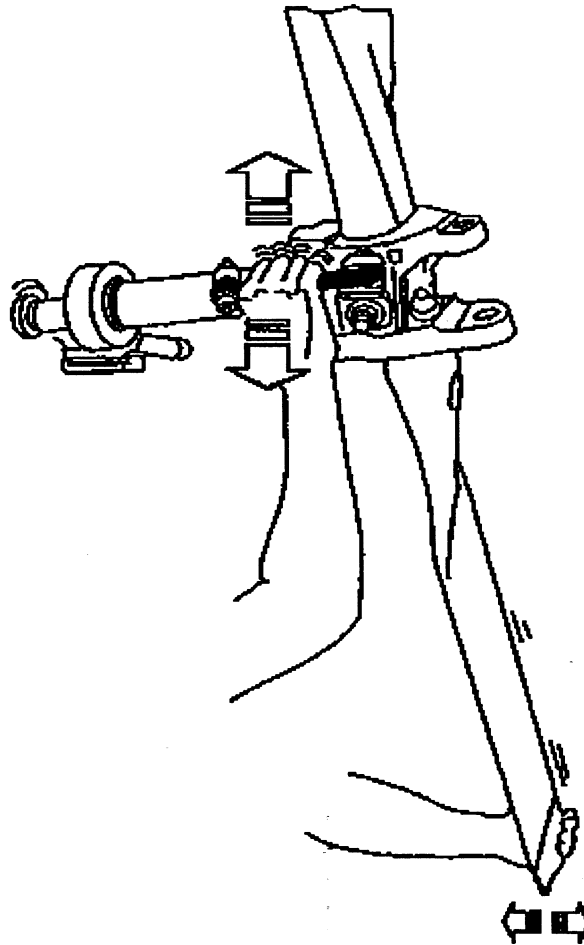
Figure 1: Manual Check for Play of the Tail Rotor Pitch Control Rod

(a) Before the first flight of each day, place the tail rotor pedals in the neutral position. If the helicopter is fitted with a tail rotor load compensator, discharge the accumulator as described in the rotorcraft flight manual. Check the bearing for play on the helicopter, by observation and feel, by slightly moving the tail rotor blade in the flapping axis while monitoring the bearing for movement. See the following Figure 1 of this AD:

(1) If the Teflon cloth is coming out of its normal position within the bearing, totally or partially, or if there is discoloration or scoring on the bearing, the bearing is unairworthy.

(2) An owner/operator (pilot) holding at least a private pilot certificate may perform this check and must enter compliance into the aircraft maintenance records in accordance with 14 CFR 43.11 and 91.417(a)(2)(v).

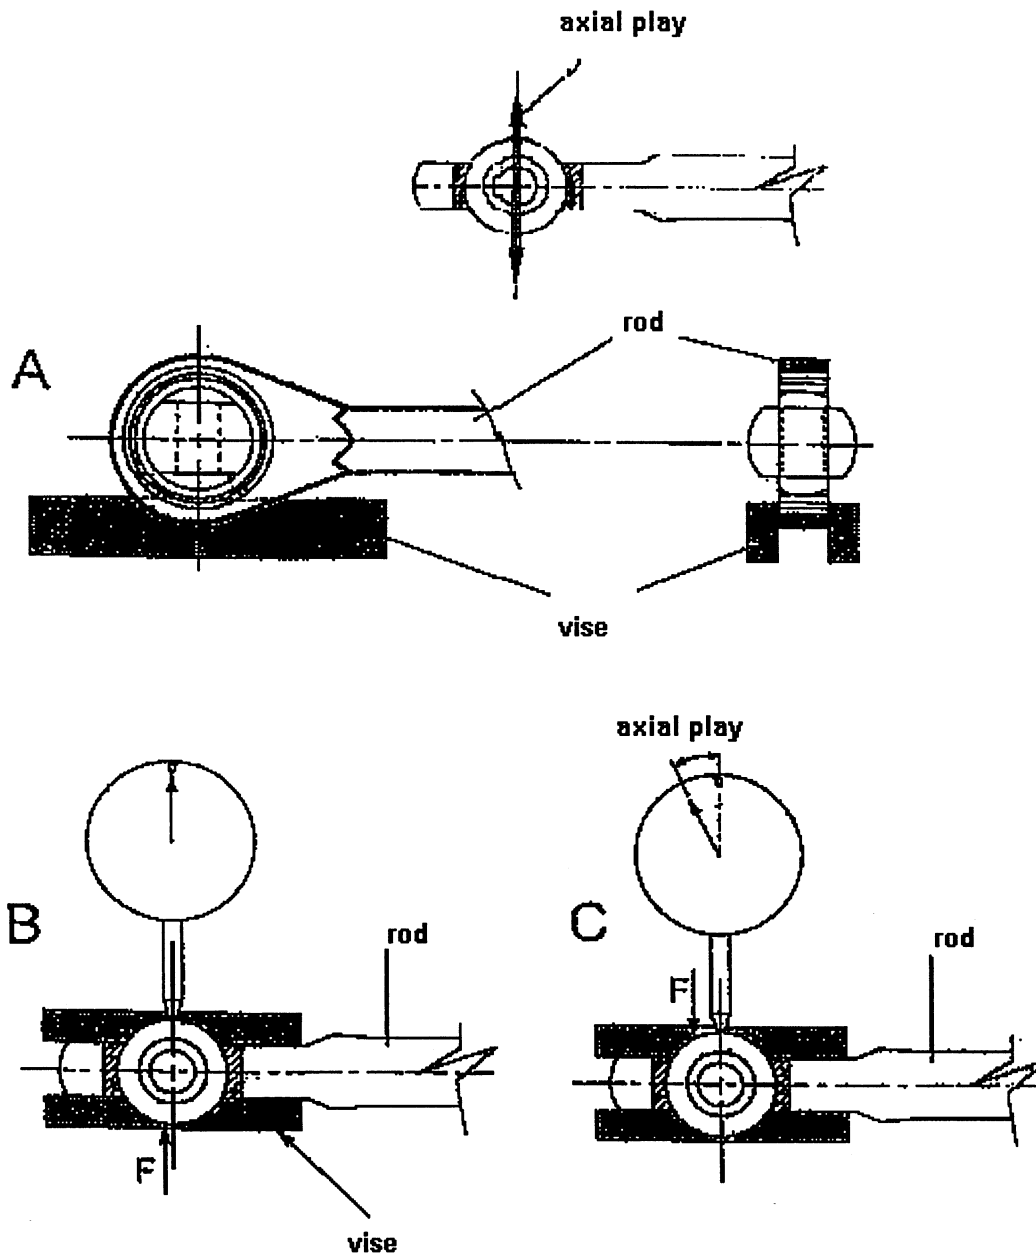
Figure 2: Measurement of the Axial Play (A) of the Bearing

(b) If a pilot or mechanic detects play, a mechanic must remove the control rod from the helicopter, and using a dial indicator, measure the bearing wear according to the following and as shown in Figures 2 and 3 of this AD:

(2) Mount the control rod in a vise as shown in Figure 2 of this AD.

(3) Using a dial indicator, take axial play readings by moving the spherical bearing in the direction F (up and down) as shown in Figure 2 of this AD.

(8) If the radial play exceeds 0.008 inch or axial play exceeds 0.016 inch, replace the

control rod with an airworthy control rod before further flight.

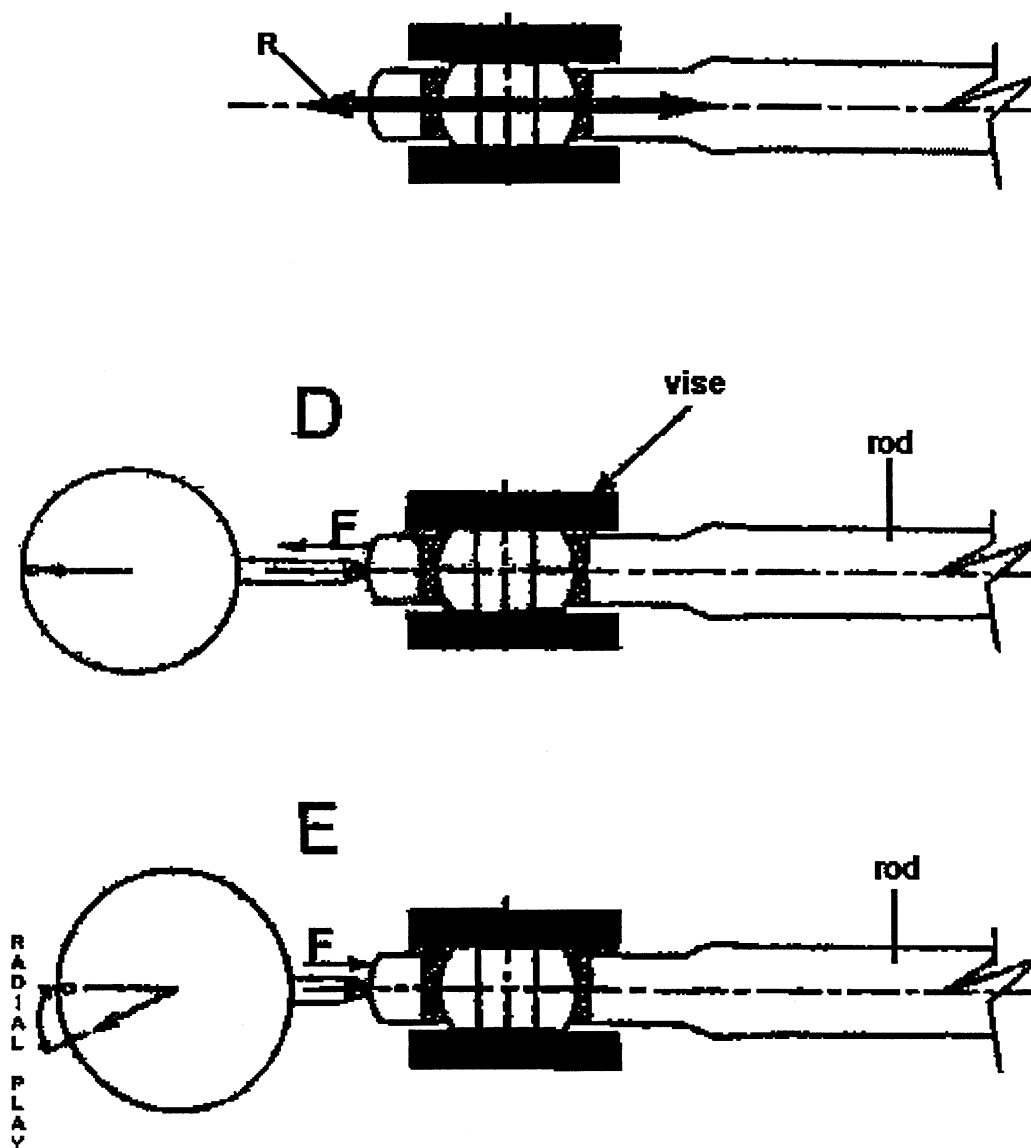
Figure 3: Measurement of the Radial Play (R) of the Bearing

(5) Mount the bearing in a vise as shown in Figure 3 of this AD.

(6) Using a dial indicator, take radial play measurements by moving the control rod in the direction F as shown in Figure 3 of this AD.
