DEPARTMENT OF TRANSPORTATION

[Docket No. 2002–SW–17–AD]

Airworthiness Directives; Eurocopter France Model AS 350B3, SA–365N, N1, AS–365N2, AS 365N3, and EC 155B Helicopters

ACTION: Notice of proposed rulemaking (NPRM).

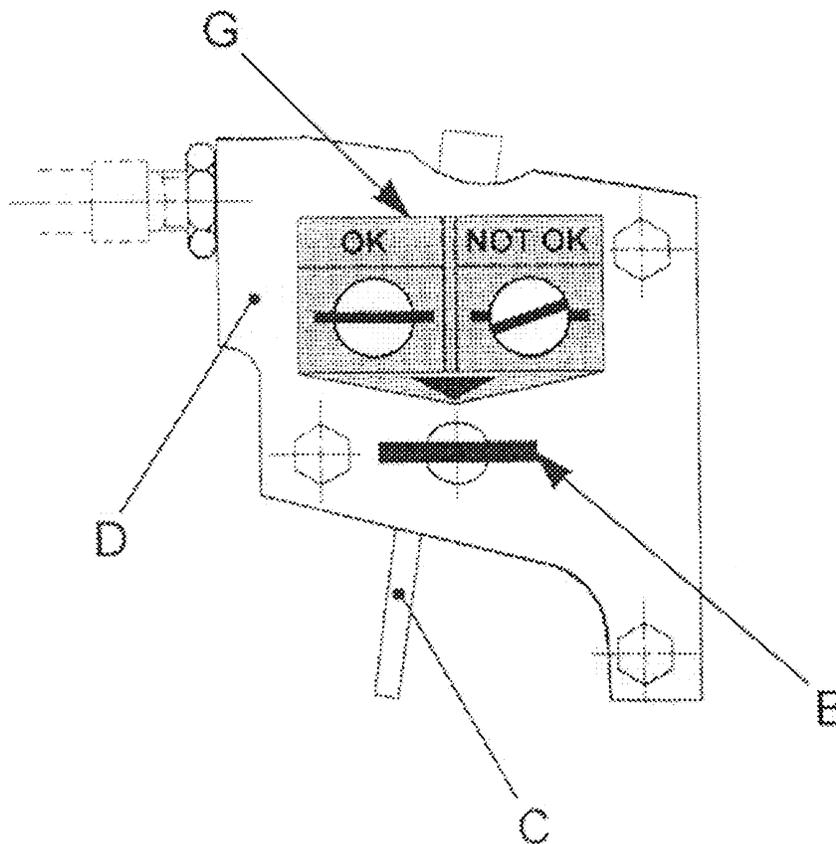
To detect internal corrosion of the Siren cargo hook locking catch (locking catch), which can cause the locking catch to return to an incomplete locking position, undetectable by the operator, and result in an unexpected cargo load release, accomplish the following:

(a) For cargo hook, P/N AS-21-5-7, with Amendment B incorporated, before the first use of the cargo hook on each day that the cargo hook is used, check for corrosion on the locking catch as follows. Amendment B has been incorporated if the letter "B" is marked on the amendment identification plate of the release unit of the cargo hook and placard "G" is installed on the release unit cover plate "D" and reference line "B" is marked over the nut and cover plate as depicted in Figure 1 of this AD. The identification plate is located on cover plate "D", on the opposite side of the electrical connector. See Figure 1:

(3) Determine whether the section of reference line (B) marked on the bolt (A) and the section of reference line (B) marked on the cover plate (D) form a straight line.

(i) If the reference line is straight, the cargo hook is considered airworthy.

(ii) If the reference line is not straight, the cargo hook is unairworthy and may not be used.

(1) With the cargo hook installed, cycle the red manual release control lever several times over its travel range.

(2) Return the red manual release control lever to the initial position.

(c) For cargo hook, P/N AS-21-5-7, without Amendment B, before the next sling load flight, incorporate Amendment B to the cargo hook in accordance with the Accomplishment Instructions, paragraphs 2.A.2.(a) and 2.A.2.(b), of Alert No. 05.00.39, for Model AS 350B3 helicopters; No. 05.00.41, for Model SA-365N, N1, AS-
