[Docket No. 2003-SW-20-AD; Amendment 39-13181; AD 2003-08-53]

**Airworthiness Directives; Eurocopter France Model SA-365N1, AS365-N2, AS 365 N3, and SA-366G1 Helicopters**

#### 2003-08-53 Eurocopter France:

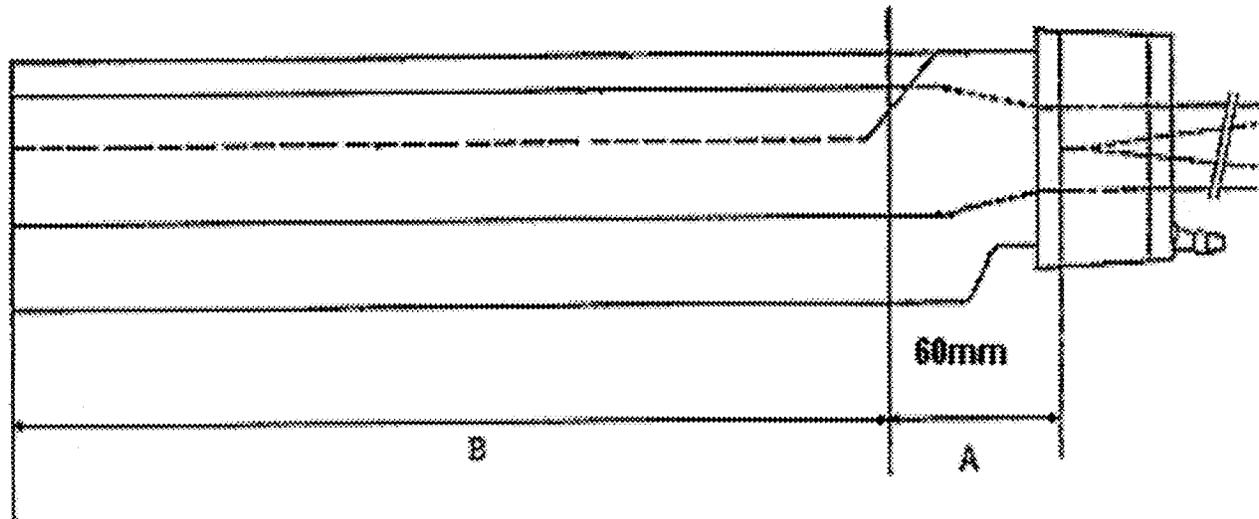
(a) Within 10 hours time-in-service (TIS) and thereafter before the first flight of each day, visually check each blade for a crack, blister, or wrinkling. An owner/operator (pilot), holding at least a private pilot certificate, may perform the visual check and must enter compliance into the aircraft maintenance records in accordance with 14 CFR sections 43.11 and 91.417(a)(2)(v)). See Figure 1 as follows:

(b) If a crack, blister, or wrinkling is found as a result of the visual check, accomplish the following before further flight (see Figure 1 of this AD):

(1) Zone A: If a blister is detected on the blade suction face, conduct a tapping test inspection on the whole blade for bonding separation.

(2) Zone B: If a crack, wrinkling, or a blister is found, replace the blade with an airworthy blade before further flight.

(i) For blades, P/N 365A33-2131-all dash numbers, 365A12-0010-all dash numbers, and 365A12-0020-00, and -01, if bonding separation or a crack is found, replace the blade with an airworthy blade before further flight.

(ii) For blades, P/N 365A12-0020-02, and -03, if bonding separation exceeds 900 mm<sup>2</sup> in a 30 x 30 mm square or if there is a crack, replace the blade with an airworthy blade before further flight.

(2) Thereafter, at intervals not to exceed 25 hours TIS, conduct a tapping test inspection for bonding separation on blades, P/N 365A12-0020-02 or 365A12-0020-03, in Zone A as depicted in Figure 1 of this AD.

(3) Thereafter, at intervals not to exceed 100 hours TIS or 200 cycles, whichever occurs first, conduct a tapping test inspection for bonding separation on blades, P/N 365A12-0020-02 or 365A12-0020-03, in Zone B as depicted in Figure 1 of this AD. If a crack, wrinkling, or a blister is found, replace the blade with an airworthy blade before further flight.
