[Docket No. 2003–SW–26–AD; Amendment 39–13198; AD 2003–12–13]

Airworthiness Directives; Agusta S.p.A. Model A109K2 Helicopters

2003-12-13 Agusta S.p.A.: Amendment 39-13198. Docket No. 2003-SW-26-AD.

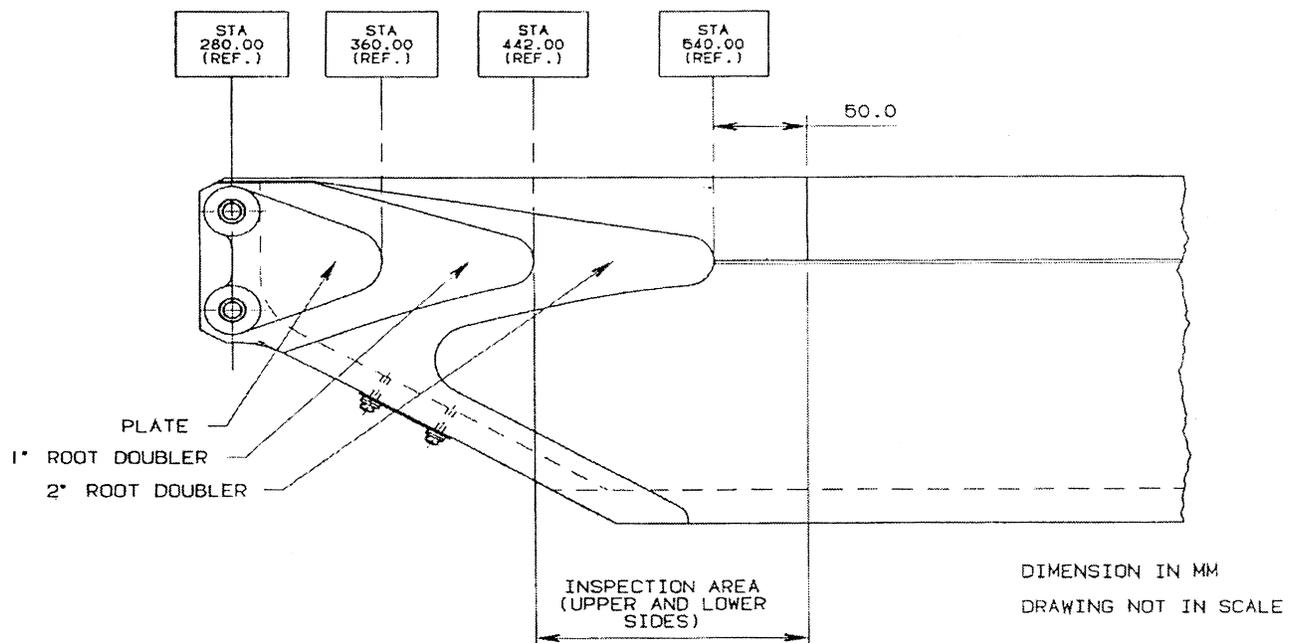
FIGURE 1

(a) Before each start of the helicopter engines, visually check the upper and lower surfaces of each blade for a crack in the area depicted in Figure 1 of this AD. An owner/operator (pilot) holding at least a private pilot certificate may perform this check, but must enter compliance with this paragraph into the aircraft records in accordance with 14 CFR sections 43.11 and 91.417(a)(2)(v). See Figure 1:

Note 1: Paint irregularities on the blade may be due to a crack.

(b) Before the first flight of each day, and thereafter at intervals not to exceed 5 hours TIS, and anytime an increase in vibration levels occurs, inspect each blade for a crack using a 5x or higher magnifying glass in accordance with Part II of the Compliance Instructions of Alert Bollettino Tecnico No.

(c) After each visual inspection using a 5x or higher magnifying glass and before further flight, if you are unable to determine by the visual inspection whether there is a crack, inspect each blade for a crack using a dye-penetrant method in accordance with Part II of the Compliance Instructions of the ABT and Figure 1 of this AD.

(d) If a crack is found, replace each cracked blade with an airworthy blade before further flight.
