[Docket No. 2003-SW-17-AD; Amendment 39-13215; AD 2003-08-51]

Airworthiness Directives; MD Helicopters, Inc. Model 369A, D, E, H, HE, HM, HS, F, and FF Helicopters

2003-08-51 MD Helicopters, Inc.:
Amendment 39-13215. Docket No. 2003-SW-17-AD.

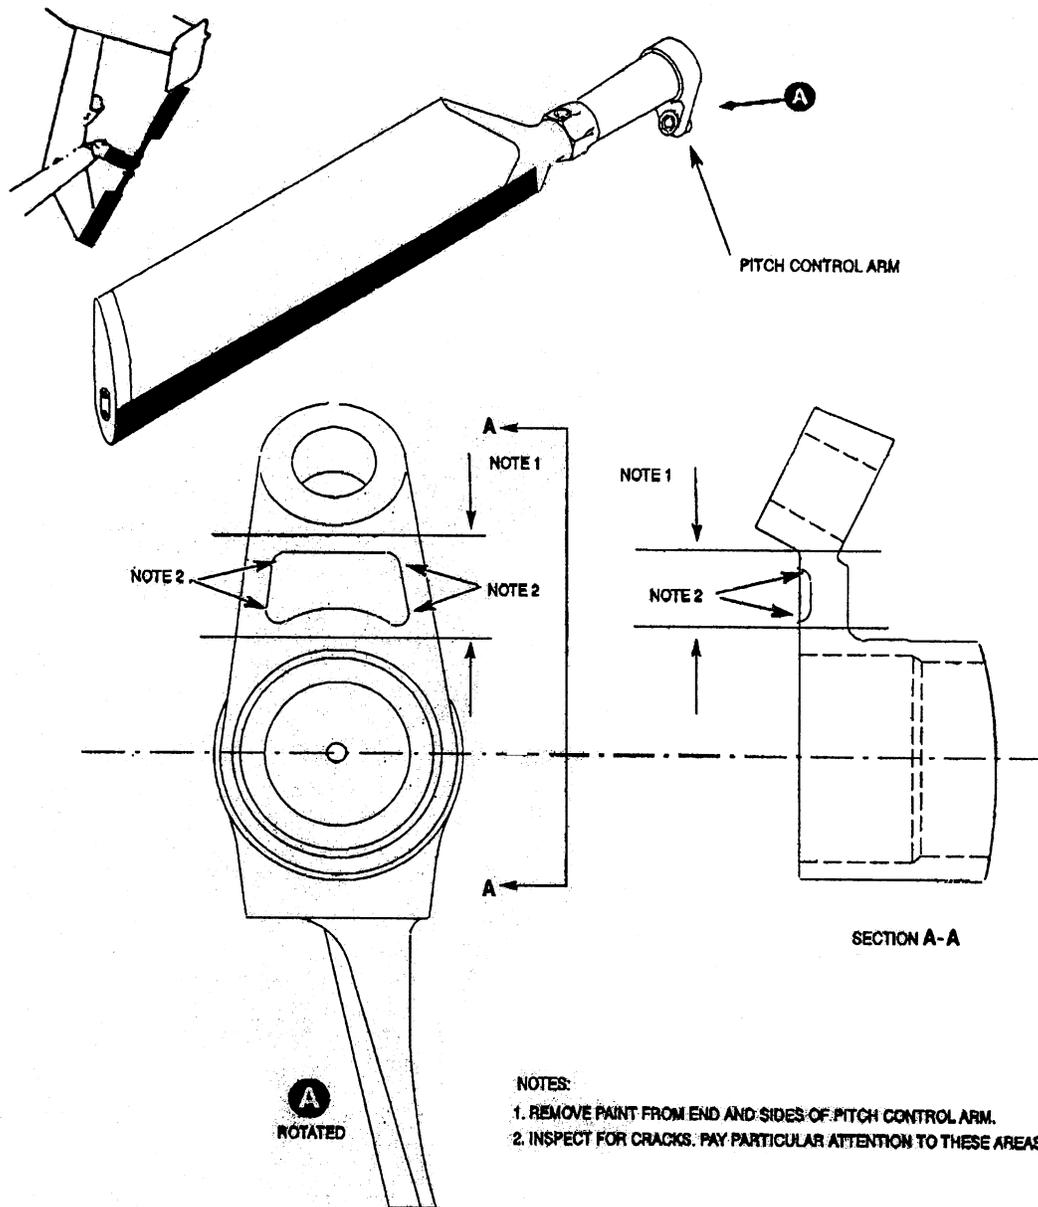
Figure 1. Tail Rotor Blade Assembly Inspection

To prevent a tail rotor blade pitch horn (pitch horn) from separating from the tail

rotor blade, leading to an unbalanced condition, vibration, loss of tail rotor pitch control, and loss of directional control of the helicopter, accomplish the following:

(b) Before further flight, perform a one-time visual inspection of each pitch horn for a crack or corrosion in the area indicated by Note 2 in Figure 1 of this AD. Paint removal in accordance with Note 1 of Figure 1 of this AD is not required for the visual inspection.

(a) This airworthiness directive (AD) establishes a new retirement life of 400 hours time-in-service (TIS) for the tail rotor blades listed in the Applicability section. For helicopters with an affected tail rotor blade installed that has 390 through 700 hours TIS, remove and replace the tail rotor blade with

an airworthy tail rotor blade within 10 hours TIS.

repair facility may be issued only upon completion of an eddy current surface scan of each affected pitch horn (see Figure 1 of this AD). Paint removal in accordance with Note 1 of the Figure 1 of this AD IS required for the surface scan. If a crack is found,

remove the tail rotor blade and replace it with an airworthy tail rotor blade before further flight.
