[Docket No. 2003-SW-17-AD; Amendment 39-13215; AD 2003-08-51]

#### **Airworthiness Directives; MD Helicopters, Inc. Model 369A, D, E, H, HE, HM, HS, F, and FF Helicopters**

**2003-08-51 MD Helicopters, Inc.:**  
Amendment 39-13215. Docket No. 2003-SW-17-AD.

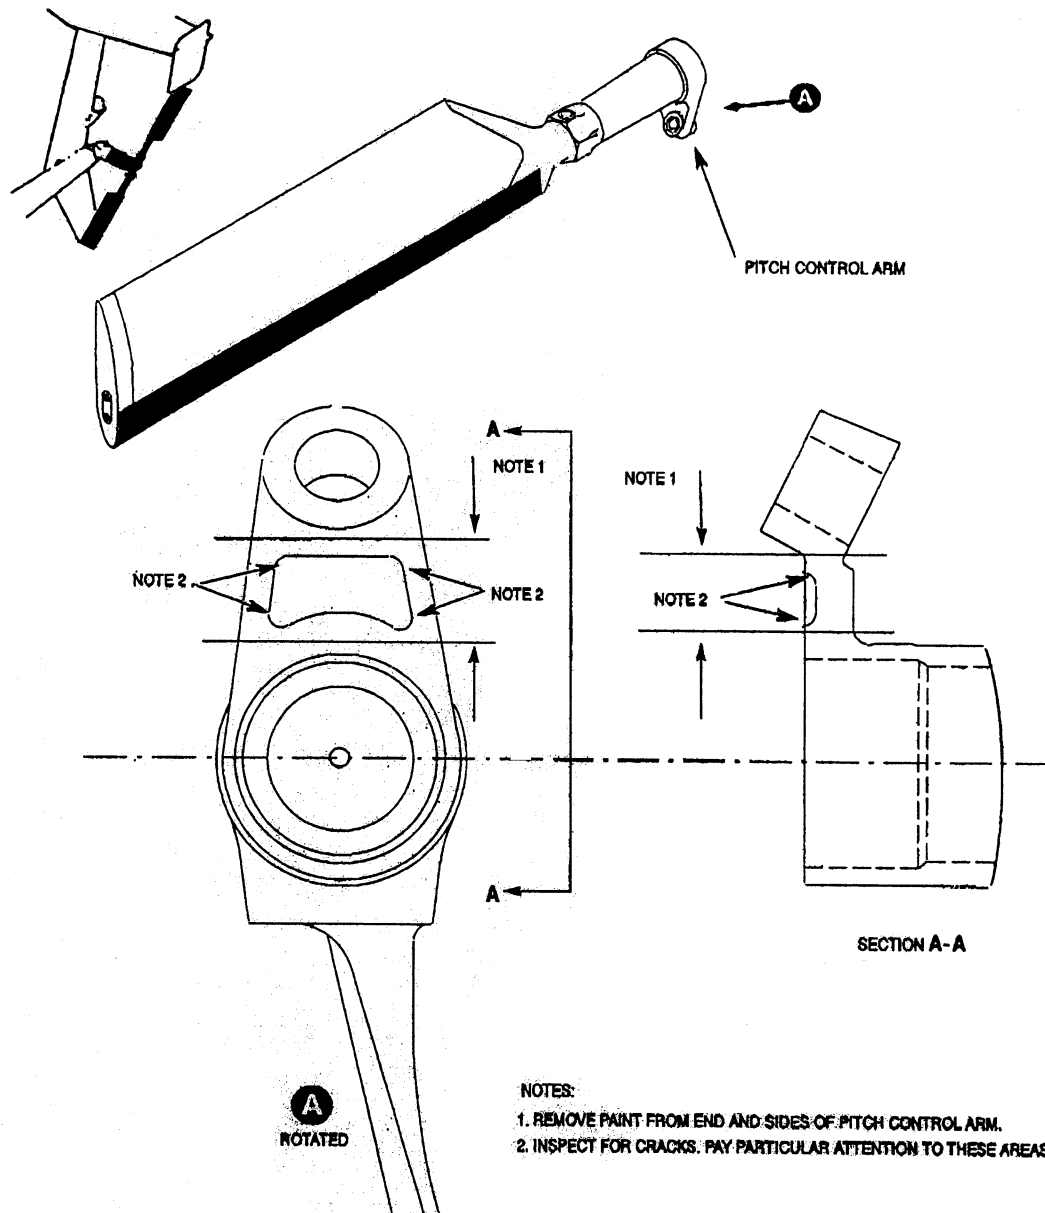
**Figure 1. Tail Rotor Blade Assembly Inspection**

manual to reflect the reduced retirement life, and reporting information to the FAA within 24 hours following the one-time inspection. That action was prompted by two reports of cracked pitch horns that failed during flight. In both occurrences, the pilot was able to land the helicopter without further incident. Investigation revealed that the cause of the failures was a fatigue crack in the pitch horns that developed before the tail rotor blade reached its retirement life. This condition, if not corrected, could result in a pitch horn separating from the tail rotor blade, leading to an unbalanced condition, vibration, loss of tail rotor pitch control, and loss of directional control of the helicopter.

(b) Before further flight, perform a one-time visual inspection of each pitch horn for a crack or corrosion in the area indicated by Note 2 in Figure 1 of this AD. Paint removal in accordance with Note 1 of Figure 1 of this AD is not required for the visual inspection.

repair facility may be issued only upon completion of an eddy current surface scan of each affected pitch horn (see Figure 1 of this AD). Paint removal in accordance with Note 1 of the Figure 1 of this AD IS required for the surface scan. If a crack is found,

remove the tail rotor blade and replace it with an airworthy tail rotor blade before further flight.
