Airworthiness Directives; Eurocopter France Model AS355E, F, F1, F2, and N Helicopters

ACTION: Notice of proposed rulemaking (NPRM).

Eurocopter France: Docket No. 2003-SW-10-AD. Supersedes AD 2002-21-51, Amendment 39-12982, Docket No. 2002-SW-48-AD.

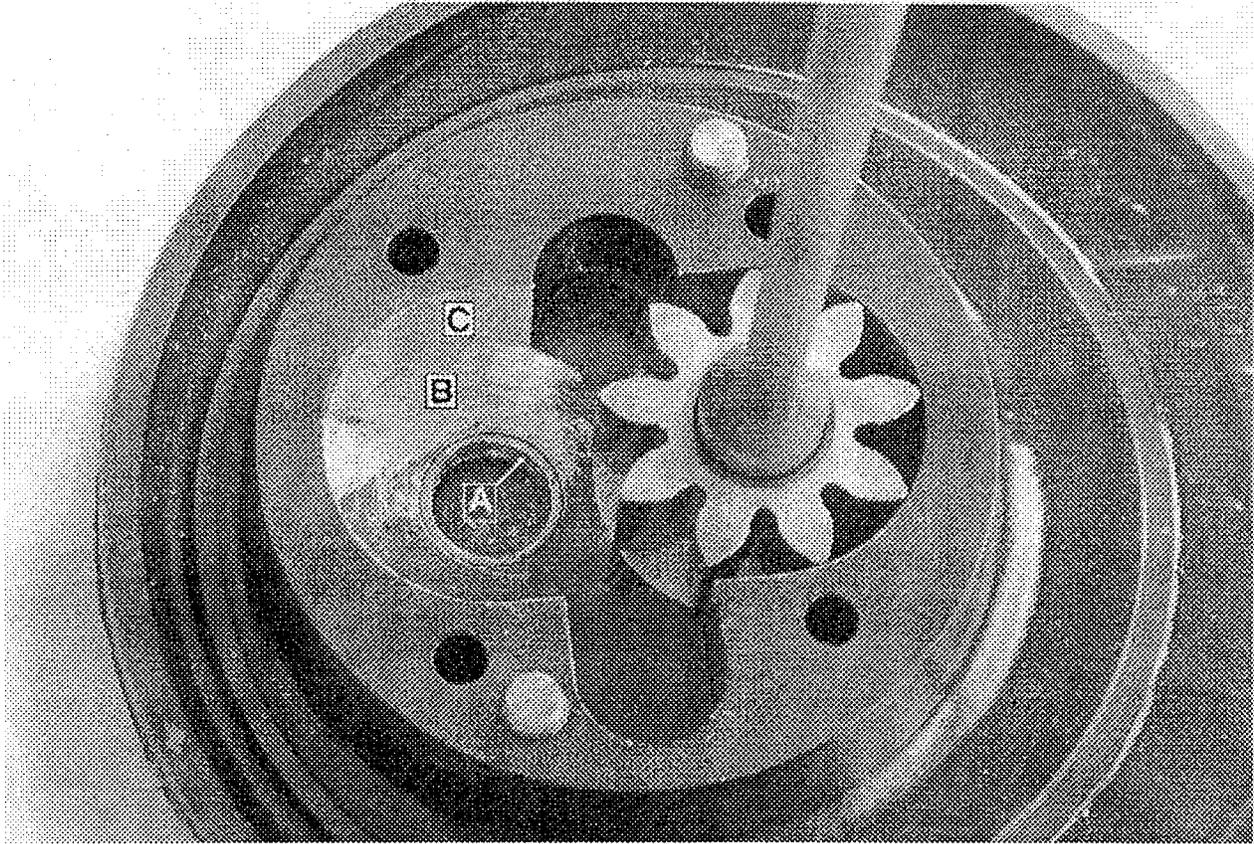
Figure 1

- (1) Crank pin play,
- (2) Out of round bronze bushing (A of Figure 1),
- (3) Offset of the driven gear pinion,
- (4) Metal chips, or
- (5) Wear (C of Figure 1).

Note 2: If wear is present in the B area only as depicted in Figure 1, replacing the MGB and the pump is not required.

(d) While inspecting the pump, if you find any of the following, replace the MGB and the pump with an airworthy MGB and pump before further flight:
