[Docket No. 2002–NM–128–AD; Amendment 39–13269; AD 2003–16–16]

**Airworthiness Directives; Boeing Model 747–400 Series Airplanes Equipped With General Electric Model CF6–80C2 Series Engines**

ACTION: Final rule.

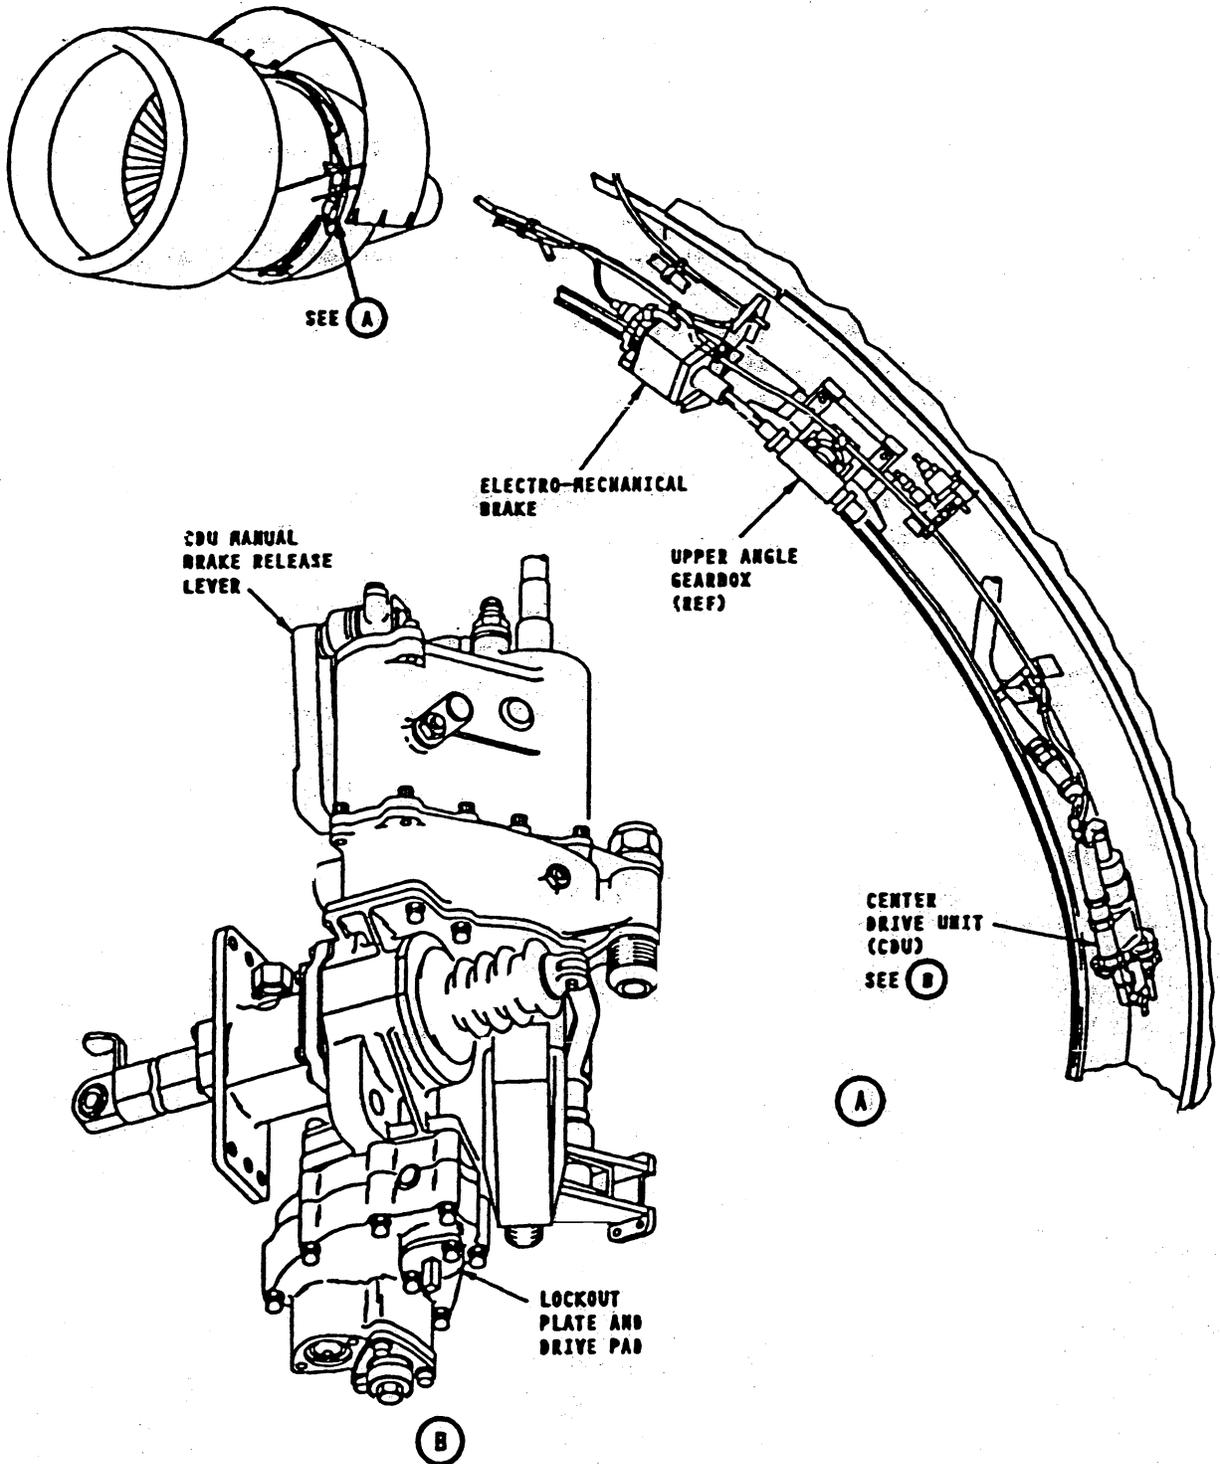
Electro-Mechanical Brake and CDU Cone Brake Torque Check  
Figure 1

1. This procedure contains steps to do a check of the holding torque of the CDU cone brake.

2. CDU cone brake check (Figure 1):

**Caution:** Do not use more than 100 pound-inches of torque when you do this check. Excessive torque will damage the CDU.

**Note:** The cone brake prevents movement in the extend direction only. If you try to measure the holding torque in the retract direction, you will get a false reading.

(8) If the torque is less than 15 pound-inches, you must replace the CDU.
