[Docket No. 2003-CE-43-AD; Amendment 39-13328; AD 2003-20-10]

Airworthiness Directives; Raytheon Aircraft Company Beech Models 1900, 1900C, and 1900D Airplanes

2003-20-10 Raytheon Aircraft Company:
Amendment 39-13328; Docket No. 2003-CE-43-AD.

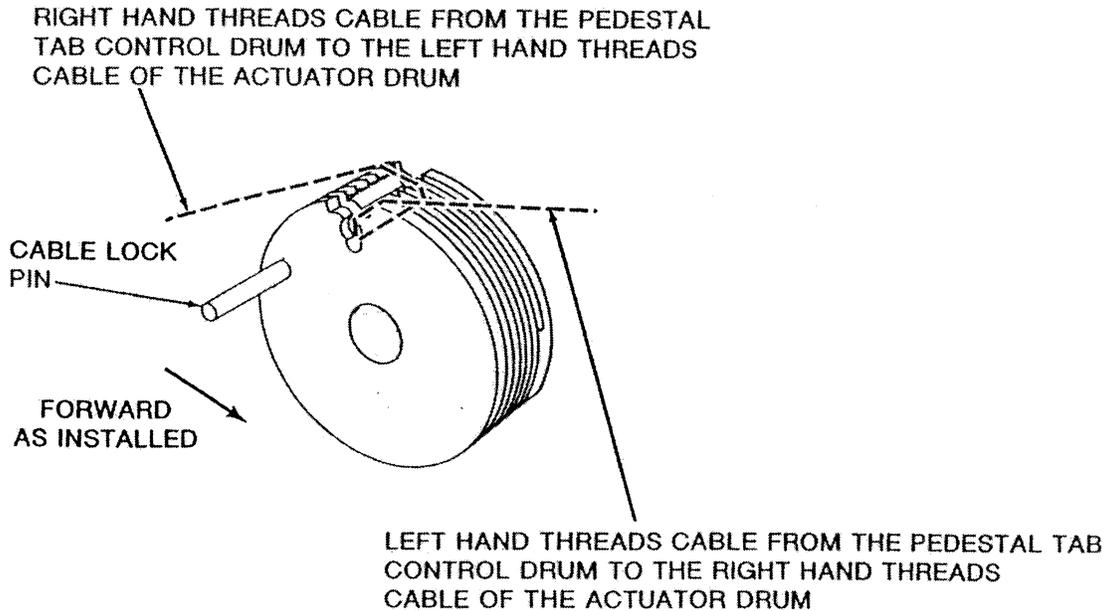
Figure 1

- The figures in the applicable maintenance manuals depict the elevator trim cable drum at 180 degrees from the installed position and show the open, keyed side of the drum instead of the flat side of the drum. Following these figures when installing the control cables on the forward control cable drum could reverse the action of the elevator manual trim system; and
- The existing procedure can be enhanced by visually confirming the trim wheel position and the trim tab position are consistent. Such a check would detect and correct any problems with the elevator trim system installation before problems occur during operation.

Although the figures (figure 9 for the 1900/1900C and figure 201 for the 1900D) in the existing maintenance manuals are incorrectly depicted, following the step-by-step written instructions in the existing procedure and referring to the orientation of the parts removed would result in the correct installation and action of the elevator trim system.

Actions	Compliance	Procedures
<p>(1) Using pen and ink, mark the applicable figure in the maintenance manual as referenced below. The depiction in the referenced figures is incorrect for the elevator trim drum only and depicts the cable drum at 180 degrees from the installed position and shows the open, keyed side of the drum instead of the flat side of the drum. Insert corrected figure (Figure 1 of this AD) into the applicable maintenance manual and identify it accordingly:</p> <ul style="list-style-type: none"> (i) Figure 9 of Chapter 27-10-00 of the Model 1900/1900C Airliner Maintenance Manual (114-590021-7B) Clearly note in pen that existing portion of Figure 9 is correct for the aileron trim drum only and insert corrected figure (Figure 1 of this AD) marked in pen as correct for the elevator trim drum only; or 	<p>Before the next time you have maintenance done on the elevator trim system.</p>	<p>As specified in Raytheon Safety Communiqué No. 234, dated September 2003.</p>

Actions	Compliance	Procedures
<p>(ii) Mark out Figure 201 of Chapter 27-30-04 of the Model 1900D Airliner Maintenance Manual (125-590000-15). Insert corrected figure (Figure 1 of this AD)</p> <p>(2) Incorporate the applicable temporary revision into the maintenance manuals as follows:</p> <p>(i) Temporary Revision No. 27-5 to the Model 1900/1900C Airliner Maintenance Manual: Revised ELEVATOR TRIM OPERATIONAL CHECK; or</p> <p>(ii) Temporary Revision No. 27-9 to the Model 1900D Airliner Maintenance Manual: Added MANUAL ELEVATOR TRIM OPERATIONAL CHECK.</p> <p>(3) Do the elevator trim operational check that is specified in the applicable maintenance manual and temporary revisions to the maintenance manual as referenced in paragraph (e)(2) of this AD</p>	<p>Before the next time you have maintenance done on the elevator trim system.</p> <p>Prior to further flight after each time you have maintenance done on the elevator trim system.</p>	<p>As specified in Raytheon Safety Communiqué No. 234, dated September 2003.</p> <p>As specified in Raytheon Safety Communiqué No. 234, dated September 2003; and Temporary Revision No. 27-5 to the Model 1900/1900C Airliner Maintenance Manual: Revised ELEVATOR TRIM OPERATIONAL CHECK; or Temporary Revision No. 27-9 to the Model 1900D Airliner Maintenance Manual: Added MANUAL ELEVATOR TRIM OPERATIONAL CHECK, both dated September 12, 2003, as applicable.</p>
