[Docket No. 2002-SW-17-AD; Amendment 39-13330; AD 2003-20-12]

#### Airworthiness Directives; Eurocopter France Model AS 350B3, SA-365N, N1, AS-365N2, AS 365N3, and EC 155B Helicopters

**ACTION:** Final rule.

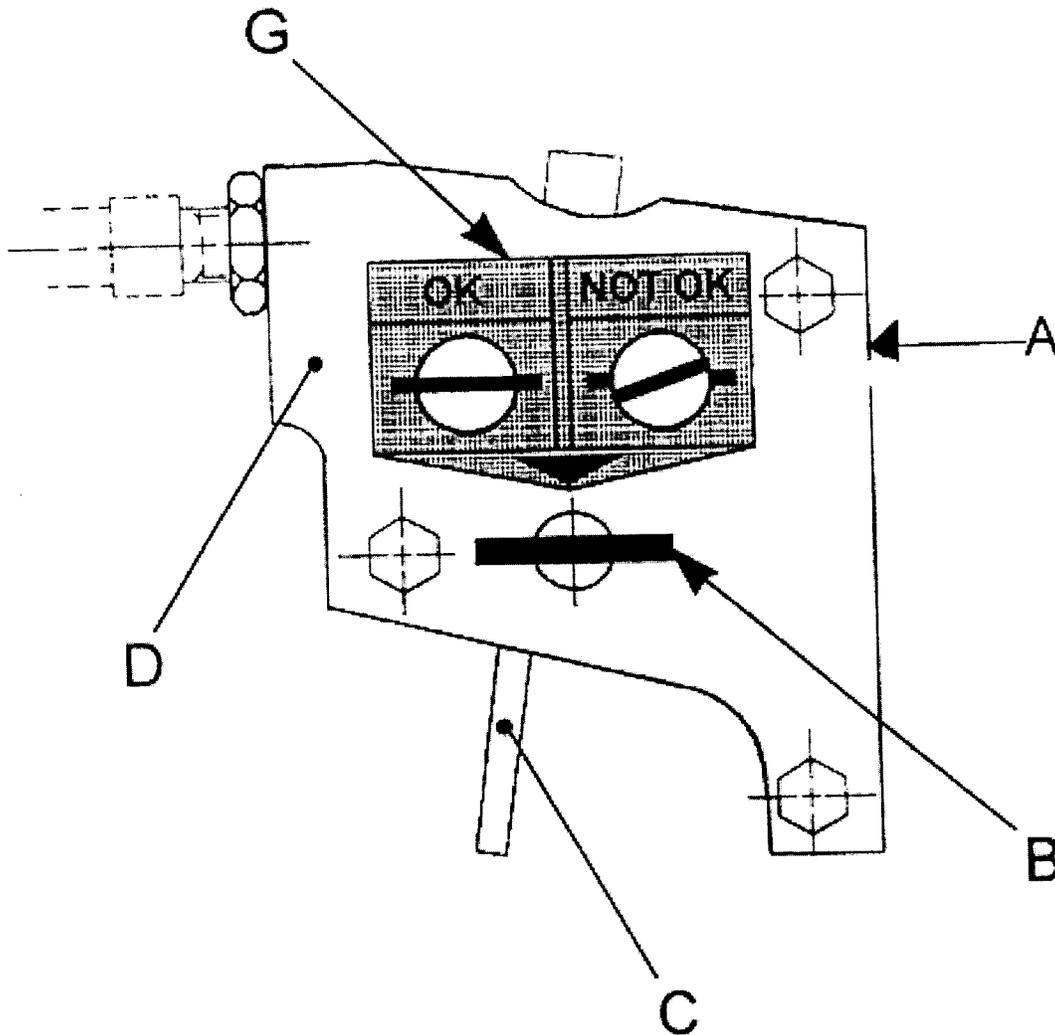
To detect internal corrosion of the Siren cargo hook locking catch (locking catch), which can cause the locking catch to return to an incomplete locking position, undetectable by the operator, and result in an unexpected cargo load release, accomplish the following:

(a) For cargo hook, P/N AS-21-5-7, with Amendment B incorporated, before the first use of the cargo hook on each day that the cargo hook is used, check for corrosion on the locking catch as follows. Amendment B has been incorporated if the letter "B" is marked on the amendment identification plate of the release unit of the cargo hook and placard "G" is installed on the release unit cover plate "D" and reference line "B" is marked over the nut and cover plate as depicted in Figure 1 of this AD. The identification plate "A" is located on cover plate "D", on the opposite side of the electrical connector. See Figure 1:

(3) Determine whether the section of reference line (B) marked on the bolt (A) and the section of reference line (B) marked on the cover plate (D) form a straight line.

(i) If the reference line is straight, the cargo hook is considered airworthy.

(ii) If the reference line is not straight, the cargo hook is unairworthy and may not be used.

(1) With the cargo hook installed, cycle the red manual release control lever several times over its travel range.

(2) Return the red manual release control lever to the initial position.

(c) For cargo hook, P/N AS-21-5-7, without Amendment B, before the next sling load flight, incorporate Amendment B to the cargo hook in accordance with the
