Airworthiness Directives; Eurocopter France Model AS355E, F, F1, F2, and N Helicopters

2003-21-09 Eurocopter France:

Amendment 39-13344. Docket No. 2003-SW-10-AD. Supersedes AD 2002-21-51, Amendment 39-12982, Docket No. 2002-SW-48-AD.

Applicability: Model AS355E, F, F1, F2, and N helicopters, with a main gearbox (MGB) lubrication pump (pump), part number 355A32-0700-00, -01, -01M, installed, certificated in any category.

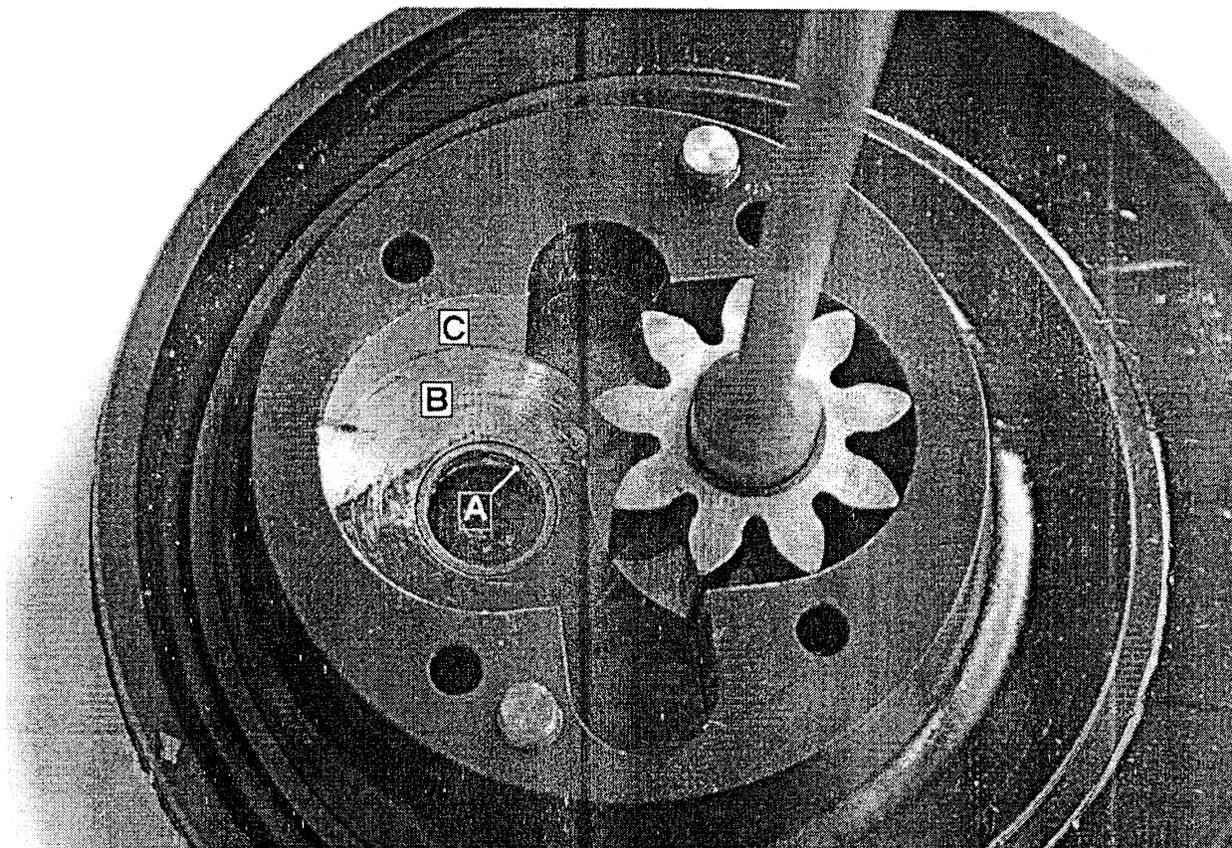
Figure 1

(d) While inspecting the pump, if you find any of the following, replace the MGB and the pump with an airworthy MGB and pump before further flight:

- (1) Crank pin play,
- (2) Out of round bronze bushing (A of Figure 1),

- (3) Offset of the driven gear pinion,
- (4) Metal chips, or
- (5) Wear (C of Figure 1).

Note 2: If wear is present in the B area only as depicted in Figure 1, replacing the MGB and the pump is not required.
