**[Docket No. 2003-NM-209-AD; Amendment 39-13353; AD 2003-19-51]**

**Airworthiness Directives; Bombardier Model CL-600-2C10 (Regional Jet Series 700 & 701) and CL-600-2D24 (Regional Jet Series 900) Series Airplanes**

**2003-19-51 Bombardier, Inc. (Formerly Canadair):** Amendment 39-13353. Docket 2003-NM-209-AD.

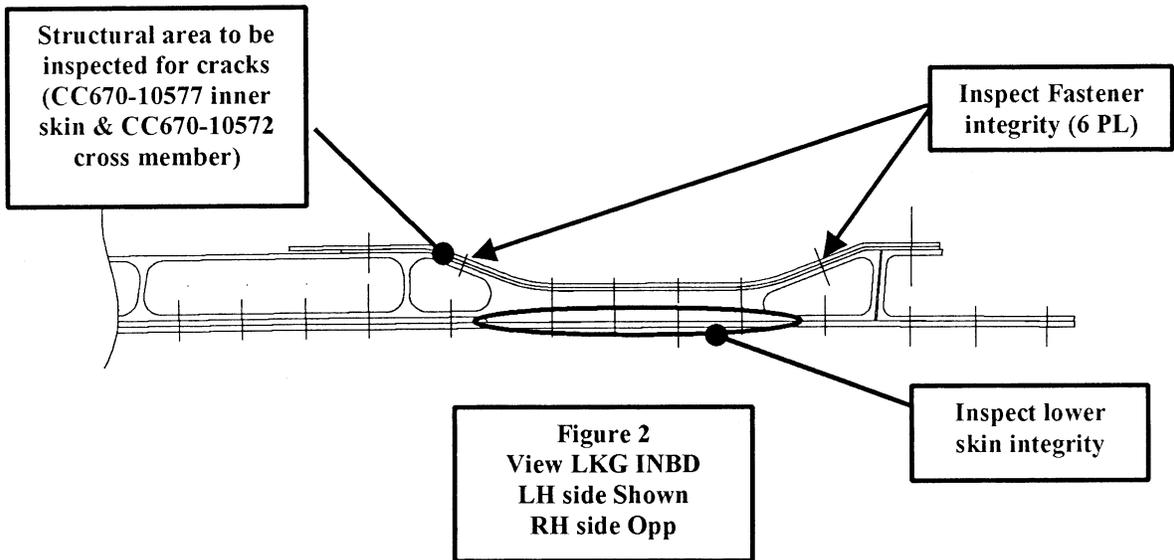
(1) Inspect the cross member, part number (P/N) CC670-10572, of the MLG door lower panel for cracking or deformation, in accordance with Figure 2 of this AD.

(2) Inspect the inner skin, P/N CC670-10577, of the MLG door lower panel at the cross member (P/N CC670-10572) for cracking or deformation, or pulled or missing fasteners, in accordance with Figure 2 of this AD.

(3) Inspect the outer skin, P/N CC670-10574, of the MLG door lower panel at the cross member (P/N CC670-10572) for cracking or deformation, or pulled or missing fasteners, in accordance with Figure 2 of this AD.

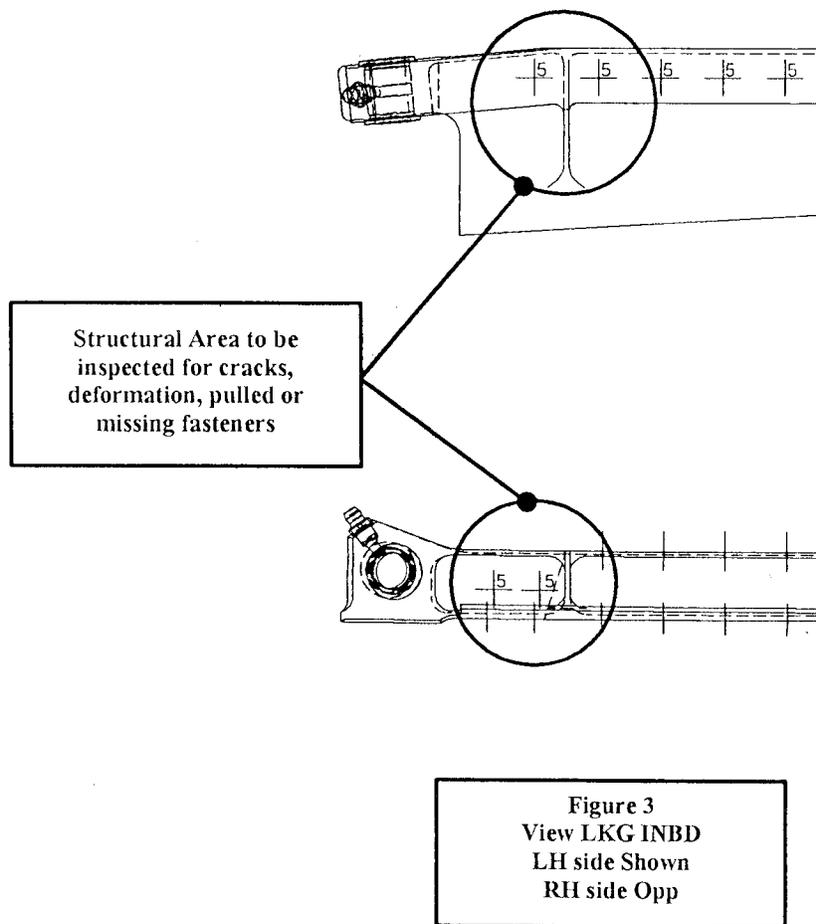
(4) Inspect the forward member, P/N CC670-10570, and aft member, P/N CC670-10571, of the MLG door lower panel, for cracking or deformation, or pulled or missing fasteners, in accordance with Figure 3 of this AD. Figures 1 through 3 of this AD follow.
