DEPARTMENT OF TRANSPORTATION

[Docket No. 2000-SW-12-AD; Amendment 39-13354; AD 2003-22-06]

Airworthiness Directives; Eurocopter France Model AS350B, B1, B2, B3, BA, C, D, D1, and AS355E, F, F1, F2, and N Helicopters

2003-22-06 Eurocopter France:
 Amendment 39-13354. Docket No. 2000-SW-12-AD. Supersedes AD 98-24-35, Amendment 39-10921, Docket No. 98-SW-41-AD.

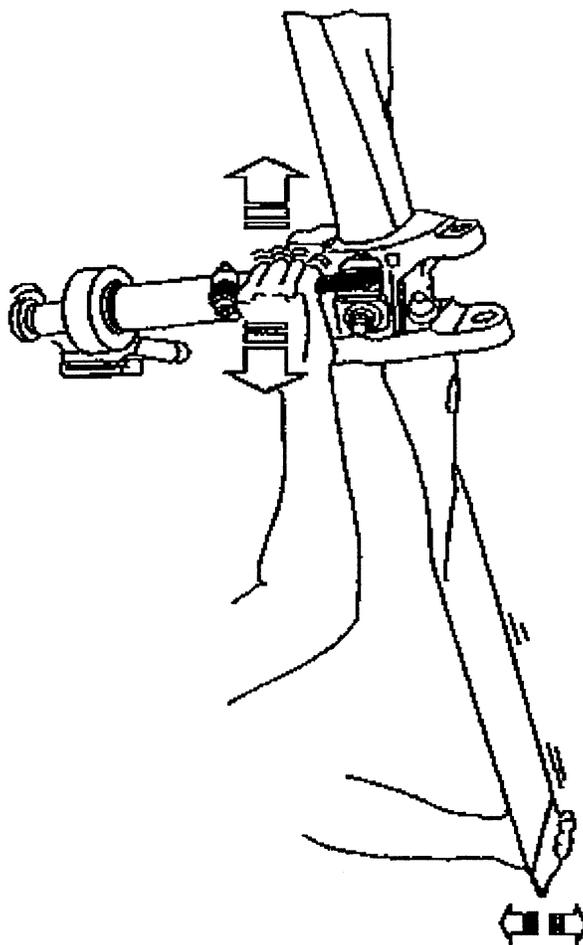
Figure 1: Manual Check for Play of the Tail Rotor Pitch Control Rod

(a) Before the first flight of each day, place the tail rotor pedals in the neutral position. If the helicopter is fitted with a tail rotor load compensator, discharge the accumulator as described in the rotorcraft flight manual. Check the bearing for play on the helicopter, by observation and feel, by slightly moving the tail rotor blade in the flapping axis while monitoring the bearing for movement. See the following Figure 1 of this AD:

(1) If the Teflon cloth is coming out of its normal position within the bearing, totally or partially, or if there is discoloration or scoring on the bearing, the bearing is unairworthy.

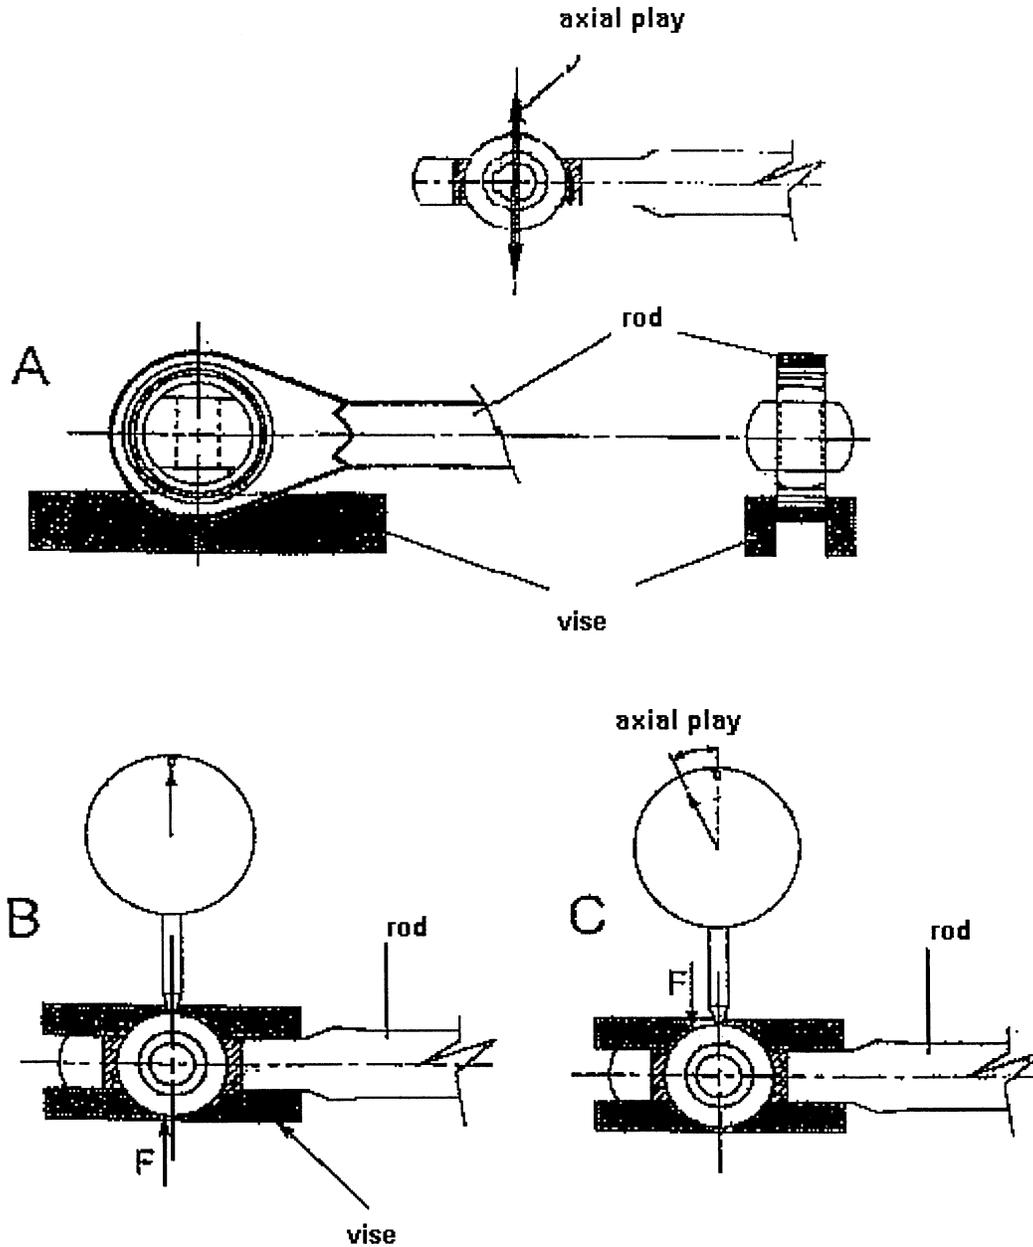
Figure 2: Measurement of the Axial Play (A) of the Bearing

(b) If a pilot or mechanic detects play, a mechanic must remove the control rod from the helicopter, and using a dial indicator, measure the bearing wear according to the following and as shown in Figures 2 and 3 of this AD:

(2) Mount the control rod in a vise as shown in Figure 2 of this AD.

(3) Using a dial indicator, take axial play readings by moving the spherical bearing in the direction F (up and down) as shown in Figure 2 of this AD.

(7) If the radial play exceeds 0.008 inch or axial play exceeds 0.016 inch, replace the control rod with an airworthy control rod before further flight.

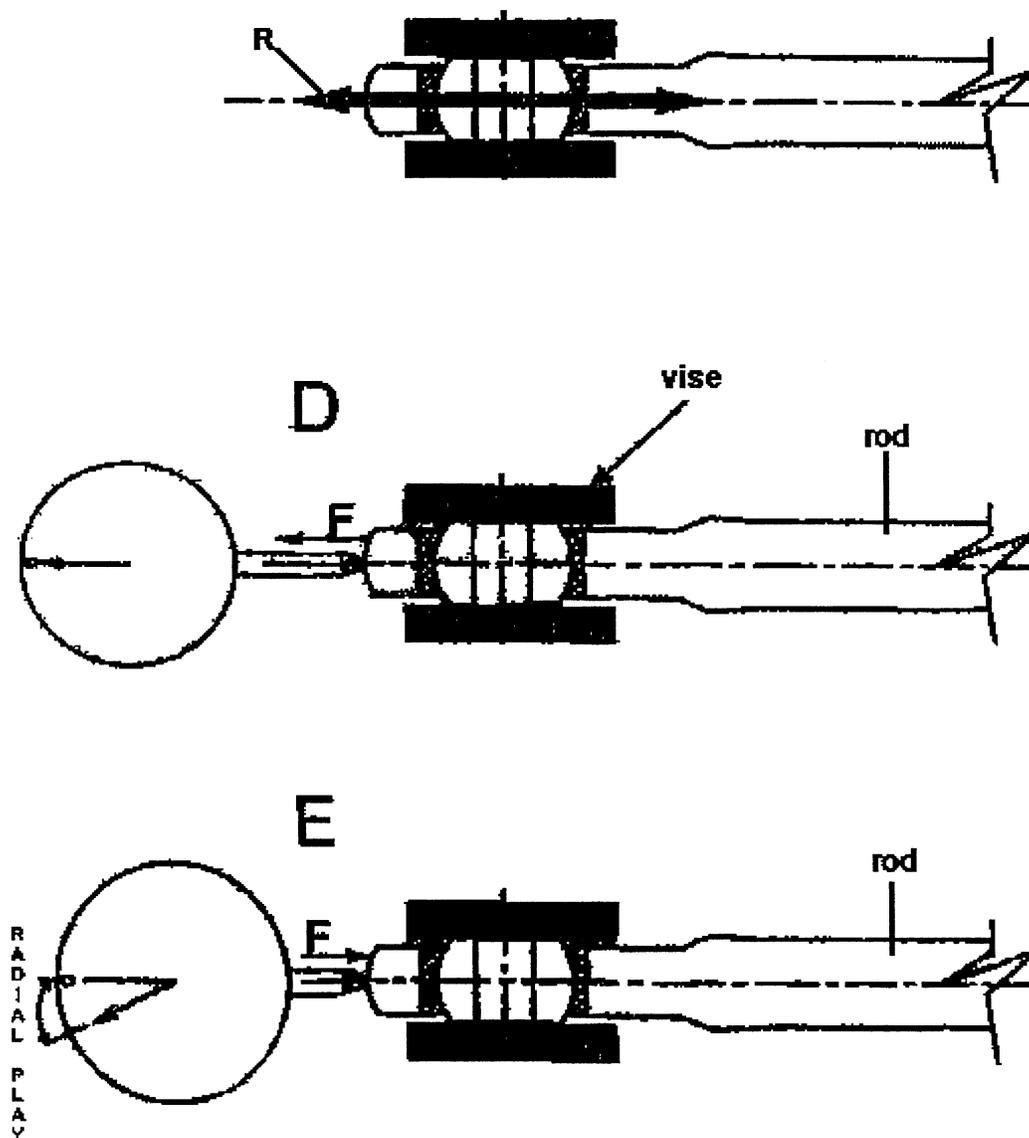
Figure 3: Measurement of the Radial Play (R) of the Bearing

(4) Mount the bearing in a vise as shown in Figure 3 of this AD.

(5) Using a dial indicator, take radial play measurements by moving the control rod in the direction F as shown in Figure 3 of this AD.
