[Docket No. 2003-NE-52-AD; Amendment 39-13381; AD 2003-24-12]

#### Airworthiness Directives; Pratt & Whitney JT9D-3A, -7, -7A, -7F, -7H, -7AH, and -7J Turbofan Engines

2003-24-12 **Pratt & Whitney:** Amendment 39-13381. Docket No. 2003-NE-52-AD.

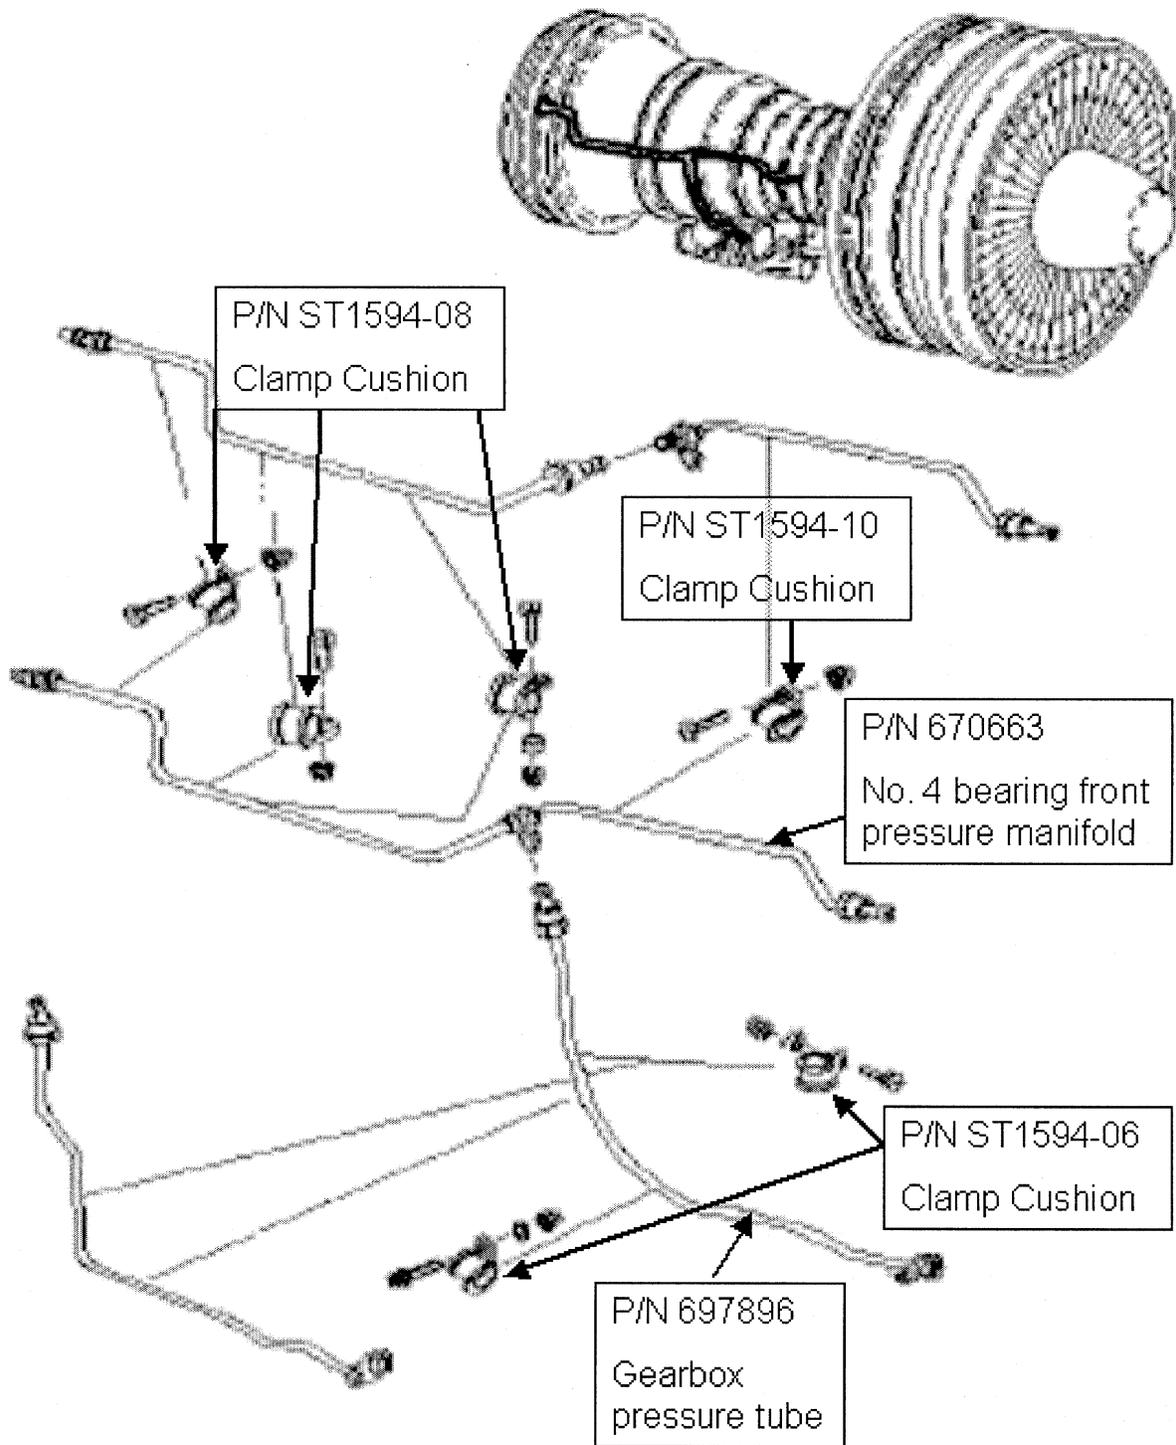
**Gearbox Pressure Tube, No. 4 Bearing Front Pressure Manifold, and Clamp Assembly Positioning**

(h) If the gearbox pressure tube, No. 4 bearing front pressure manifold, or clamp assemblies are not properly positioned, then correctly position them before further flight, as shown in the following Figure 1 of this AD.
