[Docket No. 2003-NE-52-AD Amendment 39-13410; AD 2003-24-12R1]

Airworthiness Directives; Pratt & Whitney JT9D-3A, -7, -7A, -7F, -7H, -7AH, and -7J Turbofan Engines**AGENCY:** Federal Aviation Administration (FAA), DOT.**ACTION:** Final rule; request for comments.

2003-24-12R1 Pratt & Whitney:
Amendment 39-13410. Docket No. 2003-NE-52-AD. Revises AD 2003-24-12, Amendment 39-13381.

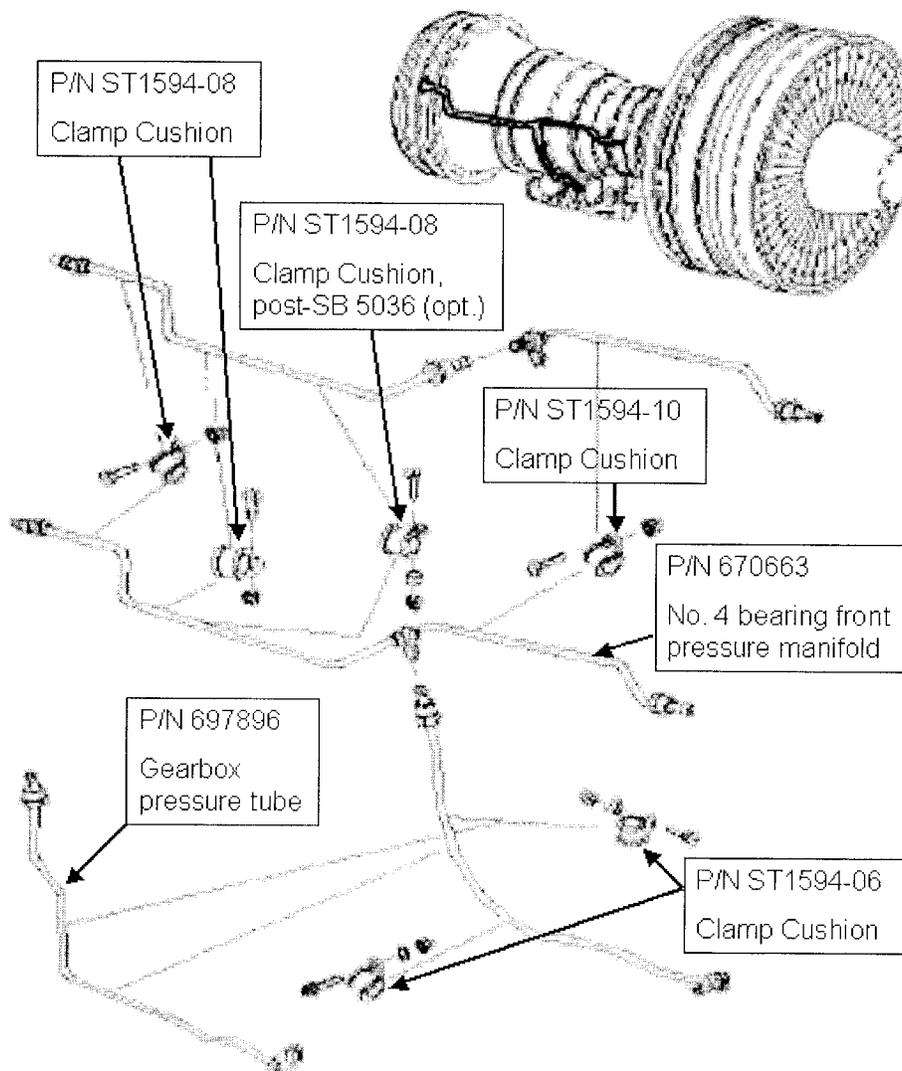
(f) Visually inspect the clamp assemblies, P/Ns ST1594-06, ST1594-08, and ST1594-10, (see Figure 1 of this AD) that attach the gearbox pressure tube and the No. 4 bearing front pressure manifold to the engine. Replace clamp assemblies before further flight that are rejected by any of the following rejection criteria:

- (1) Cracks, wear, or distortion in clamp metal.
- (2) Clamp cushions that are worn, compacted, cracked, coming apart in chunks, deteriorated, or missing. A reddish powder found around the clamp is an indication of deterioration.

(g) If one or more clamp assemblies are rejected as described in paragraph (f) of this AD, or out of position or missing (see Figure 1 of this AD), clean any debris and oil from the outer surface of the gearbox pressure tube and No. 4 bearing front pressure manifold and visually inspect the tube and manifold. Repair or replace the affected tube or manifold before further flight if it is rejected by any of the following rejection criteria:

- (1) Nicks, chafing, scratches, and or pitting 0.003 inch or greater in depth.
- (2) Dents within 0.25 inch of the ferrules or will not permit free passage of a ball having a minimum diameter of 80% of the tubing inner diameter.
- (3) Corrosion that is unable to be removed by a light polishing.
- (4) Tube or manifold is leaking oil.

(h) Ensure that the gearbox pressure tube, No. 4 bearing front pressure manifold, and clamp assemblies are properly positioned, before further flight, as shown in Figure 1 of this AD.
