[Docket No. 2003-SW-21-AD; Amendment 39-13424; AD 2004-01-10]

Airworthiness Directives; Eurocopter Deutschland Model MBB-BK-117 A-1, A-3, A-4, B-1, B-2, and C-1 Helicopters

2004-01-10 Eurocopter Deutschland:

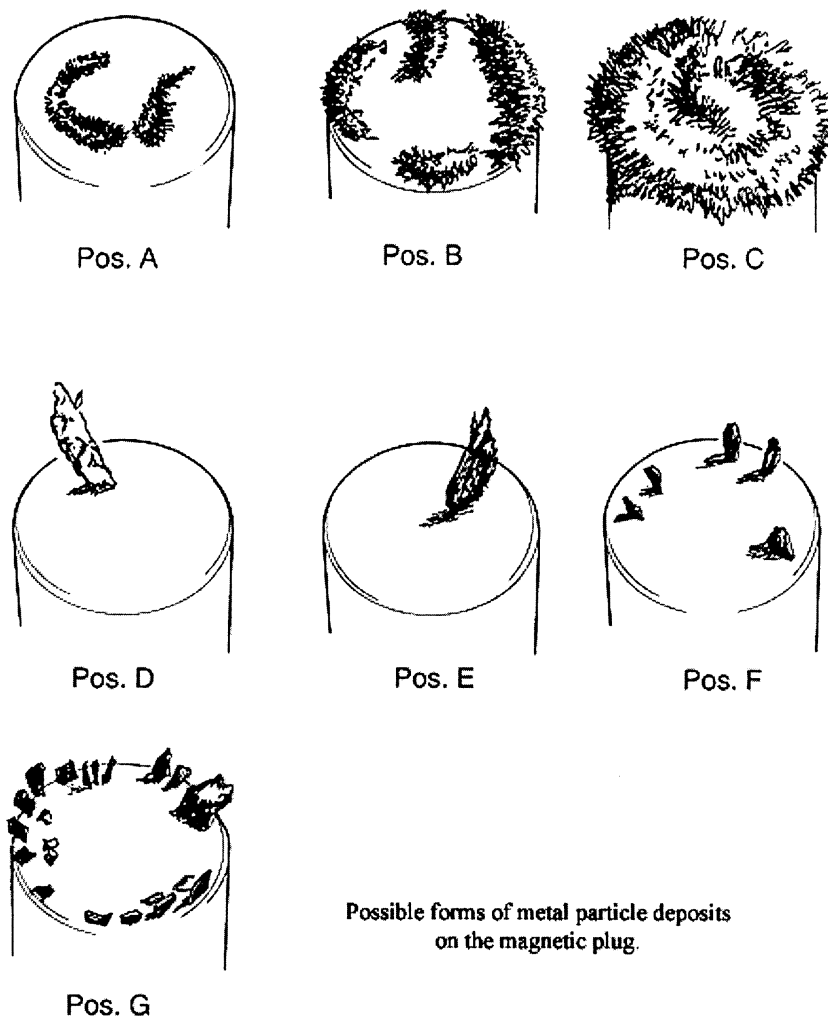
day. If a small amount of fuzz is found on the magnetic plug, the magnetic plug must be cleaned and may be reinstalled. If there is an amount of fuzz that exceeds the amount depicted in "Pos. A" of Figure 1 of this AD, then replacing the INT gearbox, TR transmission, or bearing, part number (P/N) 4639310006, with serial number (S/N) 3246 through 3598, is required within 30 days after the effective date of this AD. The short compliance time involved is required because the previously described critical unsafe condition can adversely affect the controllability and structural integrity of the helicopter. Therefore, the inspections and replacement, if necessary, are required before further flight and this AD must be issued immediately.

(a) Until you do paragraph (b) of this AD, before the first flight of each day, inspect the magnetic plugs of the TR transmission and INT gearbox for metal particles deposits by reference to Figure 1 of this AD.

(1) If you find a small amount of fine fuzz as shown in "Pos. A" of Figure 1 of this AD, clean the magnetic plug and reinstall it after ensuring that the O-ring is correctly positioned and there is no other damage.

(2) If you find an amount of fuzz as depicted in "Pos. B" or "Pos. C" or metal chip(s) as depicted in "Pos. D" through "Pos. G" or a combination of both fuzz and chips, do paragraph (b) of this AD.

(b) No later than February 23, 2004, replace bearing, P/N 4639310006 with S/N 3246 through 3598, with an airworthy bearing or replace the affected TR transmission or INT gearbox with an airworthy TR transmission and INT gearbox that does not contain the affected bearing.
