[Docket No. 2003-SW-21-AD; Amendment 39-13424; AD 2004-01-10]

#### **Airworthiness Directives; Eurocopter Deutschland Model MBB-BK-117 A-1, A-3, A-4, B-1, B-2, and C-1 Helicopters**

#### 2004-01-10 Eurocopter Deutschland:

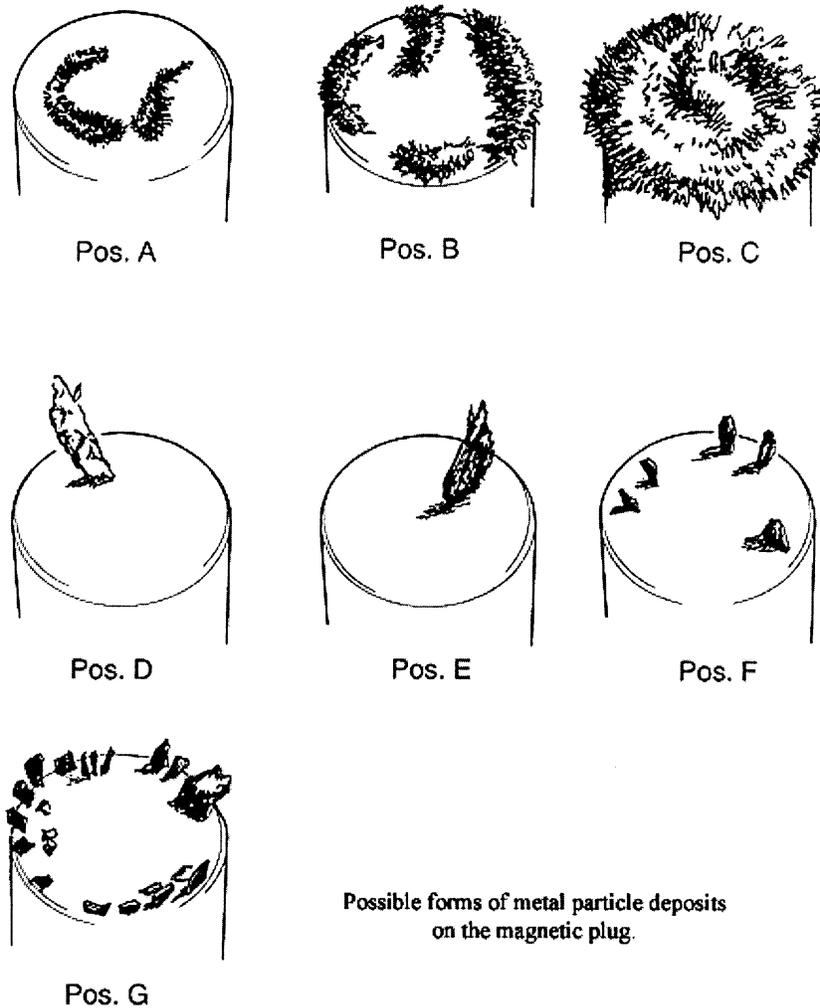
day. If a small amount of fuzz is found on the magnetic plug, the magnetic plug must be cleaned and may be reinstalled. If there is an amount of fuzz that exceeds the amount depicted in "Pos. A" of Figure 1 of this AD, then replacing the INT gearbox, TR transmission, or bearing, part number (P/N) 4639310006, with serial number (S/N) 3246 through 3598, is required within 30 days after the effective date of this AD. The short compliance time involved is required because the previously described critical unsafe condition can adversely affect the controllability and structural integrity of the helicopter. Therefore, the inspections and replacement, if necessary, are required before further flight and this AD must be issued immediately.

(1) If you find a small amount of fine fuzz as shown in "Pos. A" of Figure 1 of this AD, clean the magnetic plug and reinstall it after ensuring that the O-ring is correctly positioned and there is no other damage.

(2) If you find an amount of fuzz as depicted in "Pos. B" or "Pos. C" or metal chip(s) as depicted in "Pos. D" through "Pos. G" or a combination of both fuzz and chips, do paragraph (b) of this AD.

(a) Until you do paragraph (b) of this AD, before the first flight of each day, inspect the magnetic plugs of the TR transmission and INT gearbox for metal particles deposits by reference to Figure 1 of this AD.

(b) No later than February 23, 2004, replace bearing, P/N 4639310006 with S/N 3246 through 3598, with an airworthy bearing or replace the affected TR transmission or INT gearbox with an airworthy TR transmission and INT gearbox that does not contain the affected bearing.
