[Docket No. 2003-SW-23-AD]

Airworthiness Directives; Bell Helicopter Textron, a Division of Textron Canada Model 222, 222B, 222U and 230 Helicopters

ACTION: Notice of proposed rulemaking (NPRM).

Bell Helicopter Textron, a Division of Textron Canada: Docket No. 2003–SW–23–AD. Supersedes AD 2002–08–54, Amendment 39–12835, Docket No. 2002–SW–22–AD.

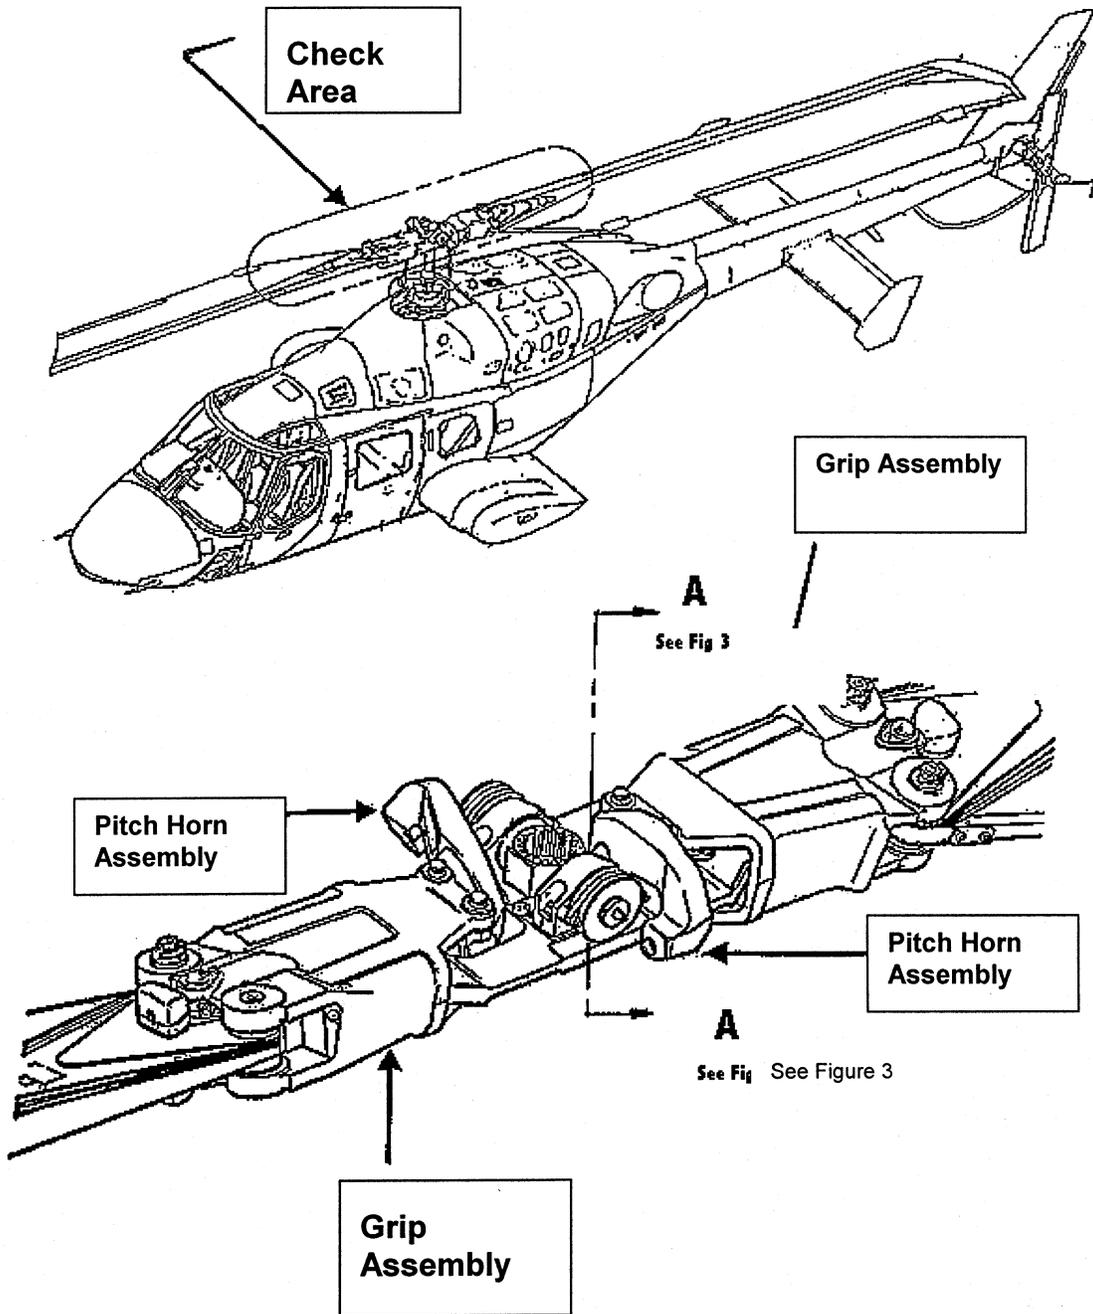
(1) Wipe clean the main rotor grip and pitch horn surfaces to remove grease and dirt

in the check area as shown in Figure 1 of this AD:

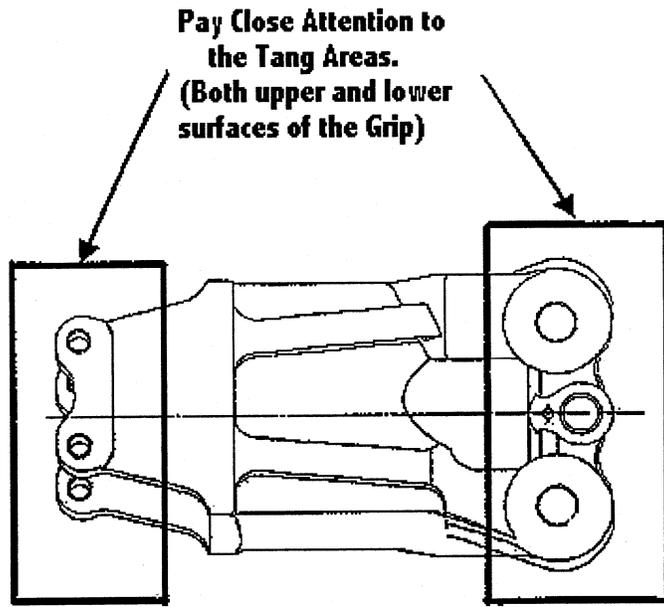
(2) Visually check both main rotor grips for a crack. Pay particular attention to the inboard and outboard tangs portions of the

grip, which are in direct contact with the pitch horns and the main rotor blades and check the area to at least 3 inches beyond the

grip to pitch and grip to blade contact areas as shown in Figure 2 of this AD:

Entire surface of the grip must be checked

(d) If a crack is found, replace the cracked part with an airworthy part before further flight.

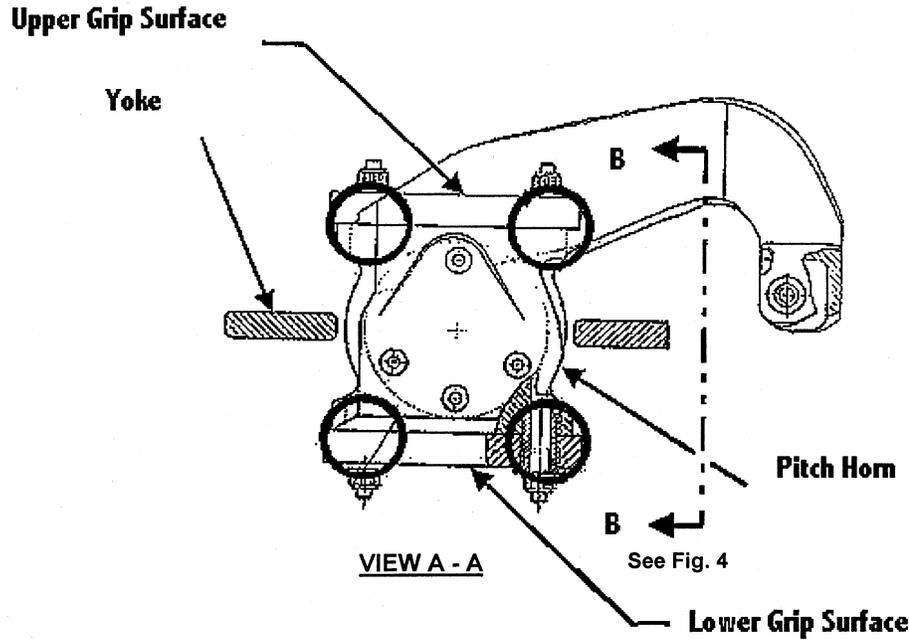
(3) Visually check all visible portions of each pitch horn for a crack. Pay particular attention to the attachment lugs of the pitch

horns, which are in direct contact with the inboard tangs of the main rotor grips, as shown in Figure 3 of this AD, and the four

**All visible portions of the pitch horn must be checked.
Pay particular attention to the circled areas shown above and View B-B, Fig. 4.**

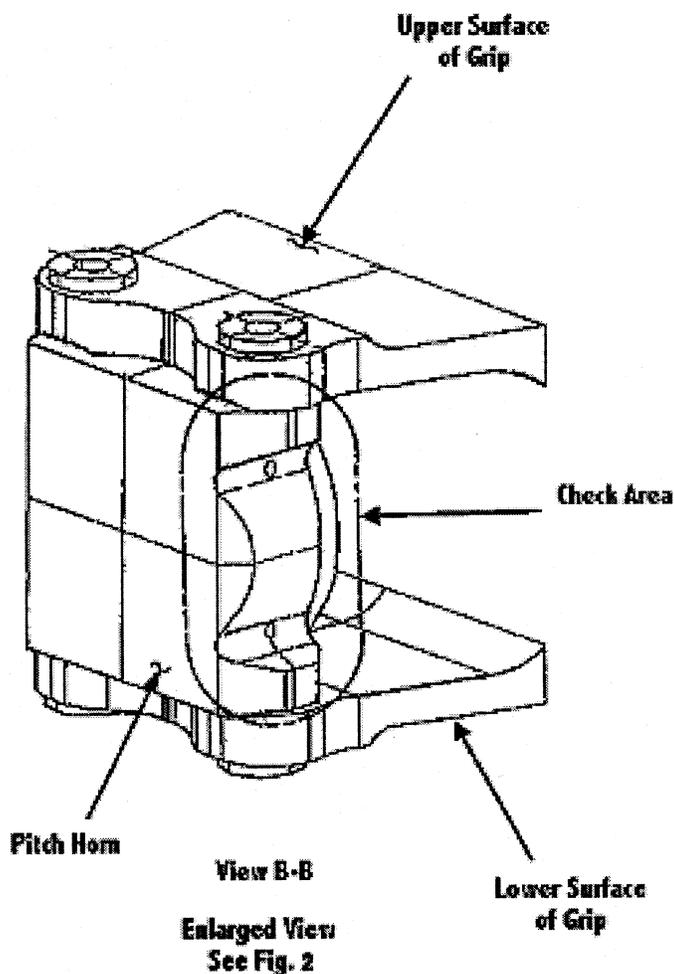
large bolt cutouts, as shown in Figure 4 of this AD:
