[Docket No. 2003-SW-38-AD]

Airworthiness Directives; Eurocopter Deutschland Model MBB-BK 117 A-1, A-3, A-4, B-1, B-2, and C-1

ACTION: Notice of proposed rulemaking (NPRM).

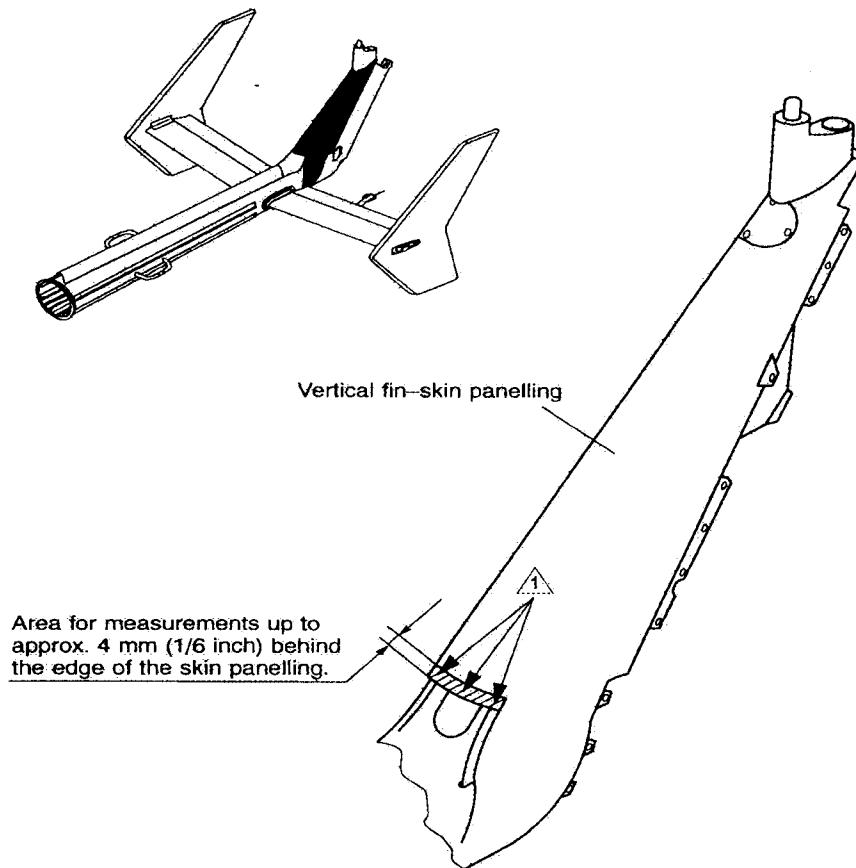
Vertical Fin-Skin Panelling
Figure 1

Model A-1 up to B-2, serial number (S/N) all, and Model C-1, S/N 7500 up to 7545. The LBA advises that during tail boom production, metal sheeting of 0.6-millimeter (mm) thickness was found instead of the specified 0.8-mm thickness for the skin paneling of several tail booms.

(a) Using external calipers, measure the wall thickness, including primer coating, of the skin paneling of the vertical fin at the locations shown in Figure 1 of this AD.

⚠ Measurements are to be taken at at least three locations on the skin panel of the vertical fin. Care has to be taken that the external calipers are held squarely to the skin panel wall while measurements are being taken, since tilting of the calipers can lead to false results. If the panel thickness, including the primer coating, is at least 0.778 mm (0.03063 inch) at every measured location, no further action is necessary.

(b) If the wall thickness, including the primer coating, of the paneling is less than 0.778 millimeter (0.03063 inch) at any of the measured locations, replace the vertical fin with an airworthy part before further flight.
