[Docket No. 2003-SW-38-AD]

Airworthiness Directives; Eurocopter Deutschland Model MBB-BK 117 A-1, A-3, A-4, B-1, B-2, and C-1

ACTION: Notice of proposed rulemaking (NPRM).

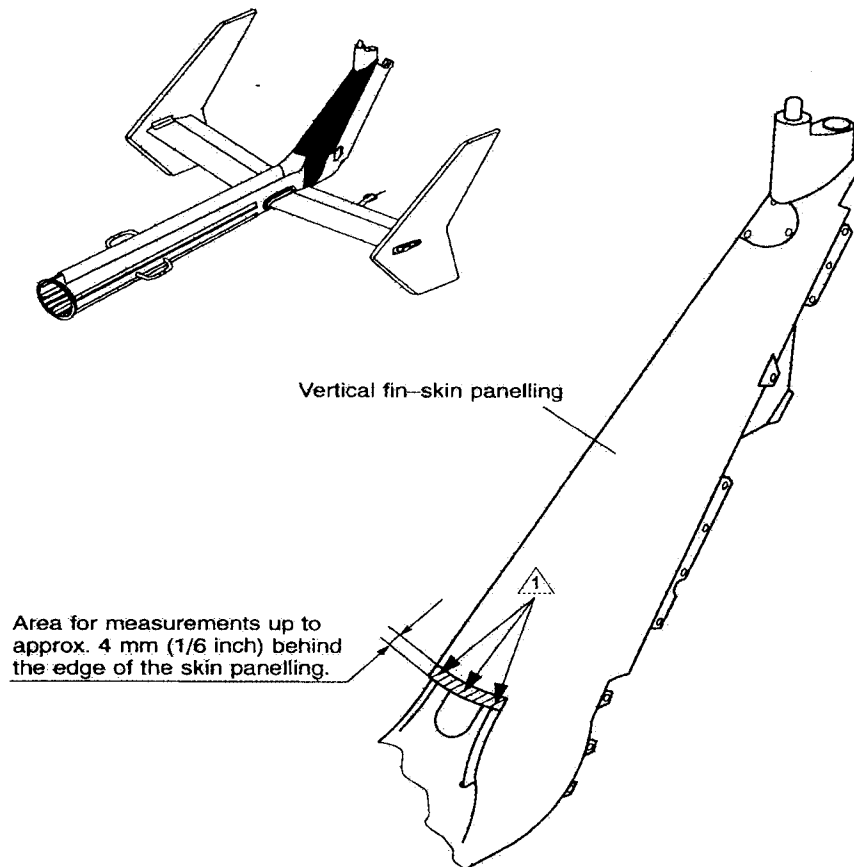
Vertical Fin-Skin Panelling
Figure 1

Model A-1 up to B-2, serial number (S/N) all, and Model C-1, S/N 7500 up to 7545. The LBA advises that during tail boom production, metal sheeting of 0.6-millimeter (mm) thickness was found instead of the specified 0.8-mm thickness for the skin paneling of several tail booms.

(a) Using external calipers, measure the wall thickness, including primer coating, of the skin paneling of the vertical fin at the locations shown in Figure 1 of this AD.

- △ 1 Measurements are to be taken at at least three locations on the skin panel of the vertical fin. Care has to be taken that the external calipers are held squarely to the skin panel wall while measurements are being taken, since tilting of the calipers can lead to false results. If the panel thickness, including the primer coating, is at least 0.778 mm (0.03063 inch) at every measured location, no further action is necessary.

(b) If the wall thickness, including the primer coating, of the panelling is less than 0.778 millimeter (0.03063 inch) at any of the measured locations, replace the vertical fin with an airworthy part before further flight.
