[Docket No. 2004-NE-07-AD; Amendment 39-13579; AD 2004-08-10]

Airworthiness Directives; Engine Components Incorporated (ECi) Reciprocating Engine Cylinders

2004-08-10 Engine Components

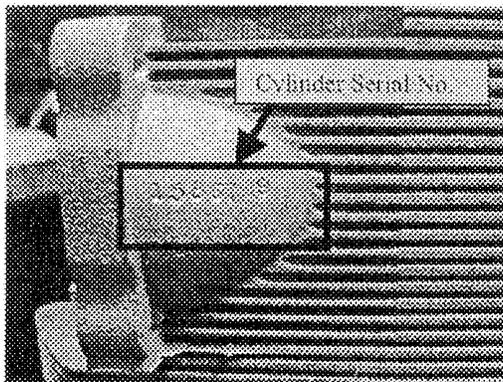
Figure 1.

(i) Determine the SN of the cylinder by looking in the engine records or by inspecting the cylinder for a SN on the intake port boss (see Figure 1) or on the flat area next to the head to barrel junction (see Figure 2). Disregard any dash numbers that might follow the four digit SN.

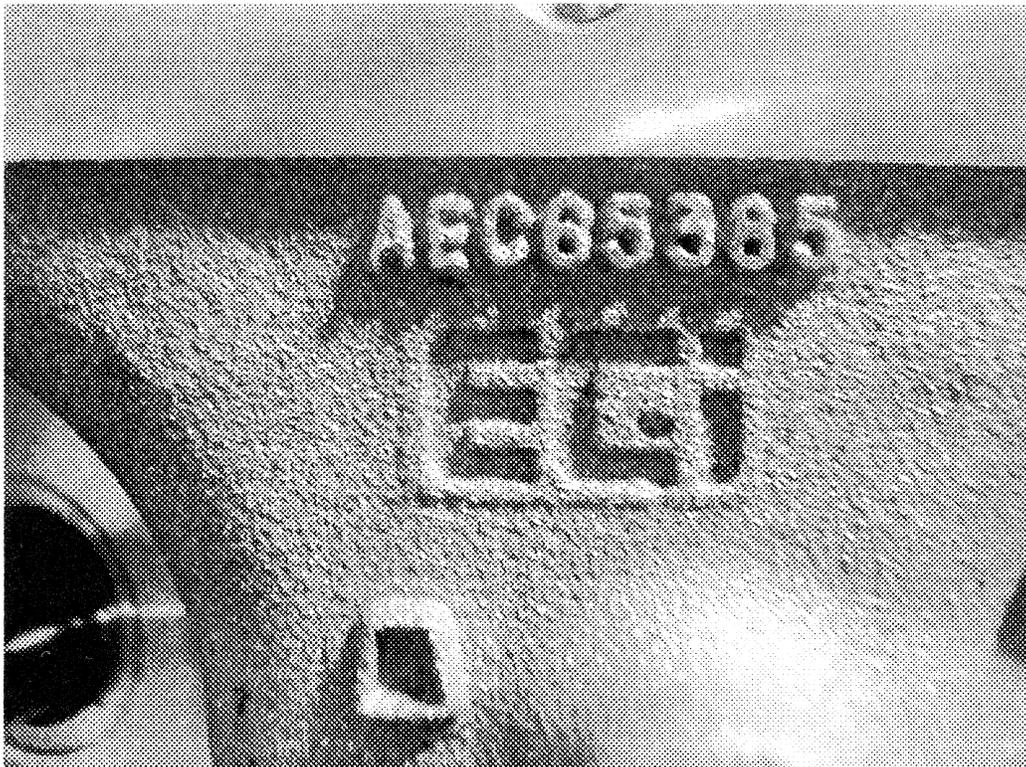
(iii) If the casting has AEC65385, and an "O" under the ECI logo, the cylinder is P/N AEC631397. See Figure 3.

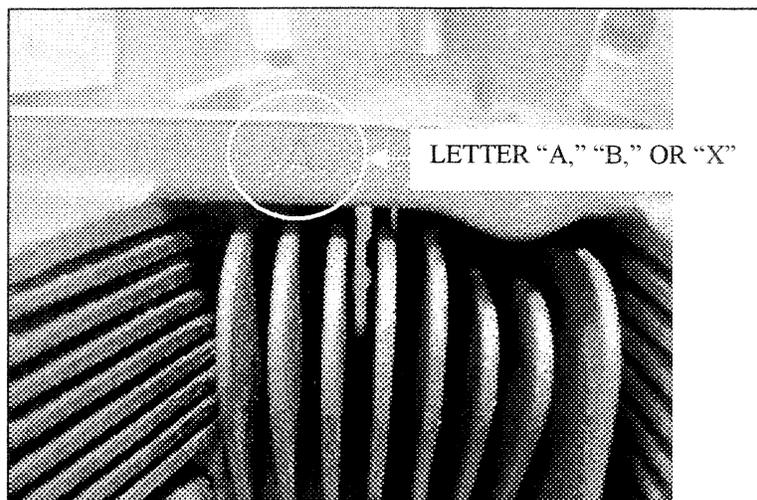
(ii) If there is a letter "A," "B," or "X" stamped on the flange of the rocker box, no further action is required. See Figure 4.

(iii) If there is no letter "A," "B," or "X" stamped on the flange of the rocker box, replace the cylinder before further flight.
