[Docket No. 2004-SW-09-AD; Amendment 39-13651; AD 2004-06-51]

Airworthiness Directives; Boeing Defense and Space Group Model 234 Helicopters

2004-06-51 Boeing Defense and Space Group: Amendment 39-13651. Docket No. 2004-SW-09-AD.

Applicability: Model 234 helicopters, with aft vertical shaft assembly, part number (P/N) 234D3300, serial number-181 or lower with a prefix of A, installed, certificated in any category.

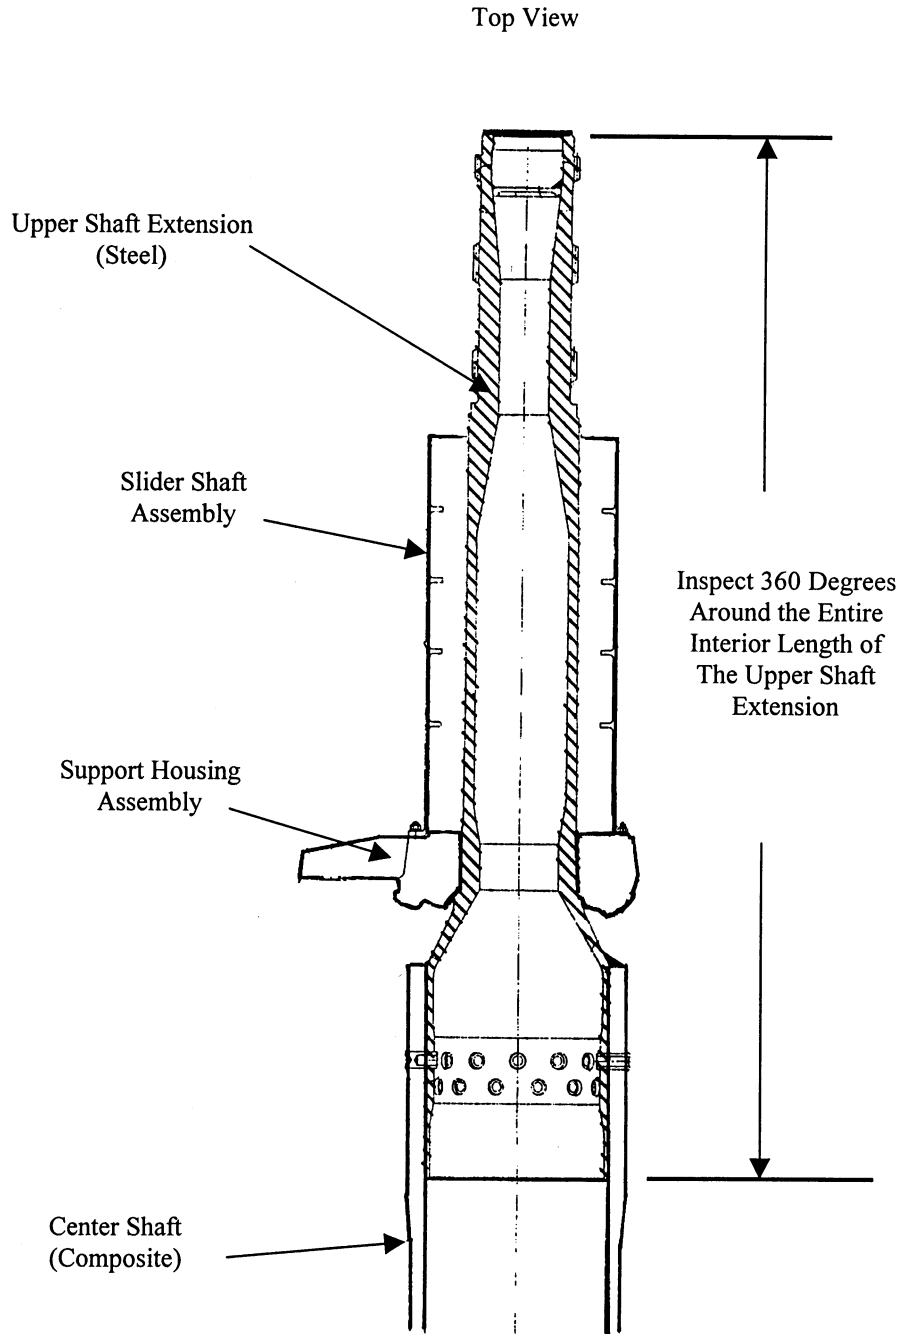
Aft Vertical Shaft
Assembly Inspection Area
Figure 1

To detect a crack in the upper shaft extension, which could result in catastrophic failure of the aft vertical shaft assembly and subsequent loss of control of the helicopter, accomplish the following:

(5) Inspect the upper shaft extension, P/N 114D3248, using a borescope or other lighted device that provides direct visual observation of the interior of the aft rotor shaft. Inspect 360 degrees around the entire interior length of the upper shaft extension. If any crack is found, replace the aft vertical shaft assembly, P/N 234D3300, with an airworthy assembly before further flight. See the following Figure 1 of this AD for the area to inspect:

(3) Inspect the upper shaft extension, P/N 114D3248, using a borescope or other lighted device that provides direct visual observation of the interior of the aft rotor shaft. Inspect 360 degrees around the entire interior length of the upper shaft extension (see Figure 1 of this AD). If any crack is found, replace the aft vertical shaft assembly, P/N 234D3300,
