Federal Register

[Docket No. 2004-SW-04-AD]

#### Airworthiness Directives; Bell Helicopter Textron Canada Model 222, 222B, 222U, and 230 Helicopters

**ACTION:** Notice of proposed rulemaking (NPRM).

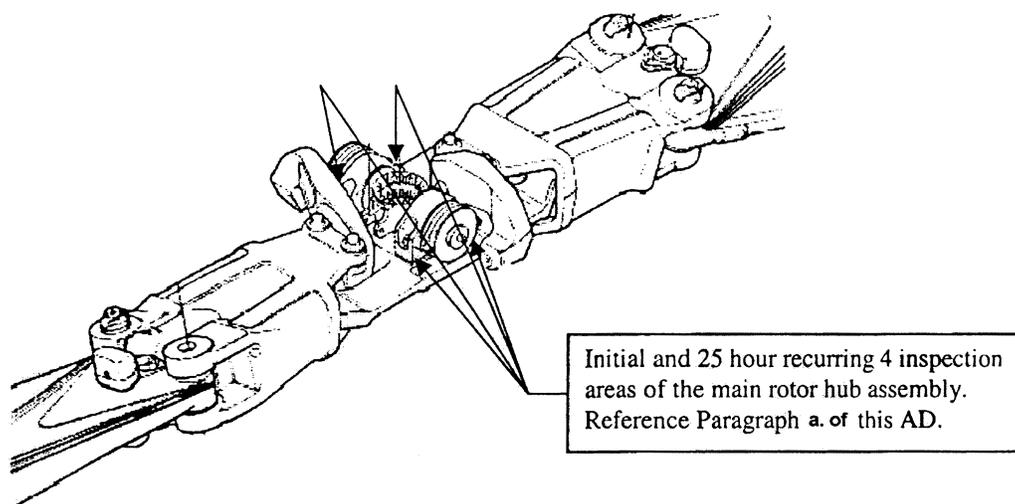
**Figure 1. Main Rotor Hub Assembly**

- (a) Within 50 hours time-in-service (TIS) or by the next scheduled inspection for the hub assembly, whichever occurs first, and thereafter at intervals not to exceed 25 hours TIS, using a 10X or higher magnifying glass, visually inspect the main rotor yoke (yoke)

for a crack, fretting or buffer deterioration in the four areas around the flapping bearing attachment bushings as shown in the following Figure 1 of this AD:

(1) If a crack is found, before further flight, replace the yoke with an airworthy yoke.

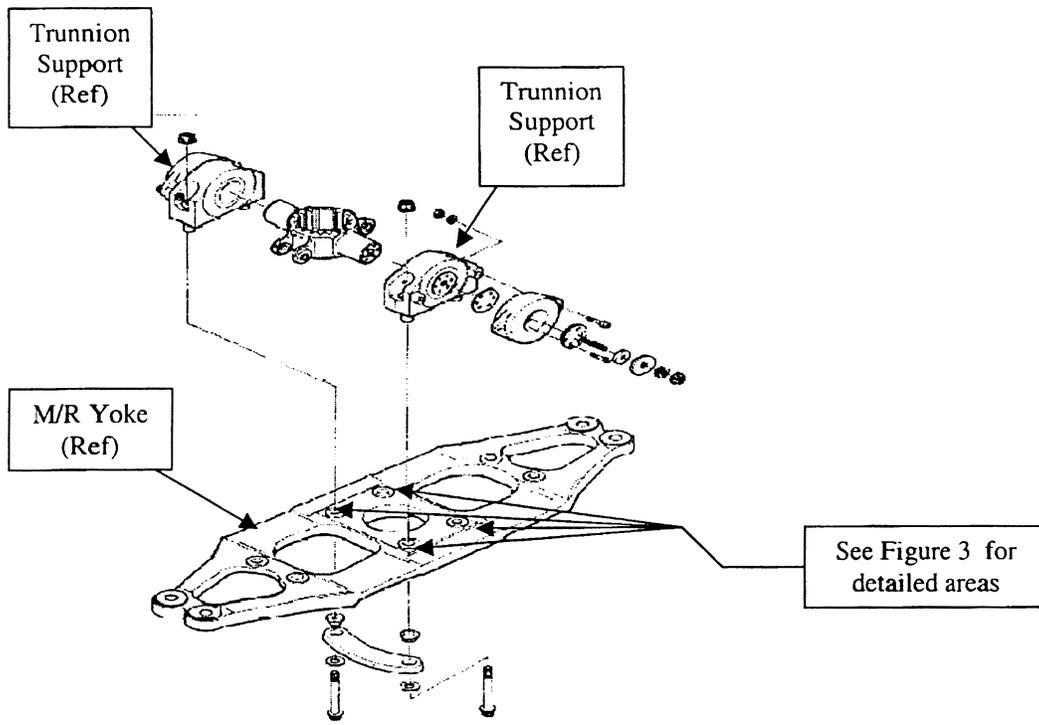
**Figure 2. Main Rotor Yoke**

(2) If fretting or buffer deterioration is found on the yoke in the areas shown in Figure 1 of this AD, before further flight, disassemble the hub assembly and further inspect the yoke with a 10X or higher magnifying glass in the four areas shown in Figures 2 and 3 of this AD.

(i) If a crack is found on any part, before further flight, replace the part with an airworthy part.

(ii) If fretting or buffer deterioration is found on any part, before further flight, repair any unairworthy part or replace the part with an airworthy part.
