[Docket No. 2002-NE-19-AD; Amendment  
39-13693; AD 2004-13-11]

**Airworthiness Directives; Rolls-Royce  
plc RB211 Trent 875-17, Trent 877-17,  
Trent 884-17, Trent 884B-17, Trent  
892-17, Trent 892B-17, and Trent 895-  
17 Series Turbofan Engines**

[Docket No. 2001-SW-15-AD; Amendment 39-13687; AD 2001-24-07 R1]

**Airworthiness Directives; Agusta S.p.A. Model A109C, A109E, and A109K2 Helicopters**

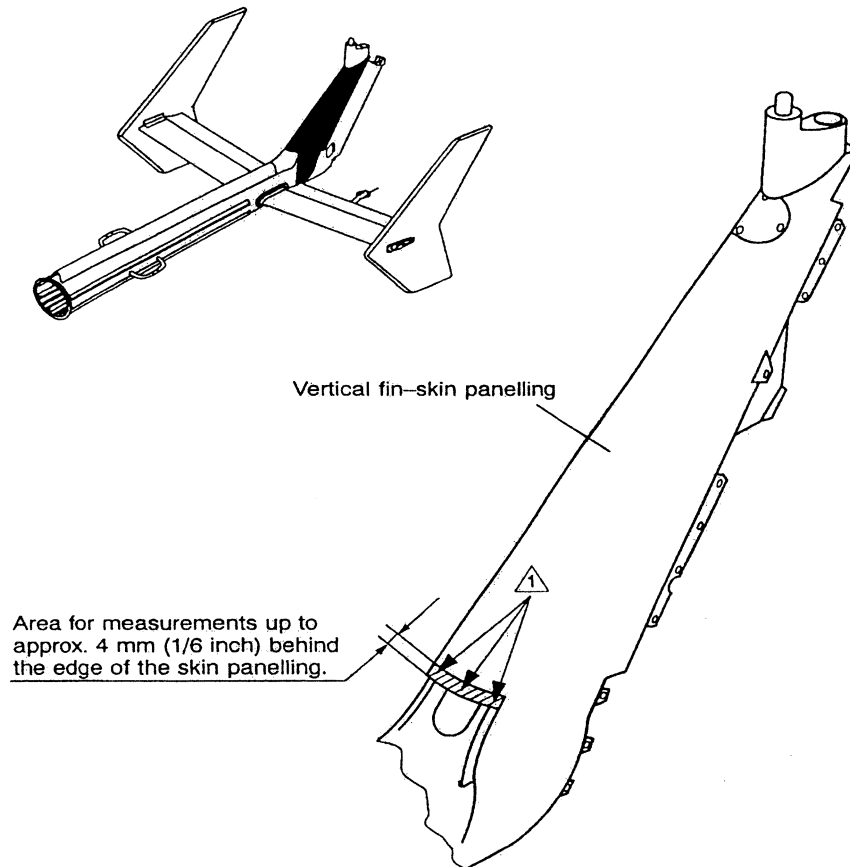
Vertical Fin-Skin Panelling  
Figure 1

△ Measurements are to be taken at at least three locations on the skin panel of the vertical fin. Care has to be taken that the external calipers are held squarely to the skin panel wall while measurements are being taken, since tilting of the calipers can lead to false results. If the panel thickness, including the primer coating, is at least 0.778 mm (0.03063 inch) at every measured location, no further action is necessary.

(b) If the wall thickness, including the primer coating, of the panelling is less than 0.778 millimeter (0.03063 inch) at any of the measured locations, replace the vertical fin with an airworthy part before further flight.
