[Docket No. 2002-SW-25-AD; Amendment 39-13709; AD 2003-13-15 R1]

Airworthiness Directives; Schweizer Aircraft Corporation Model 269A, 269A-1, 269B, 269C, and TH-55A Helicopters

ACTION: Final rule.

2003-13-15 R1 Schweizer Aircraft Corporation: Amendment 39-13709. Docket No. 2002-SW-25-AD. Revises

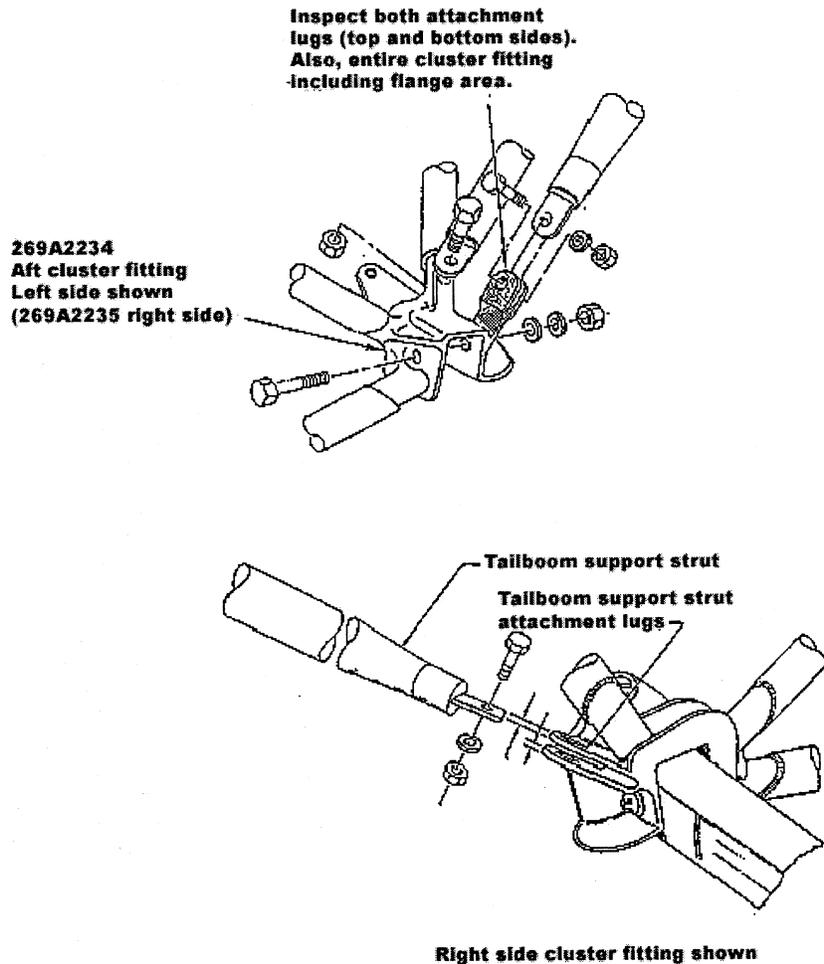
Figure 1

To prevent failure of a tailboom support strut or lug on a cluster fitting, which could cause rotation of a tailboom into the main rotor blades, and subsequent loss of control of the helicopter, accomplish the following:

(2) Dye-penetrant inspect the lugs on each cluster fitting. See the following Figure 1:

(3) If a crack is found, before further flight, replace the cracked cluster fitting with an airworthy cluster fitting.

(c) Within 150 hours TIS or 6 months, whichever occurs first, replace each cluster fitting, P/N 269A2234 and P/N 269A2235, with an airworthy cluster fitting or modify each cluster fitting, P/N 269A2234 and P/N 269A2235, with Kit, P/N SA-269K-106-1. Installing the kit is terminating action for the 50-hour TIS repetitive dye-penetrant inspection for these cluster fittings. Broken or cracked cluster fittings are not eligible for the kit modification.
