[Docket No. FAA-2004-18850; Directorate Identifier 2004-SW-19-AD; Amendment 39-13771; AD 2004-16-15]

**Airworthiness Directives; Eurocopter France Model AS-365N2, AS 365 N3, EC 155B, EC155B1, SA-365N and N1, and SA-366G1 Helicopters**

**SUMMARY:** This amendment adopts a new airworthiness directive (AD) for the specified Eurocopter France (Eurocopter) helicopters. This action requires inspecting the main gearbox

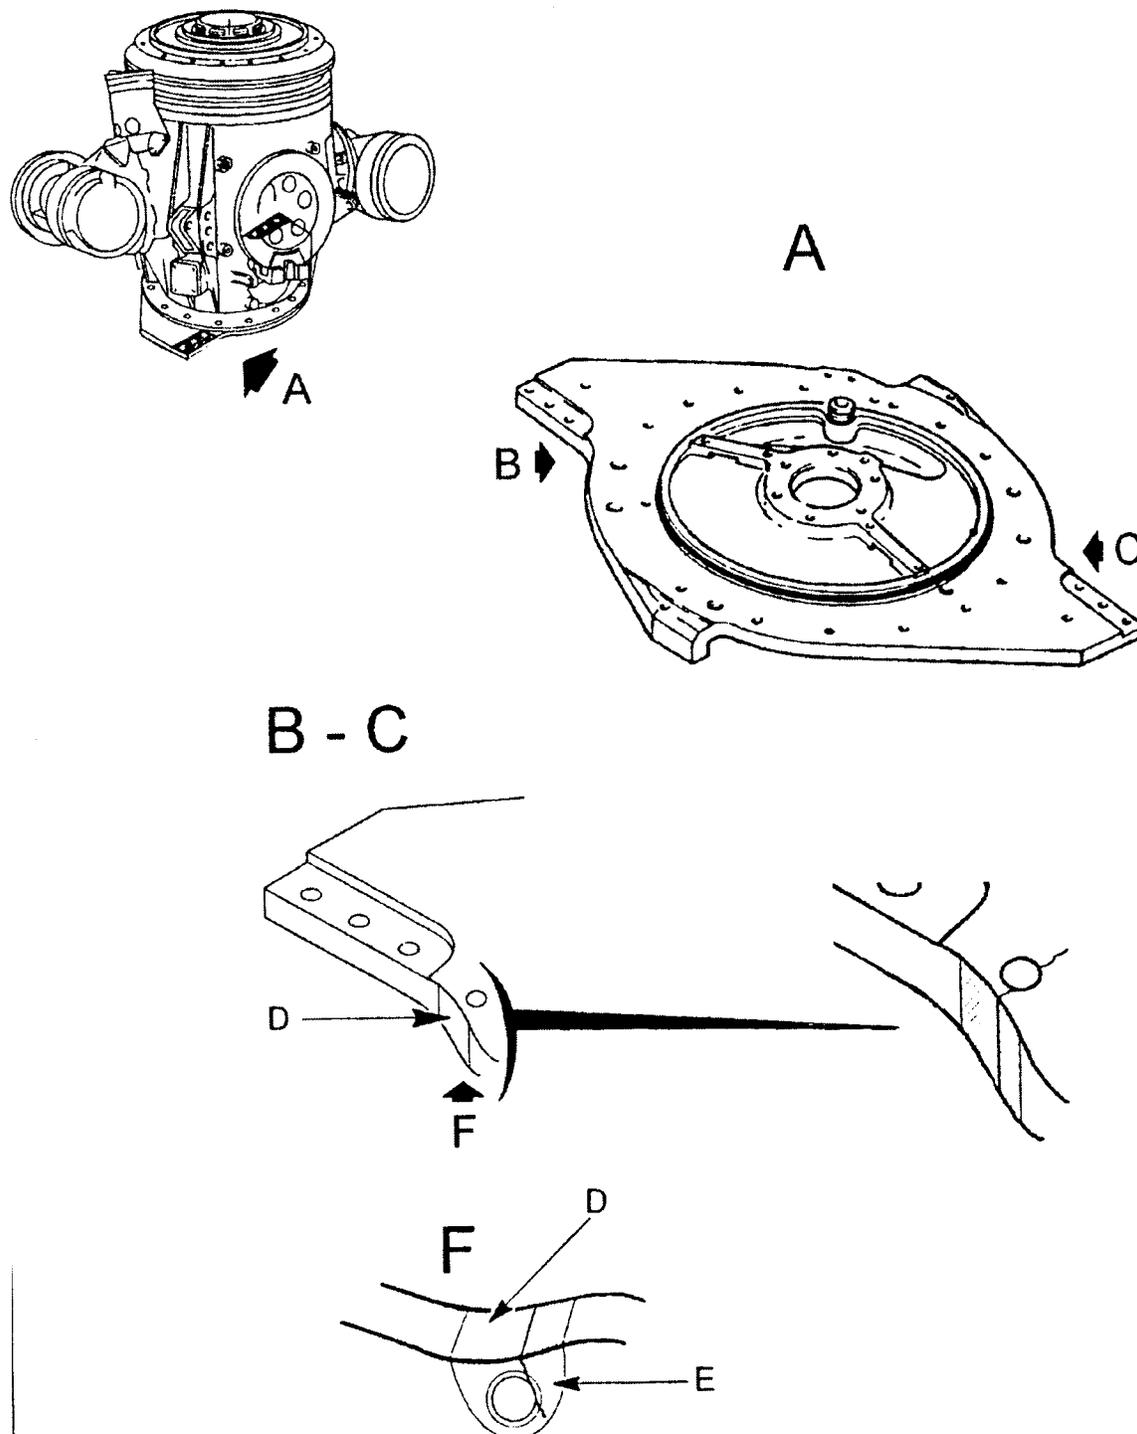
Figure 1

paint from area "D" on both sides ("B" and "C") of the MGB base plate as depicted in Figure 1.

(b) At the times indicated in the compliance table, inspect area "D" of the MGB base plate for a crack using a 10x or higher magnifying glass.

(c) If a crack is found in a MGB base plate, remove and replace the MGB with an airworthy MGB before further flight.
