[Docket No. 2004-SW-04-AD; Amendment 39-13812; AD 2004-20-07]

Airworthiness Directives; Bell Helicopter Textron Canada Model 222, 222B, 222U, and 230 Helicopters

ACTION: Final rule.

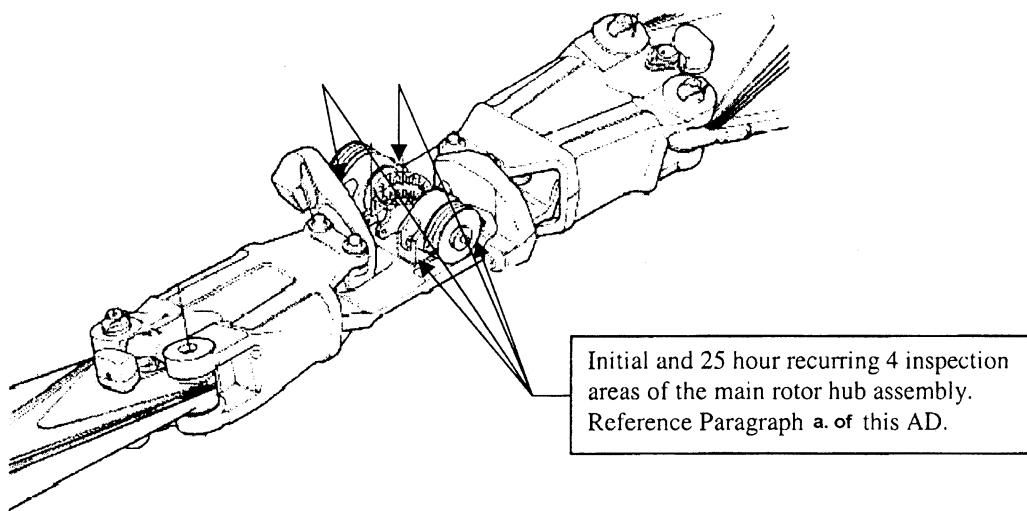
Figure 1. Main Rotor Hub Assembly

(a) Within 50 hours time-in-service (TIS) or by the next scheduled inspection for the hub assembly, whichever occurs first, and thereafter at intervals not to exceed 25 hours TIS, using a 10X or higher magnifying glass, visually inspect the main rotor yoke (yoke)

for a crack, fretting or buffer deterioration in the four areas around the flapping bearing attachment bushings as shown in the following Figure 1 of this AD:

(1) If a crack is found, before further flight, replace the yoke with an airworthy yoke.

(2) If fretting or buffer deterioration is found on the yoke in the areas shown in Figure 1 of this AD, before further flight, disassemble the hub assembly and further

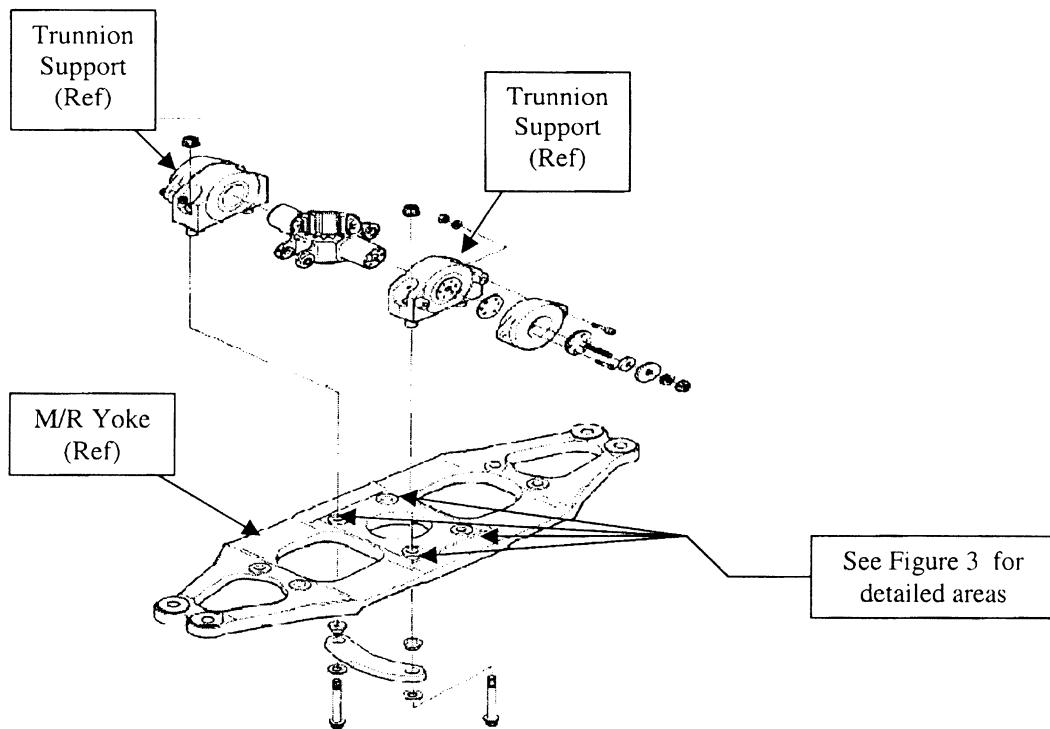
Figure 2. Main Rotor Yoke

inspect the yoke with a 10X or higher magnifying glass in the four areas shown in Figures 2 and 3 of this AD.

Shown with trunnion supports removed.

(i) If a crack is found on any part, before further flight, replace the part with an airworthy part.

(ii) If fretting or buffer deterioration is found on any part, before further flight, repair any unairworthy part or replace the part with an airworthy part.
