[Docket No. 2004-SW-12-AD; Amendment 39-13884; AD 2004-24-08]

Airworthiness Directives; Bell Helicopter Textron Canada Model 206A, B, L, L-1, L-3, and L-4 Helicopters

ACTION: Final rule; request for comments.

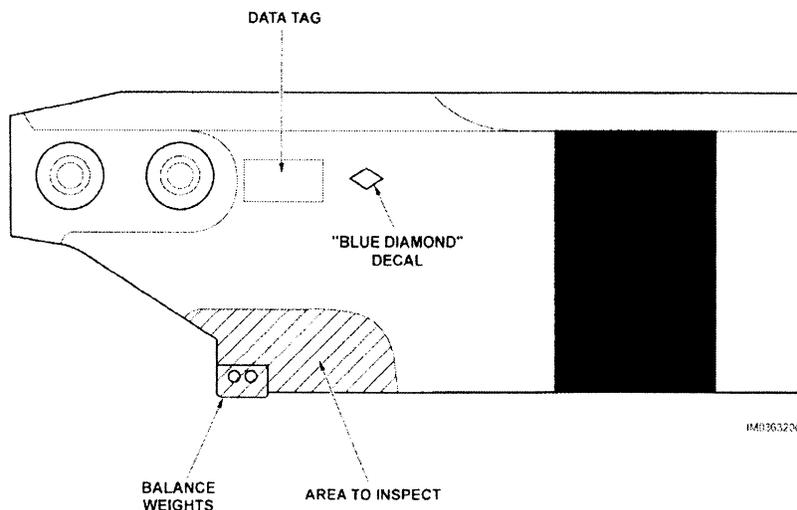
Figure 1. Tail rotor blade inspection.

crack, and a bent or deformed weight in the area shown in Figure 1 of this AD.

Note 1: Paint irregularities on the blade may indicate a crack.

(1) At intervals not to exceed 12 hours time-in-service (TIS), using a 10X or higher magnifying glass, inspect both sides of each blade for a deformation, a crack, and a bent or deformed weight in the area shown in Figure 1 of this AD, or

(2) Inspect and check both sides of each blade for a deformation, a crack, and a bent or deformed weight in the area shown in Figure 1 of this AD as follows:

(c) Before further flight, replace any blade that has a deformation, a crack, or a bent or deformed weight with an airworthy blade.
