[Docket No. FAA-2004-18744; Directorate Identifier 2004-CE-24-AD; Amendment 39-13910; AD 2004-25-22]

Airworthiness Directives; Great Lakes Aircraft Company, LLC, Models 2T-1A-1 and 2T-1A-2 Airplanes

2004-25-22 Great Lakes Aircraft

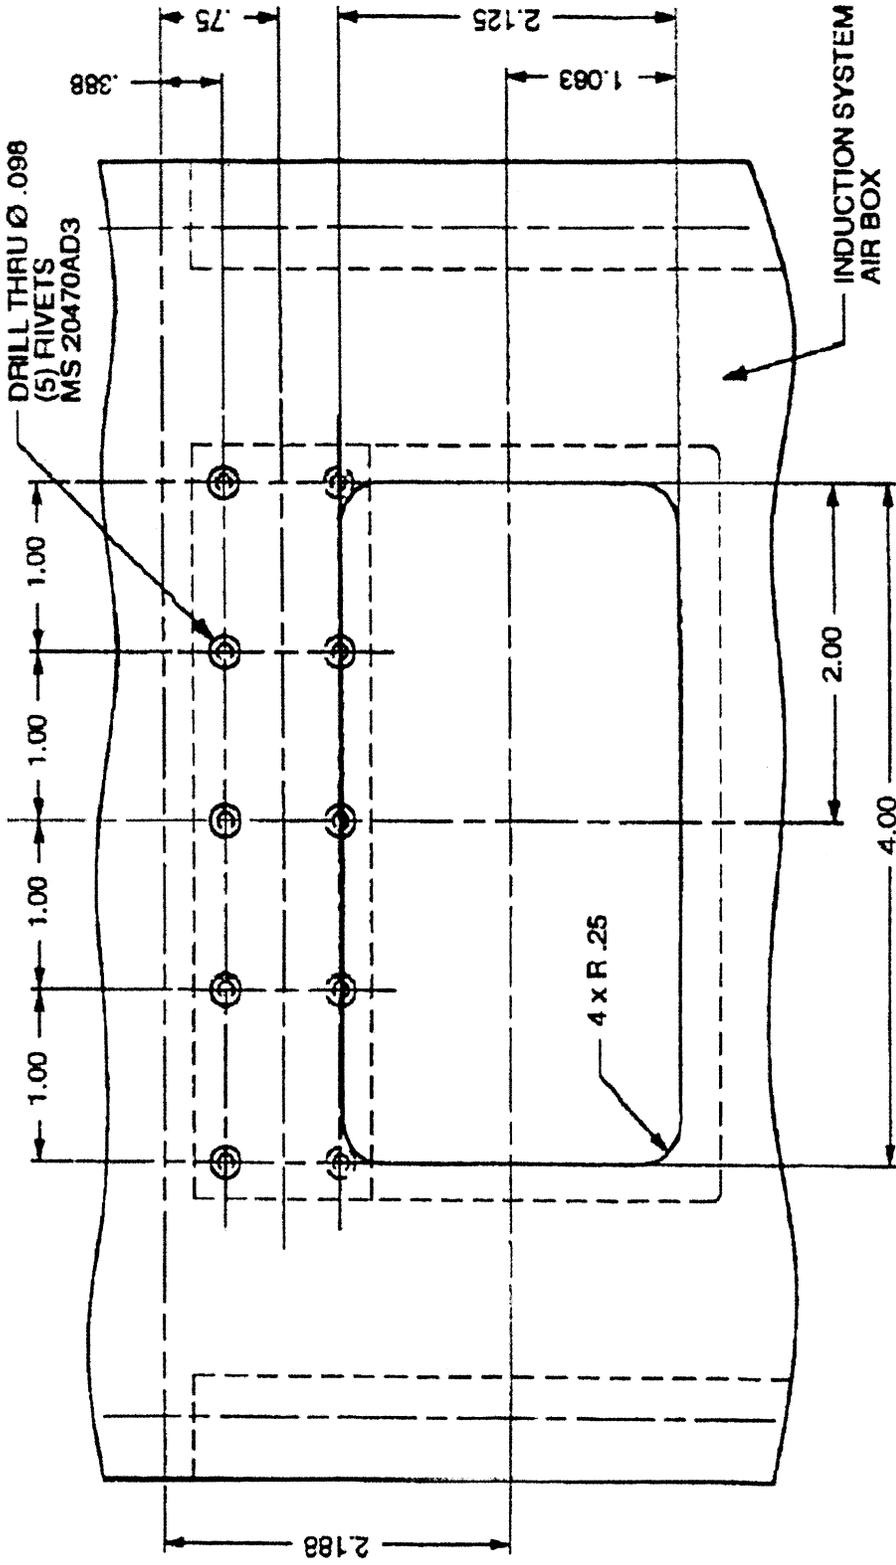
Figure 1

GREAT LAKES AIRCRAFT, TYPES 2T-1A-1 AND 2T-1A-2
ENGINE INDUCTION SYSTEM AD 79-20-08
ALTERNATE AIR DOOR INSTALLATION
FULL SCALE

Actions	Compliance	Procedures
(2) Visually inspect the alternate air door for distortion, heat damage, and cracks. If any damage is found, repair or fabricate a new door following Figure 1, Figure 2, and Figure 3 in this AD.	<i>For airplanes previously affected by AD 79-20-08:</i> Initially inspect at the next scheduled inspection required by AD 79-20-08 or within the next 25 hours TIS after January 28, 2005 (the effective date of this AD), whichever occurs later. Repetitively inspect thereafter at intervals not to exceed 100 hours TIS. <i>For airplanes not previously affected by AD 79-20-08:</i> Inspect within the next 25 hours TIS after January 28, 2005 (the effective date of this AD). Repetitively inspect thereafter at intervals not to exceed 100 hours TIS. <i>For all affected airplanes:</i> After each inspection, if damage is found during any inspection, before further flight, repair, replace the damaged alternate air door.	Not applicable.

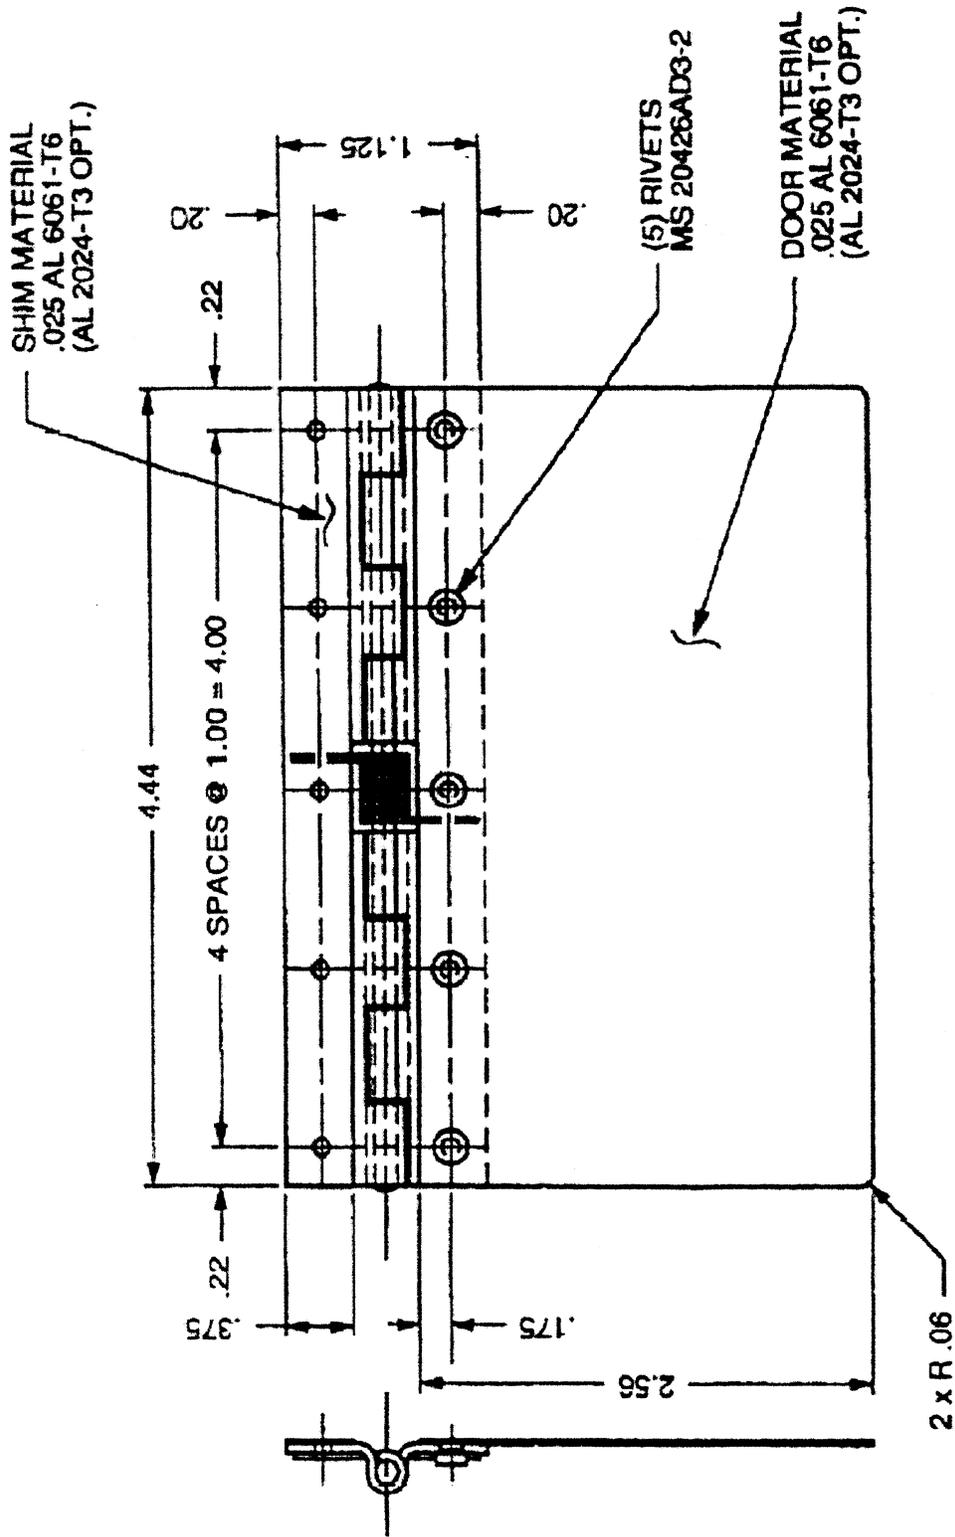
Figure 2

GREAT LAKES AIRCRAFT, TYPES 2T-1A-1 AND 2T-1A-2
ENGINE INDUCTION SYSTEM AD 79-20-08
ALTERNATE AIR DOOR FABRICATION DETAIL
FULL SCALE

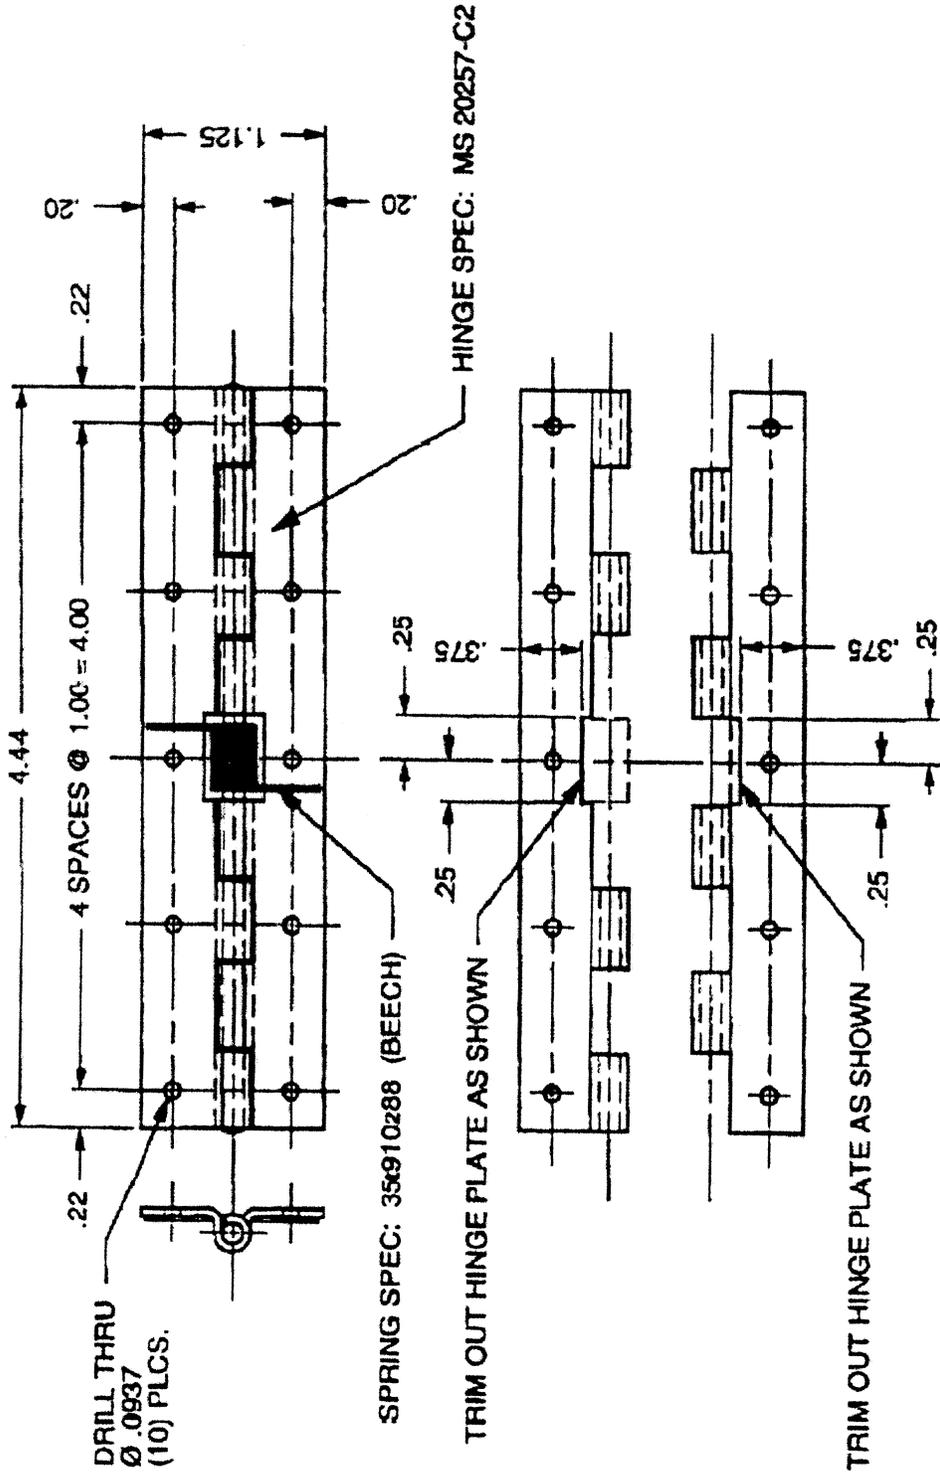
Figure 3

GREAT LAKES AIRCRAFT, TYPES 2T-1A-1 AND 2T-1A-2
ENGINE INDUCTION SYSTEM AD 79-20-08
ALTERNATE AIR DOOR HINGE DETAIL
FULL SCALE
