[Docket No. FAA-2004-19969; Directorate Identifier 2004-SW-43-AD; Amendment 39-13923; AD 2004-26-11]

Airworthiness Directives; Bell Helicopter Textron Canada Model 222, 222B, 222U, 230, and 430 Helicopters

AD 2004-26-11 Bell Helicopter Textron Canada: Amendment 39-13923. Docket No. FAA-2004-19969; Directorate Identifier 2004-SW-43-AD.

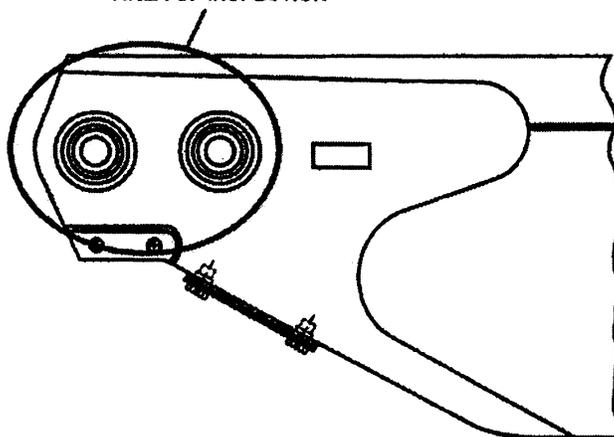
222-016-001-123 and -127

Transport Canada, the airworthiness authority for Canada, notified the FAA that an unsafe condition may exist on the specified BHTC model helicopters. Transport Canada advises of the discovery of cracked blades during scheduled inspections on three occasions. Two cracks originated from the outboard feathering bearing bore underneath the flanged sleeves. The third crack started from the inboard feathering bearing bore. Investigation found that the cracks originated from either a machining burr or a corrosion site in the bearing bore underneath the flanged sleeves.

- (a) Within 3 hours time-in-service (TIS) and at intervals not to exceed 3 hours TIS, clean and visually check both sides of each blade for a crack in the paint in the areas shown in Figure 1 of this AD. An owner/operator (pilot), holding at least a private

(i) If a crack is found, before further flight, replace the blade with an airworthy blade.

(ii) If no crack is found in the blade surface, refinish the blade by applying one coat of MIL-P-23377 or MIL-P-85582 Epoxy Polyamide Primer so that the primer overlaps

the existing coats just beyond the abraded area. Let the area dry for 30 minutes to 1 hour. Then, apply one sealer coat of Polyurethane MILC85285 TYI CL2, color Number 27925 (semi-gloss white) per Fed. Std. 595. Reinstall the blade.
