Federal Register

[Docket No. FAA-2004-19960; Directorate Identifier 2004-CE-47-AD]

#### Airworthiness Directives; The New Piper Aircraft, Inc. PA-34 Series Airplanes

**ACTION:** Notice of proposed rulemaking (NPRM).

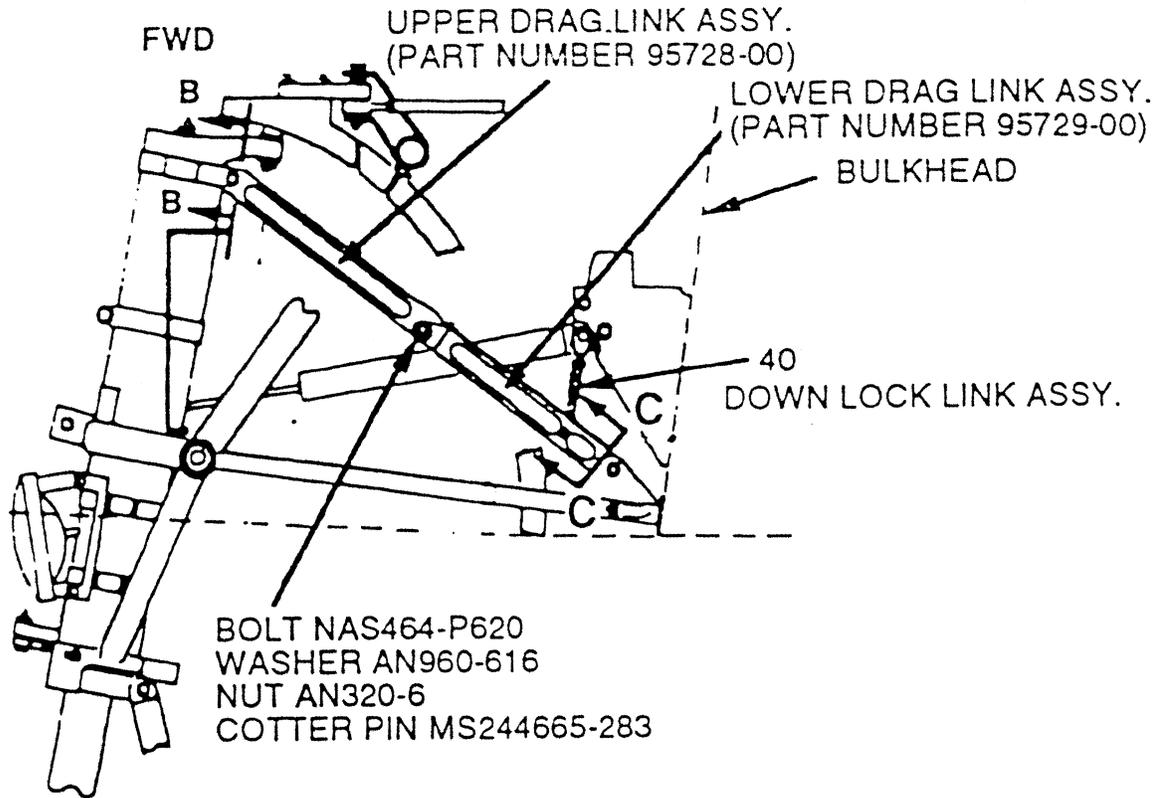
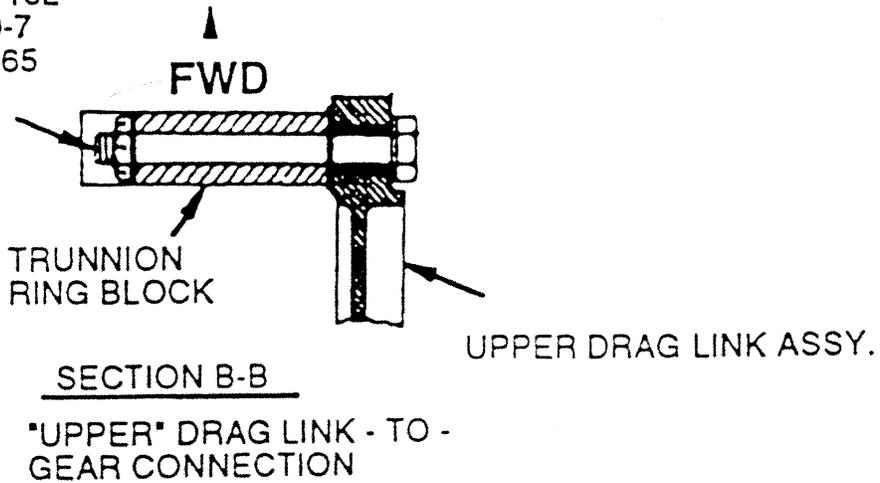
AN7-35  
AN960-716  
OR  
AN960-716L  
AN320-7  
MS24665

Actions	Compliance	Procedures
(1) Replace the bolt and stack up that connects the upper drag link to the nose gear trunnion with new parts of the following: (i) Piper part number (P/N) 400 274 (AN7-35) bolt; (ii) Piper P/N 407 591 (AN960-716L) washer, as applicable; (iii) Piper P/N 407 568 (AN960-716); (iv) Piper P/N 404 396 (AN320-7) nut; and (v) Piper P/N 424 085 cotter pin.	Within the next 100 hours time-in-service (TIS) after January 28, 1994 (the effective date of AD 93-24-14), unless already done within the last 400 hours TIS before January 28, 1994 (compliance with AD 93-24-14). Repetitively replace thereafter at intervals not to exceed 500 hours TIS. Continue to repetitively replace until the actions in paragraph (e)(2) and (e)(3) of this AD begin.	Follow Figure 1 of this AD.
