[Docket No. FAA-2004-19960; Directorate Identifier 2004-CE-47-AD]

Airworthiness Directives; The New Piper Aircraft, Inc. PA-34 Series Airplanes

ACTION: Notice of proposed rulemaking (NPRM).

SUMMARY: The FAA proposes to supersede Airworthiness Directive (AD) 93-24-14, which applies to all The New Piper Aircraft, Inc. (Piper) PA-34 series airplanes. AD 93-24-14 currently requires you to repetitively replace the bolt and stack up that connect the upper drag link to the nose gear trunnion. This proposed AD is the result of many service difficulty reports related to the collapse or inadvertent retraction of the nose landing gear (NLG). Consequently, this proposed AD would retain the actions required in AD 93-24-14 until the actions of the proposed AD would begin, require you to inspect the NLG and components of the NLG using new procedures for rigging the nose gear installation, and require you to replace unserviceable parts. We are also issuing this proposed AD to detect, correct, and prevent future failure in certain components of the NLG, lack of cleanliness of the NLG due to inadequate maintenance, or lack of lubricant in the NLG or NLG components. This failure of the NLG could l

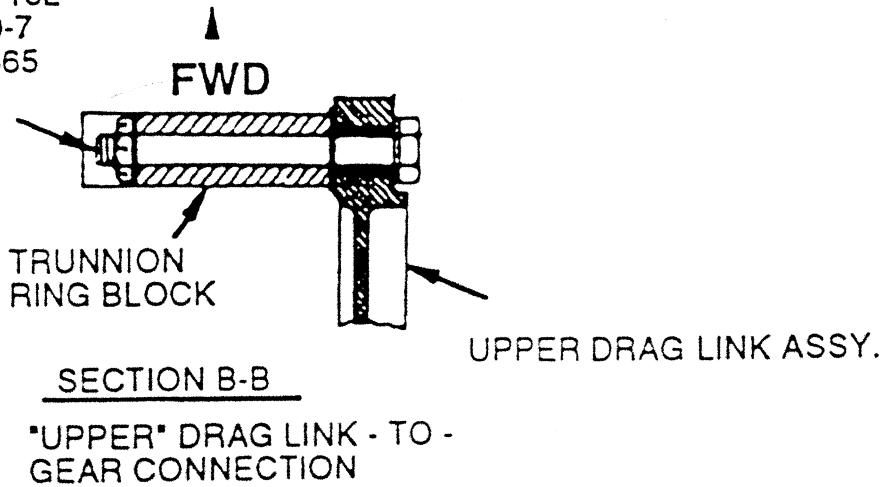
AN7-35
AN960-716
OR
AN960-716L
AN320-7
MS24665

Actions	Compliance	Procedures
(1) Replace the bolt and stack up that connects the upper drag link to the nose gear trunion with new parts of the following: (i) Piper part number (P/N) 400 274 (AN7-35) bolt; (ii) Piper P/N 407 591 (AN960-716L) washer, as applicable; (iii) Piper P/N 407 568 (AN960-716); (iv) Piper P/N 404 396 (AN320-7) nut; and (v) Piper P/N 424 085 cotter pin.	Within the next 100 hours time-in-service (TIS) after January 28, 1994 (the effective date of AD 93-24-14), unless already done within the last 400 hours TIS before January 28, 1994 (compliance with AD 93-24-14). Repetitively replace thereafter at intervals not to exceed 500 hours TIS. Continue to repetitively replace until the actions in paragraph (e)(2) and (e)(3) of this AD begin.	Follow Figure 1 of this AD.
