[Docket No. FAA-2004-19960; Directorate Identifier 2004-CE-47-AD]

#### Airworthiness Directives; The New Piper Aircraft, Inc. PA-34 Series Airplanes

**ACTION:** Notice of proposed rulemaking (NPRM).

**SUMMARY:** The FAA proposes to supersede Airworthiness Directive (AD) 93-24-14, which applies to all The New Piper Aircraft, Inc. (Piper) PA-34 series airplanes. AD 93-24-14 currently requires you to repetitively replace the bolt and stack up that connect the upper drag link to the nose gear trunnion. This proposed AD is the result of many service difficulty reports related to the collapse or inadvertent retraction of the nose landing gear (NLG). Consequently, this proposed AD would retain the actions required in AD 93-24-14 until the actions of the proposed AD would begin, require you to inspect the NLG and components of the NLG using new procedures for rigging the nose gear installation, and require you to replace unserviceable parts. We are also issuing this proposed AD to detect, correct, and prevent future failure in certain components of the NLG, lack of cleanliness of the NLG due to inadequate maintenance, or lack of lubricant in the NLG or NLG components. This failure of th

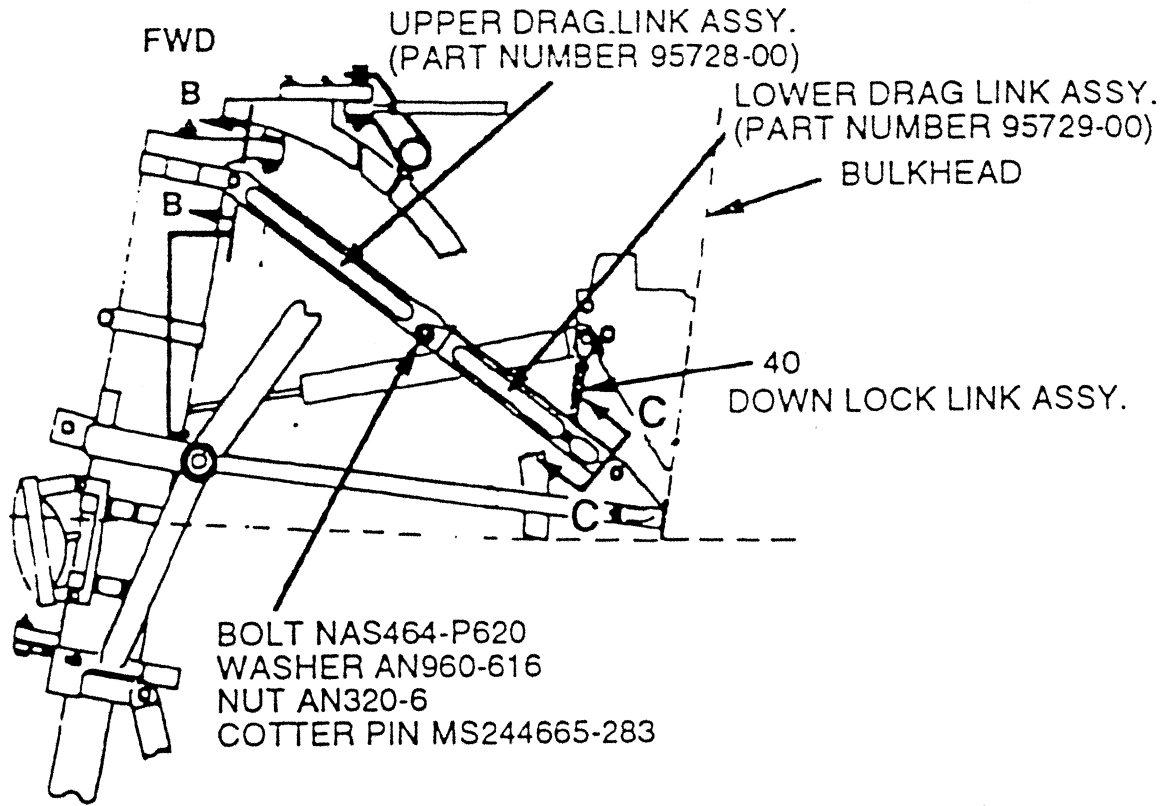
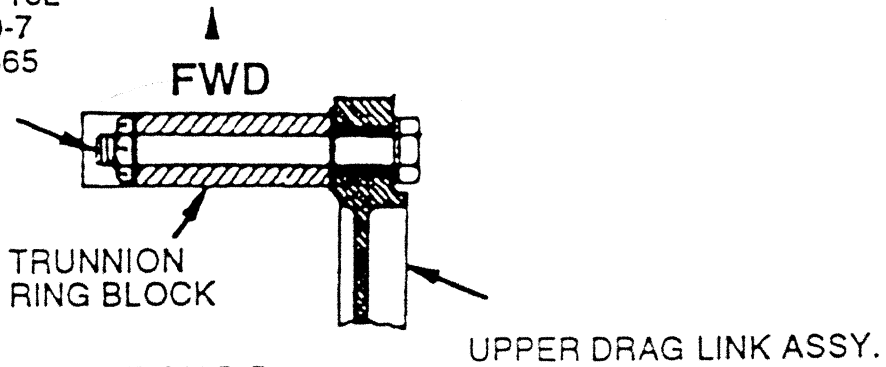
"UPPER" DRAG LINK - TO -  
GEAR CONNECTION

Actions	Compliance	Procedures
(1) Replace the bolt and stack up that connects the upper drag link to the nose gear trunnion with new parts of the following: (i) Piper part number (P/N) 400 274 (AN7-35) bolt; (ii) Piper P/N 407 591 (AN960-716L) washer, as applicable; (iii) Piper P/N 407 568 (AN960-716); (iv) Piper P/N 404 396 (AN320-7) nut; and (v) Piper P/N 424 085 cotter pin.	Within the next 100 hours time-in-service (TIS) after January 28, 1994 (the effective date of AD 93-24-14), unless already done within the last 400 hours TIS before January 28, 1994 (compliance with AD 93-24-14). Repetitively replace thereafter at intervals not to exceed 500 hours TIS. Continue to repetitively replace until the actions in paragraph (e)(2) and (e)(3) of this AD begin.	Follow Figure 1 of this AD.
