[Docket No. 83-ANE-14-AD; Amendment 39-14043; AD 83-08-01R2]

Airworthiness Directives; Hartzell Propeller Inc. (Formerly TRW Hartzell Propeller) Models HC-B3TN-2, HC-B3TN-3, HC-B3TN-5, HC-B4TN-3, HC-B4TN-5, HC-B4MN-5, and HC-B5MP-3 Turbopropellers

83-08-01R2 Hartzell Propeller Inc. (formerly TRW Hartzell Propeller):
Amendment 39-14043. Docket No. 83-ANE-14-AD. Revises AD 83-08-01R1, Amendment 39-4633

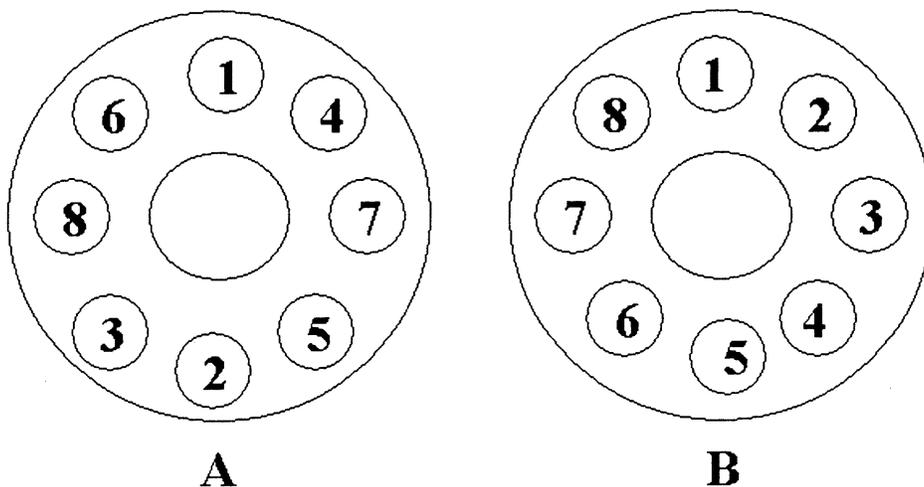
To preclude propeller attaching bolt failures or improperly secured propellers, which could lead to separation of the propeller from the airplane, do the following:

(5) Torque all attaching bolts with a torque wrench and an appropriate adapter, to 40 ft.-lbs., and then to 80 ft.-lbs., following sequence "A" (shown below). Final torque all attaching bolts using sequence "B" (shown below) to 100 ft.-lbs. to 105 ft.-lbs. Safety wire all attaching bolts in an FAA-approved manner.
