[Docket No. FAA-2004-19960; Directorate Identifier 2004-CE-47-AD; Amendment 39-14153; AD 2005-13-16]

Airworthiness Directives; The New Piper Aircraft, Inc. PA-34 Series Airplanes

ACTION: Final rule.

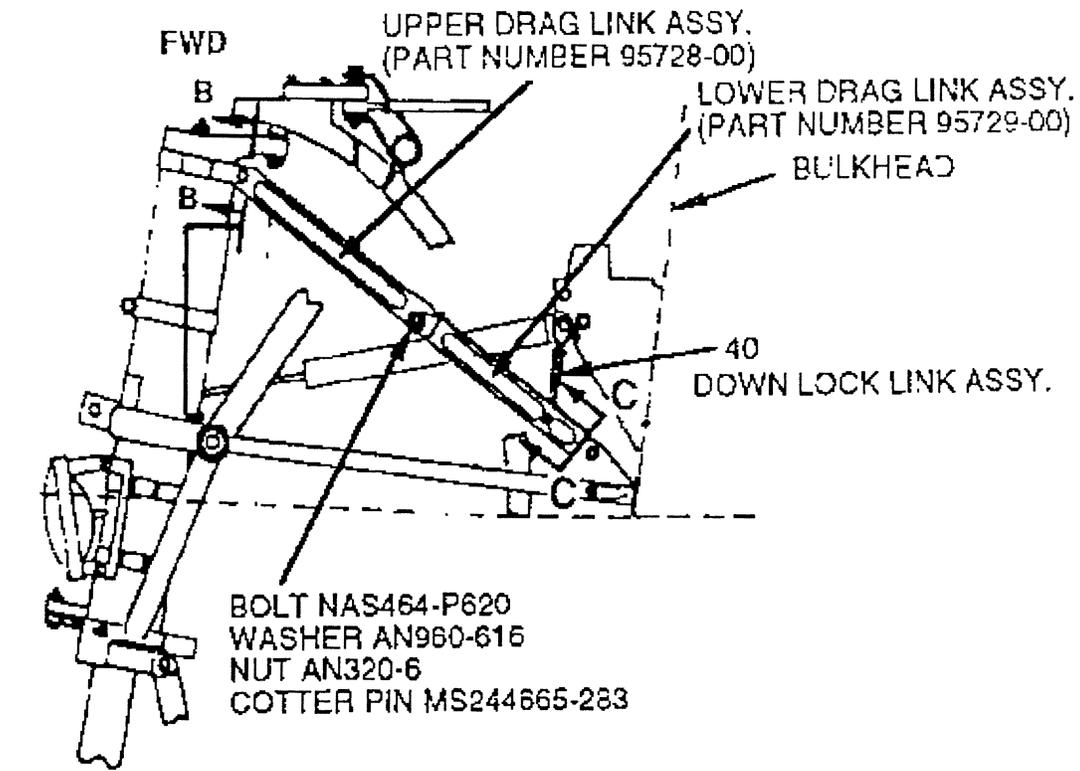
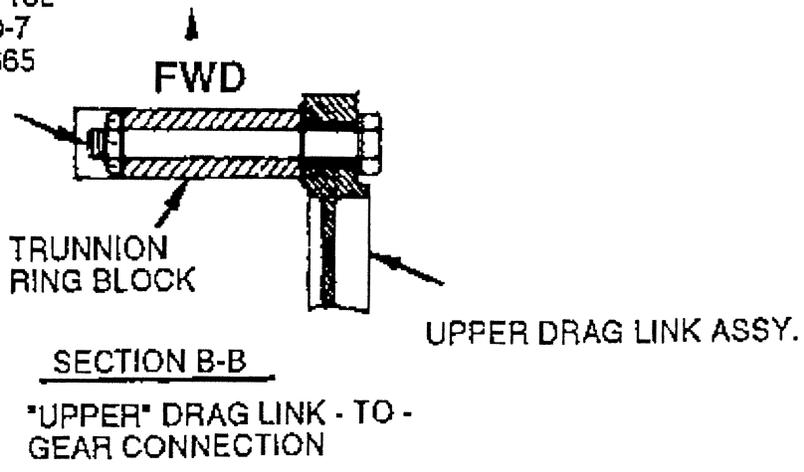
Figure 1.

What events have caused this AD? Several incidents where the nose landing gear (NLG) on The New Piper Aircraft, Inc. (Piper) PA-34 series airplanes collapsed caused us to issue AD 93-24-14, Amendment 39-8762 (58 FR 65115, December 13, 1993). AD 93-24-14 currently requires the repetitive replacement of the bolt and stack up that connect the upper drag link to the nose gear trunnion on all Piper PA-34 series airplanes.

AN7-35
AN960-716
OR
AN960-716L
AN320-7
MS24665

Actions	Compliance	Procedures
<p>(1) Replace the bolt and stack up that connects the upper drag link to the nose gear trunnion with new parts (or FAA-approved equivalent part numbers (P/N)) of the following:</p> <ul style="list-style-type: none"> (i) Piper P/N 400 274 (AN7-35) bolt; (ii) Piper P/N 407 591 (AN960-716L) washer, as applicable; (iii) Piper P/N 407 568 (AN960-716); (iv) Piper P/N 404 396 (AN320-7) nut; and (v) Piper P/N 424 085 cotter pin. <p>(2) Do the inspections, replacements, and other corrective actions specified in Table 1 "Specified Maintenance" of Piper Service Bulletin No. 1123A, dated November 30, 2004.</p> <p>(3) Do any necessary corrective actions as a result of the actions specified in Table 1 "Specified Maintenance" of Piper Service Bulletin No. 1123A, dated November 30, 2004.</p>	<p>Within the next 100 hours time-in-service (TIS) after January 28, 1994 (the effective date of AD 93-24-14), unless already done within the last 400 hours TIS before January 28, 1994 (compliance with AD 93-24-14). Repetitively replace thereafter at intervals not to exceed 500 hours TIS. Continue to repetitively replace until the actions in paragraphs (e)(2) and (e)(3) of this AD begin.</p> <p>Within the next 100 hours TIS after August 8, 2005 (the effective date of this AD), unless already done. Repetitively inspect thereafter at the intervals referenced in the Inspection Time column of the <i>INSTRUCTIONS</i> paragraph in Piper Service Bulletin No. 1123A, dated November 30, 2004.</p> <p>Before further flight after any action required by paragraph (e)(2) of this AD.</p>	<p>Follow Figure 1 of this AD.</p> <p>Follow The New Piper Aircraft, Inc. Service Bulletin No. 1123A, dated November 30, 2004.</p> <p>Follow The New Piper Aircraft, Inc. Service Bulletin No. 1123A, dated November 30, 2004.</p>
