Airworthiness Directives; Bell Helicopter Textron Canada Model 206A, A-1, B, B-1, L, L-1, L-3, L-4 Helicopters

ACTION: Notice of proposed rulemaking (NPRM).

Bell Helicopter Textron Canada: Docket No. FAA-2005-21680; Directorate Identifier 2004-SW-48-AD.

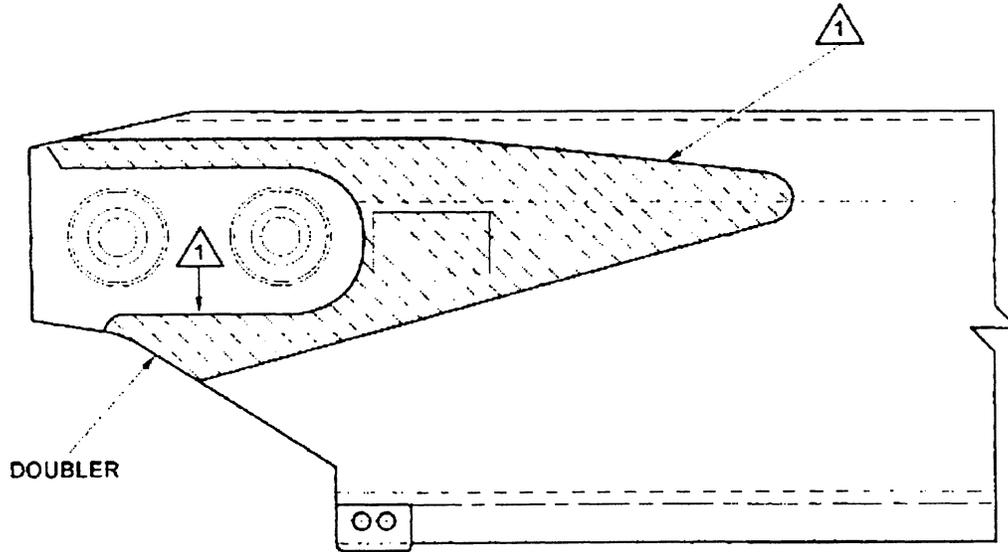
Model 206A, B, and L series helicopters. Transport Canada advises that an inadequate surface preparation on a limited number of blades resulted in two reported instances of blade root doubler de-bond. They also advise that to ensure blade integrity all suspected blades are to be checked daily until removed from service.

(a) Before the first flight of each day, clean each blade and visually check the blade root doublers for an edge void or de-bond on both sides of each blade as depicted in Figure 1 of this AD. An owner/operator (pilot), holding at least a private pilot certificate, may perform this visual check and must enter compliance with this paragraph into the helicopter maintenance records by following 14 CFR sections 43.11 and 91.417(a)(2)(v).

1 Inspect the doubler for an edge void or de-bond on both sides of each blade.

(b) If an edge void or a de-bond is found, before further flight, replace the blade with an airworthy blade with a serial number other than those to which this AD applies.

(c) Within 100 hours time-in-service, replace all affected, serial-numbered blades with airworthy blades with a serial number other than those to which this AD applies.
