Federal Register

Thursday, August 11, 2005

[Docket No. FAA-2005-22026; Directorate Identifier 2005-SW-05-AD; Amendment 39-14210; AD 2005-16-05]

Airworthiness Directives; Robinson Helicopter Company Model R-22 Series Helicopters

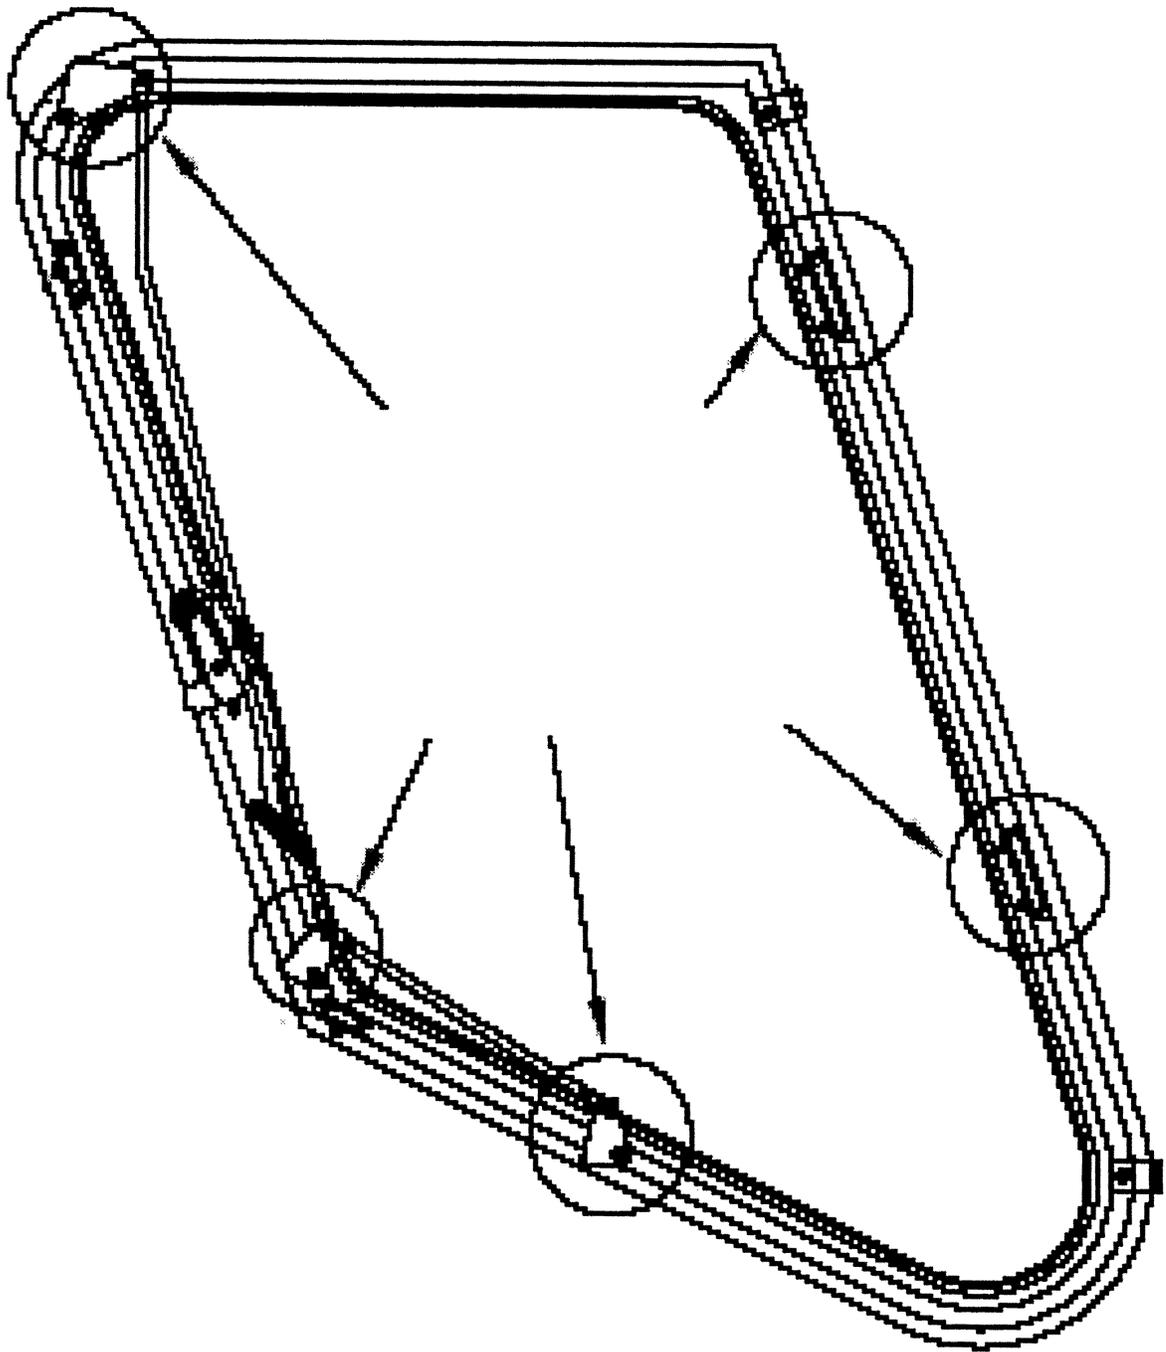
Subsequent investigation revealed cracking across the composite door assembly integral frame stiffener bead, just beneath the lower hinge on the forward edge of the door, and at the upper and lower door cam lock on the trailing edge of the door. Further investigation revealed that the door weather seal set was not the weather seal set supplied by the door assembly manufacturer. Additionally, the two nylon adjustment screws, which are required to relieve excessive force on the door hinges, were broken or missing. Finally, the door may not have been trimmed to the cabin door opening as stated in the manufacturer's door assembly installation drawings. The actions specified in this AD are intended to prevent separation of a door window or door assembly from the helicopter, which could damage the tail rotor during flight and result in loss of control of the helicopter.

(1) Visually inspect each pilot and copilot door assembly integral frame for a crack in the locations depicted in Figure 1 of this AD. If a crack is found, before further flight, replace the cracked door assembly, part number (P/N) R-22-101-51 or P/N R-22-101-53 (left-hand door assembly), or P/N R-22-101-52 or P/N R-22-101-54 (right-hand door assembly), with an airworthy door assembly. If you use door assembly, P/N R-22-101-51 or P/N R-22-101-53 (left-hand door assembly), or P/N R-22-101-52 or P/N R-22-101-54 (right-hand door assembly) as the replacement, then install it in accordance with Tech-Tool Plastics, Inc. Installation Instructions TTP-1R, Revision A, dated November 21, 1997, and with the sections titled "Door Weather Seal Installation" and "Cotter Pin Installation" in Tech-Tool Plastics, Inc. Service Bulletin No. TTP2005-01, Revision A, dated February 1, 2005 (SB).

Door Assembly (left-hand shown) View Looking Outboard

(b) After accomplishing the inspections in paragraphs (a) through (a)(2)(ii) of this AD, at intervals not to exceed 100 hours time-in-service, visually inspect each pilot and copilot door assembly integral frame for a crack in the locations depicted in Figure 1 of this AD.

(c) If a crack is found, before further flight, replace the cracked door assembly, P/N R-22-101-51 or P/N R-22-101-53 (left-hand door assembly), or P/N R-22-101-52 or P/N R-22-101-54 (right-hand door assembly), with an airworthy door assembly. If the replacement door assembly is P/N R-22-101-51 or P/N R-22-101-53 (left-hand door assembly), or P/N R-22-101-52 or P/N R-22-101-54 (right-hand door assembly), then install it in accordance with Tech-Tool Plastics, Inc. Installation Instructions TTP-1R, Revision A, dated November 21, 1997, and "Door Weather Seal Installation" and "Cotter Pin Installation" sections of the SB.
