[Docket No. FAA-2005-21680; Directorate Identifier 2004-SW-48-AD; Amendment 39-14341; AD 2005-21-03]

#### Airworthiness Directives; Bell Helicopter Textron Canada Model 206A, A-1, B, B-1, L, L-1, L-3, L-4 Helicopters

**ACTION:** Final rule.

**2005–21–03 Bell Helicopter Textron Canada:** Amendment 39–14341. Docket No. FAA–2005–21680; Directorate Identifier 2004–SW–48–AD.

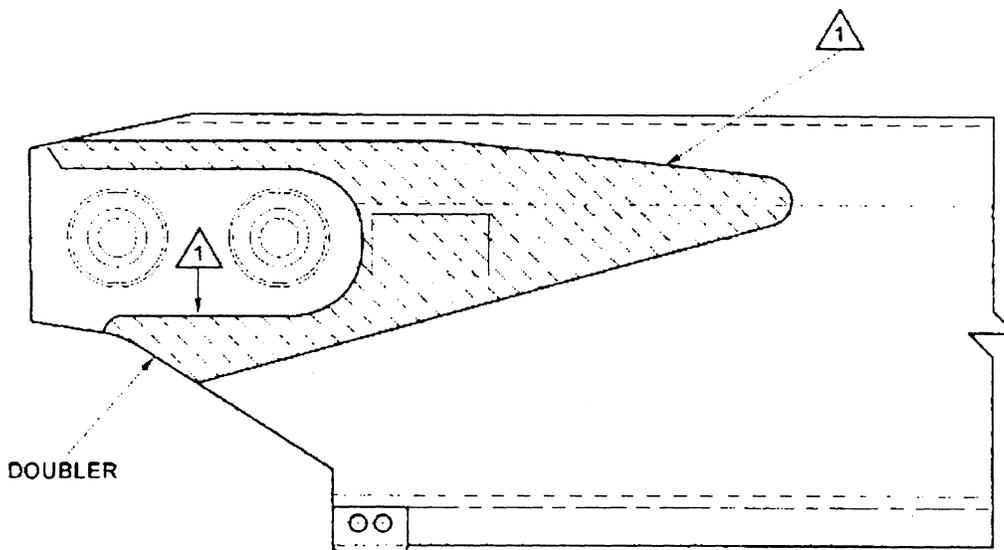
Transport Canada, the airworthiness authority for Canada, notified the FAA that an unsafe condition may exist on Model 206A, B, and L series helicopters. Transport Canada advises that an inadequate surface preparation on a limited number of blades resulted in two reported instances of blade root doubler de-bond. They also advise that to ensure blade integrity all suspected blades are to be checked daily until removed from service.

(a) Before the first flight of each day, clean each blade and visually check the blade root doublers for an edge void or de-bond on both sides of each blade as depicted in Figure 1 of this AD. An owner/operator (pilot), holding at least a private pilot certificate, may perform this visual check and must enter compliance with this paragraph into the helicopter maintenance records by following 14 CFR sections 43.11 and 91.417(a)(2)(v).

**1** Inspect the doubler for an edge void or de-bond on both sides of each blade.

(b) If an edge void or a de-bond is found, before further flight, replace the blade with an airworthy blade with a serial number other than those to which this AD applies.

(c) Within 100 hours time-in-service, replace all affected, serial-numbered blades with airworthy blades with a serial number other than those to which this AD applies.
