[Docket No. FAA-2005-22696; Directorate Identifier 2005-SW-22-AD]

Airworthiness Directives; Bell Helicopter Textron Canada Model 206A, B, L, L-1, L-3, and L-4 Helicopters

ACTION: Notice of proposed rulemaking (NPRM).

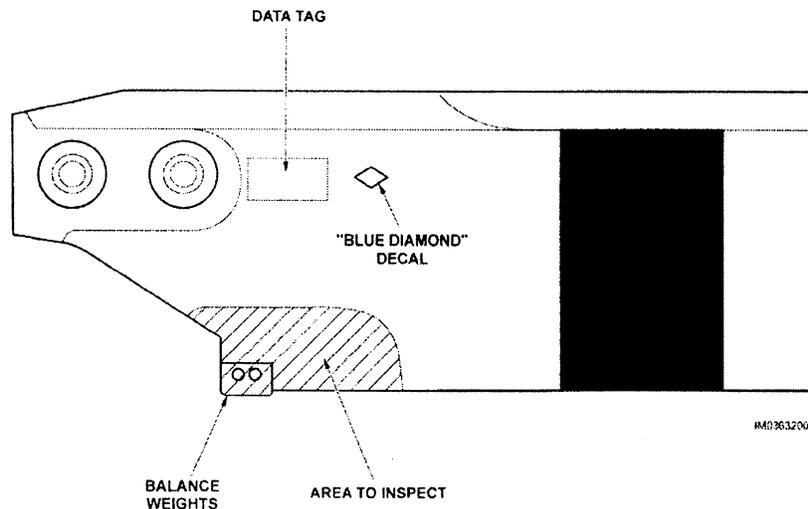
Figure 1. Tail rotor blade inspection.

installing any blade with a P/N and S/N listed in the applicability section of this AD, clean the blade. Using a 10X or higher magnifying glass, inspect both sides of each blade for a deformation, a crack, and a bent

or deformed weight in the area shown in Figure 1 of this AD.

Note 1: Paint irregularities on the blade may indicate a crack.

(1) At intervals not to exceed 12 hours time-in-service (TIS), using a 10X or higher magnifying glass, inspect both sides of each blade for a deformation, a crack, and a bent or deformed weight in the area shown in Figure 1 of this AD, or

(2) Inspect and check both sides of each blade for a deformation, a crack, and a bent or deformed weight in the area shown in Figure 1 of this AD as follows:

(c) Before further flight, replace any blade that has a deformation, a crack, or a bent or deformed weight with an airworthy blade.
