[Docket No. 98-NM-300-AD; Amendment 39-14355; AD 2005-22-11]

Airworthiness Directives; Mitsubishi Model YS-11 Airplanes, and Model YS-11A-200, YS-11A-300, YS-11A-500, and YS-11A-600 Series Airplanes

2005-22-11 Mitsubishi Heavy Industries, LTD.: Amendment 39-14355. Docket 98-NM-300-AD.

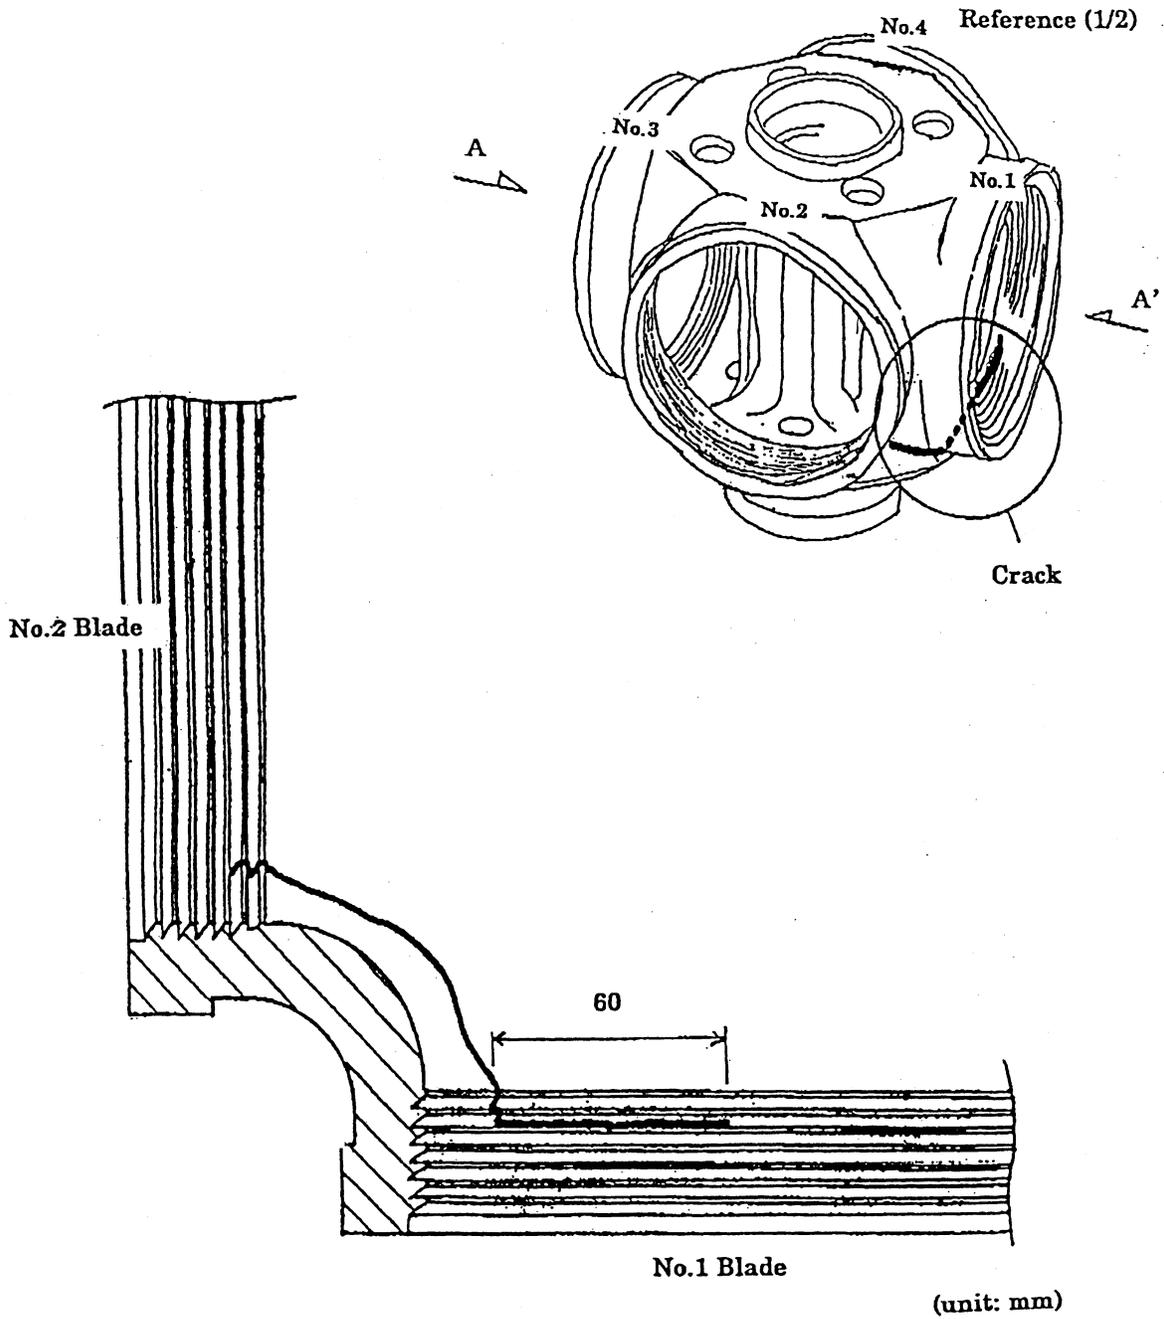
(a) Within 25 flight hours or 30 days after the effective date of this AD, whichever occurs first, remove the spinner and perform a detailed inspection for cracking of the propeller hub in the crack area shown in Figure 1 of this AD.

HUB CRACK - VIEW FROM TOP

(Cut A-A')

(1) If no crack is found, repeat the actions required by paragraph (a) of this AD thereafter at intervals not to exceed 25 flight hours.

(2) If any crack is detected, prior to further flight, replace the hub with a new hub according to a method approved by either the Manager, Los Angeles Aircraft Certification Office (ACO), FAA; or the Japan Civil Aviation Bureau (JCAB) (or its delegated agent). Chapter 61 of the Nihon Aeroplane

Manufacturing Company YS-11 and YS-11A Aircraft Maintenance Manuals is one approved method. Repeat the actions required by paragraph (a) of this AD thereafter at intervals not to exceed 25 flight hours.

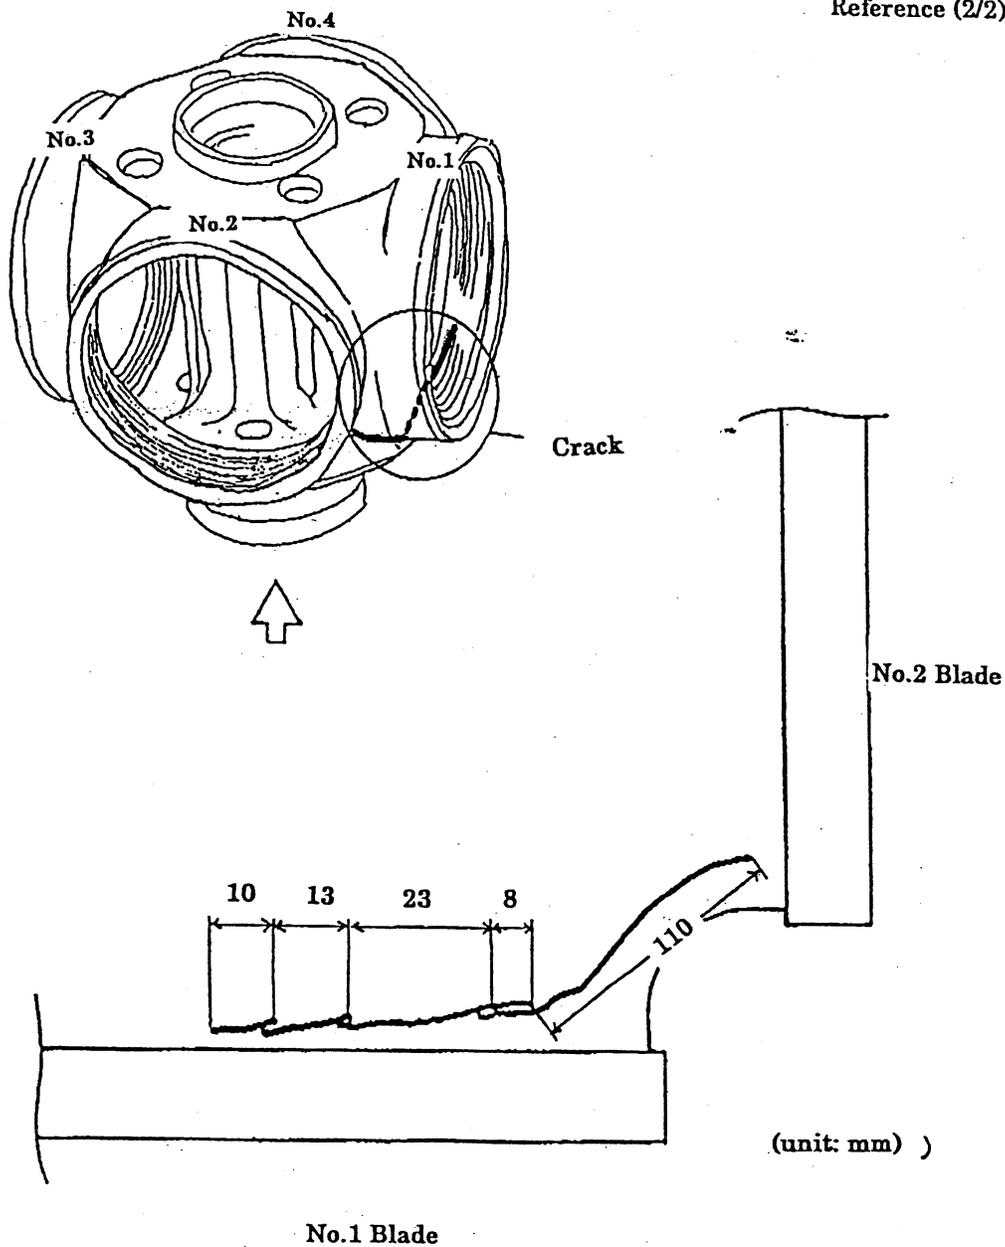
HUB CRACK - VIEW FROM BOTTOM
