[Docket No. FAA-2005-23221; Directorate Identifier 2005-CE-51-AD; Amendment 39-14459; AD 2006-02-51]

Airworthiness Directives; Raytheon Aircraft Company Model 390 Airplanes

ACTION: Final rule; request for comments.

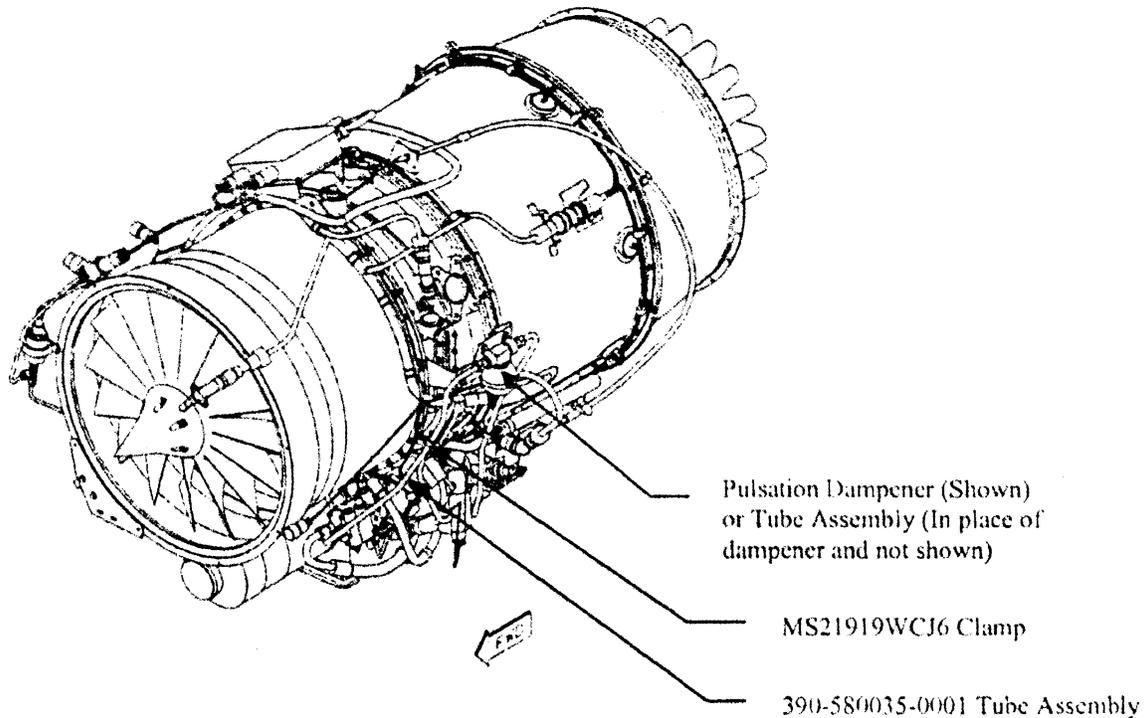
The FAA received reports of four failures of the part number (P/N) 390-580035-0001 hydraulic tube assembly located on the left engine assembly of Raytheon Model 390 airplanes. The failures resulted in in-flight loss of hydraulic fluid. The tube is installed between the hydraulic pump and the hydraulic pulsation damper and carries hydraulic pump output pressure.

(d) This AD is the result of failure of the hydraulic tube assembly, which caused in-flight loss of hydraulic fluid. We are issuing this AD to prevent failure of the hydraulic tube assembly and the clamp and consequent leaking of hydraulic fluid. This failure could result in loss of hydraulic system functions and risk of fire because of flammable fluid leakage in the engine nacelle and lead to loss of control of the airplane.

Figure 1. Hydraulic Tube Assembly with Clamp on Left Hand Engine.

Actions	Compliance	Procedures
<p>(1) Perform a one-time visual inspection of the hydraulic tube assembly and clamp using Raytheon Safety Communique No. 267, dated January 2006. Perform repetitive detailed inspections thereafter per Raytheon Mandatory Service Bulletin No. SB 29-3771, dated January, 2006.</p> <p>(i) The tube assembly part number is P/N 390-580035-0001 or P/N 390-580035-0005).</p> <p>(ii) The clamp part number is P/N MS21919WCJ6 or P/N MS21919WCJ7.</p> <p>(2) Replace the hydraulic tube assembly (P/N 390-580035-0001 or P/N 390-580035-0005) and the clamp (P/N MS21919WCJ6 or P/N MS21919WCJ7) (or FAA-approved equivalent part numbers) with new P/N 390-580035-0001 or P/N 390-580035-0005 and P/N MS21919WCJ7 (or FAA-approved equivalent part numbers) or used parts.</p> <p>(3) Report the results to FAA of each inspection or replacement required in paragraphs (e)(1) and (e)(2) of this AD. The Office of Management and Budget (OMB) approved the information collection requirements contained in this regulation under the provisions of the Paperwork Reduction Act of 1980 (44 U.S.C. 3501 and those following sections) and assigned OMB Control Number 2120-0056.</p>	<p>Visually inspect before further flight after February 2, 2006 (the effective date of this AD), except for those who received emergency AD 2006-02-51, issued January 19, 2006, unless already done. Perform the detailed inspection within 10 hours time-in-service (TIS) after February 2, 2006 (the effective date of this AD), except for those who received emergency AD 2006-02-51, issued January 19, 2006, unless already done. Inspect thereafter at intervals not to exceed 50 hours TIS. You may perform the detailed inspection before further flight instead of the visual inspection. Emergency AD 2006-02-51 contained the requirements of this amendment and became effective immediately upon receipt.</p> <p>Replace the clamp at each inspection. Replace the tube assembly prior to further flight after any inspection where evidence of chafing, excessive vibration, wear, deterioration, or hydraulic fluid leakage is found. Refer to SB 29-3771, dated January, 2006 for acceptance/rejection information for the tube assembly.</p> <p>Within 10 days after the inspection or replacement or within 10 days after February 2, 2006 (the effective date of this AD), except for those who received emergency AD 2006-02-51, issued January 19, 2006, whichever occurs later.</p>	<p>For the visual inspection, use Raytheon Safety Communique No. 267, dated January, 2006. For the detailed inspections, use the procedures in Raytheon Mandatory Service Bulletin No. SB 29-3771, dated January, 2006.</p> <p>Follow the procedures in Raytheon Mandatory Service Bulletin No. SB 29-3771, dated January, 2006.</p> <p>Include in your report the airplane serial number, the TIS of the airplane, and the TIS of the hydraulic tube assembly (P/N 390-580035-0001 or P/N 390-580035-0005) (or FAA-approved equivalent part number). E-mail/send your report to James P. Galstad, Propulsion Aerospace Engineer, ACE 116W, Wichita Aircraft Certification Office, 1801 Airport Road, Room 100, Wichita, Kansas 67209; e-mail: james.galstad@faa.gov; telephone: 316-946-4135; facsimile: 316-946-4107.</p>
